Volume XXII Issue 2 January 29, 1971

Important Information for your Service Department

Prepared and Distributed by **RCA Sales Corporation, Product Performance** 600 N. Sherman Drive, Indianapolis, Indiana 46201

Hum Bars and/or Degaussing "Interference"—CTC 44, CTC 47

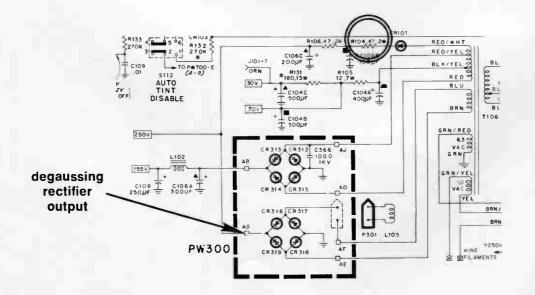
Power supply circuit—CTC 44

R104, in the 250V DC supply circuit, is a 47 ohm, 2 watt flame retardative (film) type resistor in early-production instruments. In the event this resistor fails, the instrument may continue to operate on the 220V DC supplied by the degaussing bridge rectifier output. See **Automatic Degaussing** on pages 49 and 50 of the **RCA 1971 Product Technical Manual** for a detailed circuit explanation.

Symptoms for R104 failure may include a hum bar and/or degaussing "interference" in the raster. For a quick check unplug the degaussing coils. Loss of video will result if the 250V DC supply in inoperative.

In those specific chassis where R104 fails, replace with a 47 ohm, 4 watt flame retardative type resistor (Stock No. 132879, Drawing No. 993118-241). Replacement information for R106 (47 ohm, 2w-film) is: Stock No. 132951, Drawing No. 1408729-393.

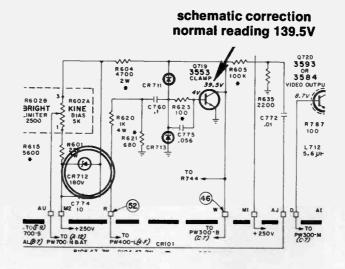
Kine bias, clamp circuitry—CTC 44

Some brightness symptoms in these chassis which are generally associated with CRT circuitry may be due to a leaky or shorted zenor diode, CR712. Symptoms may include: Retrace lines in raster; inability to cut off raster with brightness control; not possible to extinguish lines with screen and/or kine bias controls during color temperature setup procedure.

Also, in Service Data 1970 No. T15 (the CTC 44 chassis) on page 30 of the schematic diagram the collector voltage of Q719 clamp transistor should read "139.5V".

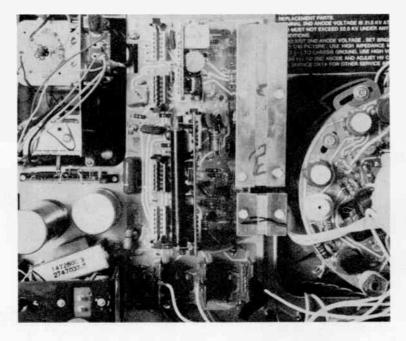
Module sockets, PW 300-CTC 49

CAUTION: When troubleshooting any chassis using plug-in modules, keep spray chemicals away from the module sockets.

This caution note pertains to both the 36 terminal type socket used in the CTC 47 Tuner Control Assembly (TCA) and the 6-terminal type socket. The 6-terminal type is utilized in several color chassis, including the CTC 49, as well as those black and white chassis equipped with plug-in modules. It has been found that certain ingredients in spray-type chemical troubleshooting aids (especially circuit coolers) attack the socket material and cause failures.

In those instances where high contact resistance at the plug-in connections is suspected, clean the edge connectors of the module with an ordinary pencil eraser. Normally the socket contacts can then be cleaned by inserting, then removing the module two or three times.

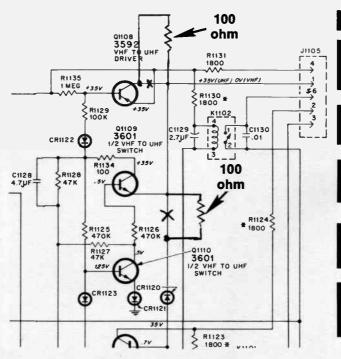
Circuit modifications-CTP 19A

If the VHF to UHF Driver transistor (Q1108) in the CTP 19A remote amplifier fails (shorts) the instrument will go to the "U" function only.

Should this failure occur in early-production versions of this chassis the following circuit changes will improve reliability. Later-production chassis have these changes.

Mechanical buzz or hum in instruments utilizing the CTC 44/CTP 19A chassis may be from the remote power transformer mounting. The buzz will be evident any time the Master switch is "on". In those specific instruments exhibiting a buzz, tighten, then solder the remote power transformer (T1102) mounting tabs.

- 1. Add a 100 ohm, 1/2 W resistor (Stock No. 502110, Drawing No. 735730-50) in series with the collector lead when replacing Q1108.
- 2. Unsolder CR1120 cathode lead and add a 100 ohm, 1/2 W resistor (Stock No. 502110, Drawing No. 735730-50) in series.

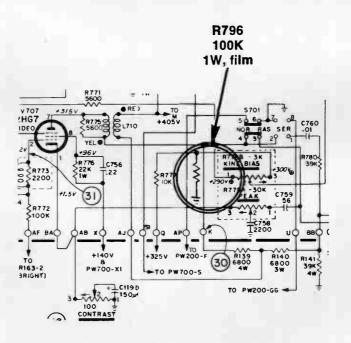
Kine bias control circuit—CTC 39X

Reduced Accu-Tint range in the CTC 39 chassis may be the result of a resistor (R796, 100K, ½ watt) changing value. There also may be a tendency towards blooming during scenes which contain large areas of red information.

In the event of R796 failure use the following replacement information.

SYMBOL	STOCK	DRAWING	DESCRIPTION
No.	No.	No.	
R796	133057	993115-273	100K ohm, 1 watt, film

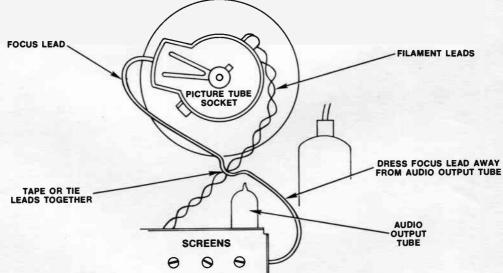
Picture tube focus lead-CTC 38

One such possibility concerns the lead dress of the focus lead attached to the picture tube socket of the CTC 38 and CTC 39 chassis. During manufacture the black focus lead is attached with tape or a wire tie to the two brown filament leads. This lead dress is established to keep the focus lead away from the audio output tube. If this lead dress is not maintained, over a period of time heat from the tube may cause deterioration of the insulation. The end result can be an audio output tube failure due to arcing between the lead and the tube elements.

To insure maximum reliability this lead dress should be checked whenever the instrument is serviced for any reason.

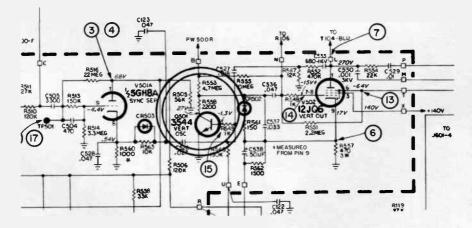
Vertical deflection circuit—CTC 36

No vertical sweep (oscillator does not restart) under these conditions indicates the possibility of an off-tolerance Q501.

Caution: Output components (such as tube V502 and/or cathode resistor R557) may be damaged if the instrument has been operated any length of time without the vertical oscillator running.

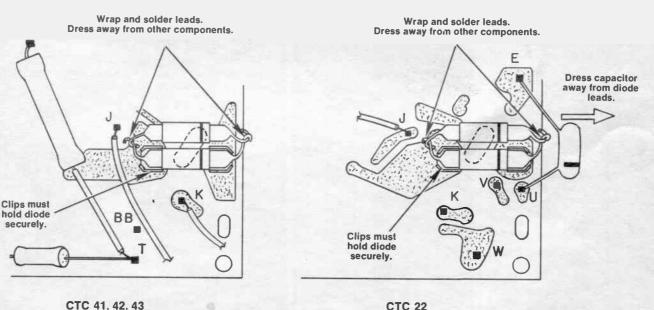
Installation of damper diodes in parallel

For maximum reliability of the solid state damper diode as utilized in these chassis, it is advisable to use two devices in parallel when replacement is required.

- 1. Wrap the diode leads together and solder. Make a good mechanical and electrical bond. Keep leads as short as possible, clip off excess. Space diodes approximately 1/8" apart for easier installation.
- 2. Install the diodes as shown in the appropriate illustration.
- Caution: Relatively high differences in potential exist between the damper diode terminals and other components in the immediate area. These components include capacitors, the metal chassis, board terminal stakes and associated leads, and printed circuitry on the PW400 board itself as well as adjacent boards. Be sure the diode leads are dressed well away from these components. Make certain the mounting clips hold the diodes securely in position after proper lead dress has been established.

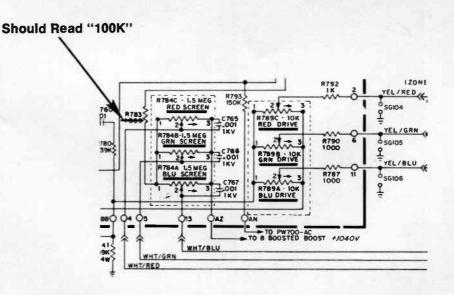
Screen Control Circuitry-CTC 39X

The resistance of R783 is shown on the schematic as "1000". The correct value is 100K. Using a 1000 ohm resistor in this application may result in color temperature setup problems and/or reduced Screen control (R784A,B,C) life.

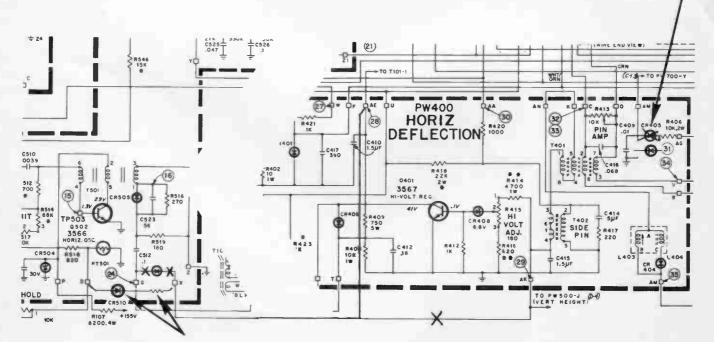
Horizontal Deflection Circuitry-CTC 44

A. Should commutator SCR (SCR 102) failure occur in early-production versions of the CTC 44 chassis the following circuit change should be made to optimize reliability.

B. CR 405 is reversed on the schematic. The cathode rather than the anode should connect to terminal PW 400-AH.

- 1. Move CR 510 anode lead from PW 500-G to PW 500-D.
- 2. Add to 1000 ohm, 20%, 1/2 watt resistor in series with CR 510 cathode lead (to PW 500-X). Use heat shrinkable tubing or spaghetti over the diode and resistor.
- 3. Change the jumper connecting terminal PW 500-X to the PW 400 board from terminal AK to AE.

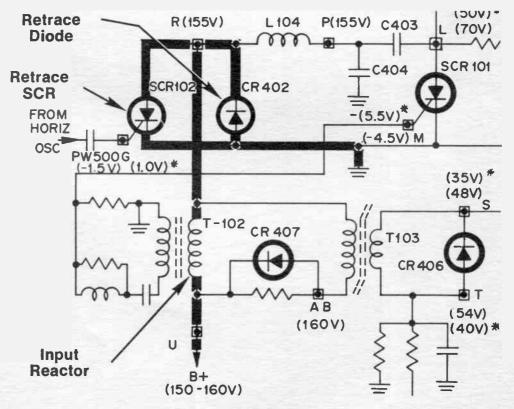
Basic SCR Deflection System—Partial Schematic

A poor, but common troubleshooting technique—the practice of jumpering the circuit breaker in order to locate B+ shorts—can often make a difficult service job out of a relatively simple one as it may cause additional component failures. Locating the **induced** problems usually requires more involved troubleshooting techniques than finding the **original** one.

One example of this can become quite evident when servicing the SCR Sweep System. In the event the Retrace SCR (SCR 102) or Retrace Diode (CR 402) fails (shorts), the 155 volt supply is connected to ground via the Input Reactor (T102) primary winding. Consequently the circuit breaker will trip—the normal protective action. If circuit breaker action is defeated for only a short time (4-8 seconds) either by holding the breaker "in" or by jumpering, the Input Reactor will be overloaded, resulting in the possibility of shorted turns. Now, after the original defective component (shorted Retrace SCR or Retrace Diode) is replaced, a new induced symptom of "No High Voltage, Circuit Breaker Holds" will be evident. Additional servicing time will be required to find that the Trace SCR has no gate pulse because the Input Reactor has shorted primary turns.

Also, damage to the filter choke and/or power transformer can be expected if the chassis is operated for any length of time with the circuit breaker jumpered. Current instruments utilizing such chassis as the CTC 46, CTC 49, and CTC 54 have a fuse in series with the circuit breaker for protection in the event breaker action is defeated.

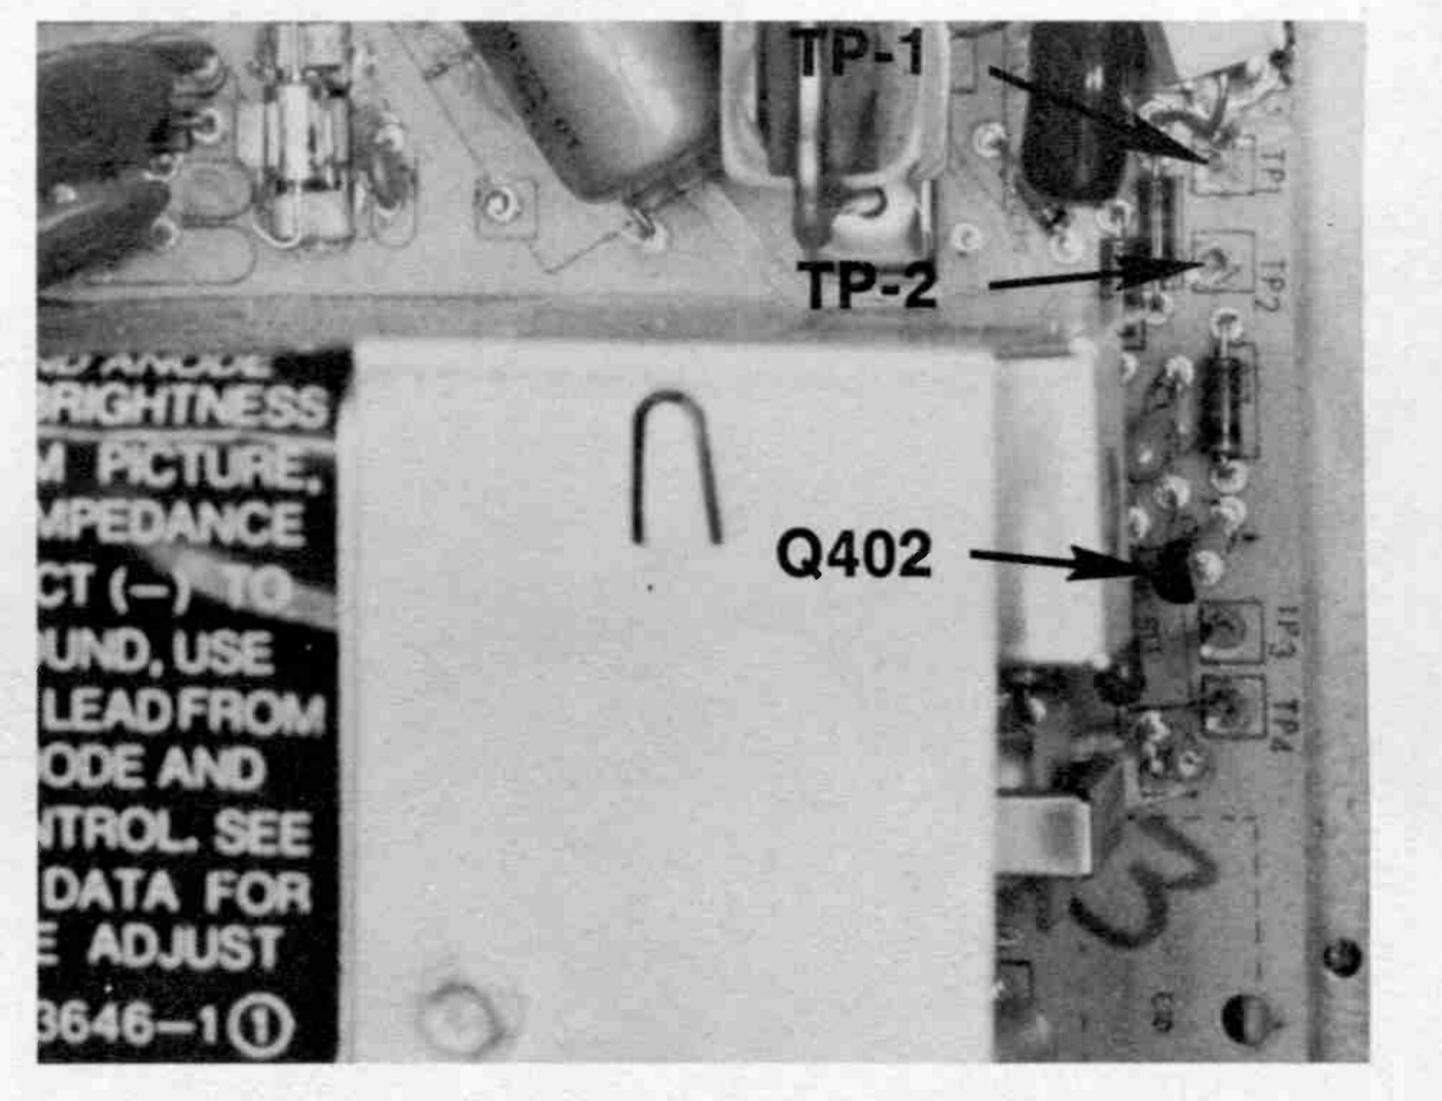
Current production instruments have incorporated

several changes to improve the reliability of this circuit. It is recommended that these changes be incorporated into any chassis where the Disable Circuit causes a problem.

- (b) If less than +9V is measured at collector, replace zener diode CR 409 (RCA Stock No. 130044), and Q402.
- (c) If a negative voltage is measured at the collector of Q402, replace CR 401 (trace diode).

- 1. Replace resistor R429 (82 ohm, ½ W located in emitter circuit of Q402) with a permanent jumper.
- 2. Change resistor R122 (4700 ohm, ½ W, film) to a 1000 ohm, 2 W wirewound resistor (RCA Stock No. 132881). R122 is mounted on a terminal strip located on the rear of the chassis immediately behind the quadrupler.

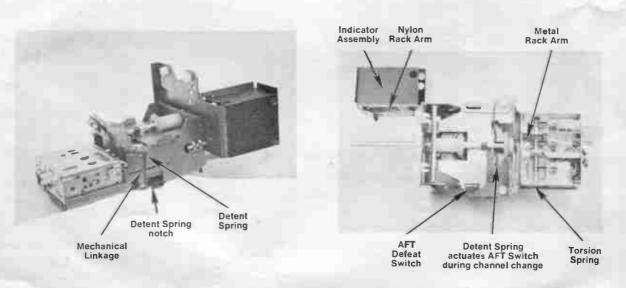
KRK 170 Tuner Assembly

Improper installation of the Detent Spring can result in poor UHF operation. If the spring is not seated in its notch (see photograph), the mechanical linkage to the UHF tuner will be restricted. This can result in the symptom of "will not tune to lower channels" or "will not tune to higher channels". Since the detent spring actuates the UHF AFT Defeat Switch during channel change, incorrect installation can result in loss of AFT during both VHF and UHF reception. In addition, there is the possibility of a weak or improperly installed Detent Spring causing the symptom of "will not return to programmed channels".

Torque to return the tuning gang to the lowest channel is supplied by a torsion spring (see photograph for location). The indicator drum is also spring-loaded by a coil spring located inside the drum. Anything that restricts the travel of either the Nylon Rack Arm (meshes with the Drum Gear) or the Metal Rack Arm (meshes with Tuning Gang Gear in Tuner) can cause the symptom of "erratic operation". Possible areas to check should this symptom exist are: Indicator Drum rubbing its cover—due to an out-of-alignment drum or peeling of the numbered tape; Nylon Retainer not seated properly—could occur when the UHF dial light is replaced; excessive or improper lubrication.
