Drake R8: Low Headphone Volume And Broken Feet

Dallas Lankford, 7 V 93

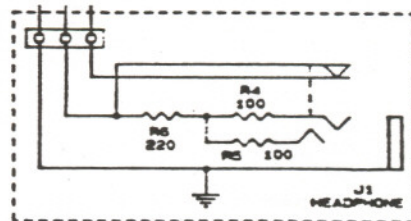
I doubt I am the first R8 owner to be annoyed by the low headphone volume. I use Radio Shack lightweight mono headphones, #20-210A, rewired to a standard stereo plug. The mono headphones are rated 16 ohms, and, presumably, rewired in series each earphone is 32 ohms. So 8 ohm headphone users must get even lower headphone volume than I got. I removed the R8 front panel (1.5 mm and 2 mm Allen metric hex wrenches required), removed the nut which secures the R8 headphone jack and small attached PC board, unplugged the small PC board, and "Chinese puzzled" it out of the R8. Then I desoldered and removed R4, R5, and R6. Use ChemWick Lite 0.100 desoldering braid, the only desoldering braid which works. I replaced R6 with 47 ohms and R4 and R5 with 10 ohm, 1/4 watt resistors (Radio Shack). Depending on the type of headphones you use, some other resistor values may be optimal for you.

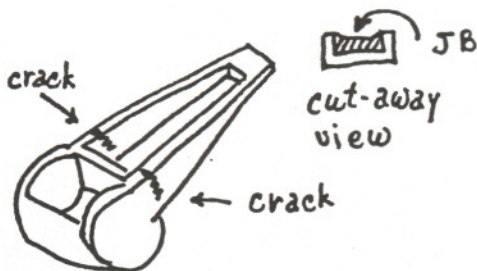
And I doubt I am the first R8 owner to have the tilt feet crack or break. Mine cracked as shown below. Getting a new pair of feet did not seem like a practical solution because they would probably crack too after a few months of use. So I tried filling the hollow space in the long "neck" with J B Weld, which is available at many discount stores. I mixed about 1/3 of each of the two 1 ounce tubes ("STEEL" and "HARDENER") to have plenty of excess, and filled up the hollow spaces in the "necks" of the feet using a toothpick to dab in the thick mixture. If you put the mixture in the feet as soon as you mix it, the mixture will "flow" a little and will mostly level out, except at the edges where surface tension draws it up. I did not fill the spaces completely, maybe within about 1/32 inch of full. Any excess I got on the sides of the feet was easy to remove with toothpicks. When dry, the J B Weld shrunk a little, which is good, because the back sides of the "necks" must clear the mounting screws. I let the J B Weld harden for about 2 days before reinstalling the feet. So far, so good. Whether this is a long term fix remains to be seen.
