RADIO SERVICE SHORT CUTS

RADIO
and
Television **RETAILING**

RADIO RETAILING'S "Service Shortcuts"

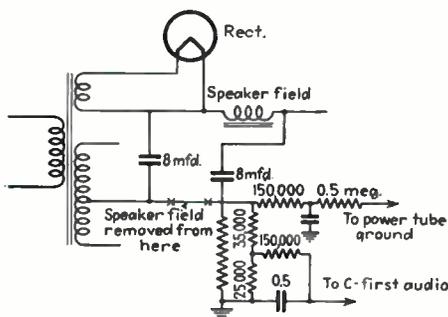
Occasionally an old set turns up that, even after a new filter is installed, hums badly. In most cases it will be found that these sets have the speaker in the negative lead. Miscellaneous bias voltages are taken from the voltage drop across the field. Additional filtering at this network is of little value.

An effective cure is to remove the field from its original position and connect in the B+ lead, as shown in the diagram. An 8 mfd condenser, each side of the field will then be sufficient to remove all hum.

The disadvantage of this system is that another bias network must be devised. This may be accomplished by grounding the B- lead through a resistance of a few hundred ohms. The exact value of the resistance depends on the total current drawn by the set and the amount of bias voltage required.

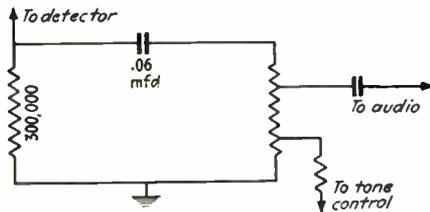
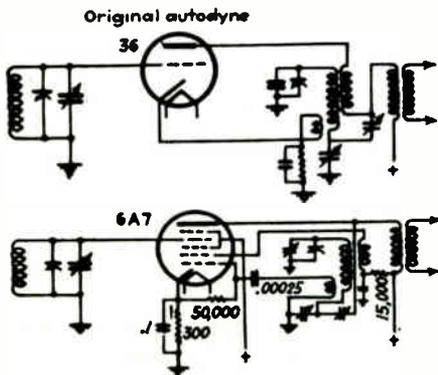
PHILCO 14, 91

PHILCO 14 (Early). 36 autodyne first detector does not oscillate stably at lower frequencies, changing of oscillator coils and bias resistor does not affect permanent cure. Nor does replacement of tube, mica in tuning gang trimmers or

cloth covered wiring . . . Substitute 6A7 for 36, employing new circuit diagrammed. The same oscillator coil is used, but the various windings employed differently. Slight retrimming of all condensers associated with circuit is all that is necessary when revamping has been done.

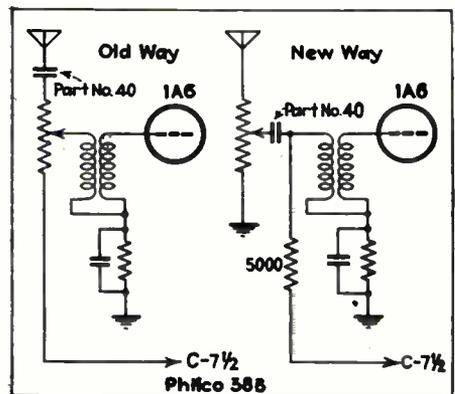
PHILCO 38B

Noisy volume control . . . bias voltage flows through control causing noise. Change circuit as shown below.

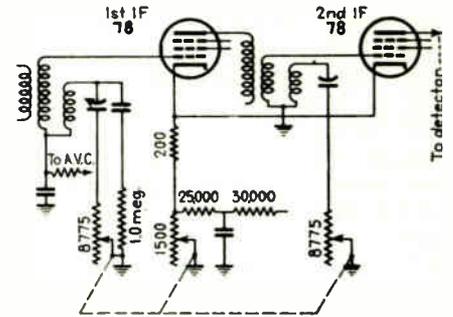
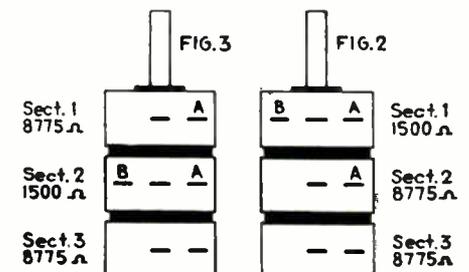
Upon installing the new control trouble was encountered. Instead of

operating like a fidelity control, the replacement part acted like a volume control.

The explanation is this: the fidelity control circuit for this set is shown in Fig. 1. Notice that the 1500 ohm section of the control is in the cathode circuit of the first and second i.f. tubes, in series with the 200 ohm resistor which provides the fixed bias. The two 8775 ohm sections are connected to the tertiary windings of the first and second i.f. stages respectively. On the original control (33-5083) the arrangement of the sections is as shown in Figure 2. In the replacement control (33-5103) the sections are arranged as shown in Figure 3. Comparison of the two figures will show that the 1500 ohm section is located differently in the replacement control, than it is in the original. It is this difference of construction which causes the unwanted volume control action, because if customary repair procedure is followed in replacing each wire in its original position, instead of having a 1500 resistance in the cathode circuit, we will have 8775 ohms. As the control shaft is rotated the bias on the 78 i.f. tubes will gradually be increased to a value which will make the tubes inoperative.

In order to obtain the correct replacement for 33-5083 it is merely necessary to transpose the wiring on sections 1 and 2. The control will then operate properly. Put the single wire, lug A section 1, on lug A, section 2. Put the two leads from lug A section 2, on lug A section 1. Lug B is blank on both controls.

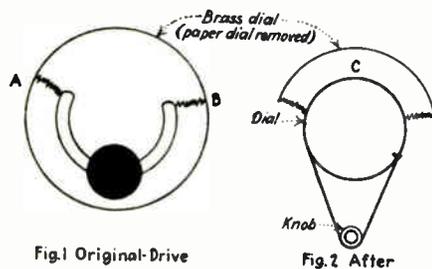
SPARTON AC7, 62, 63. Replacing worn-out friction dial drives . . . Remove chassis from set. Remove spring tension arrangement from shaft and replace with brass rod or old variable condenser spacer tube, drilled to fit snugly over shaft. File brass rod down until it is spool shaped, similar to spools used on sewing machines. This may be done by putting the rod of spacer tube on a small bolt, rotating the bolt in an electric drill and holding a file against it. The spool should now be covered with tape and metallic-xed (a cement) in place. It should then be soldered to the knob shaft, easily removed by lifting the spring before the tape is ce-

mented to the shaft. Remove the paper dial from the set by taking out the round brass clip holding it in place. Cut the slotted brass disc at A & B, shown in diagram, wrap piece of dial cable around the drum portion of dial as shown in 2. Solder in place at spot marked C and wrap two turns around spool on shaft. Splice or solder ends at C, replace paper dial and the job is done.

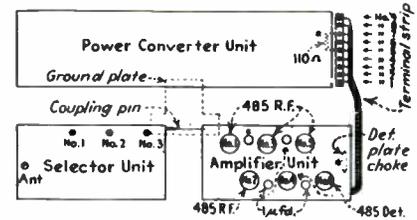
Front of Radio Chassis
Note: Asterisk - * marks location of parts which most often become defective

Turn volume control completely off. If noise similar to static results check detector plate choke before suspecting control. If new choke cannot be ob-

tained remove all wire from old choke form and scramble-wind the form full of No. 36 enamelled wire. Solder ends to terminals and do not use anything but pure rosin flux. Impregnate choke with commercial r.f. coil dope or something similar. If set operates but volume is low and decreases after passing half-way point on control trouble is usually due to open in 110-ohm wire-wound resistor connected between terminals 5 and 7.
