TELEVISION TECHNOTES

MARTIN CLIFFORD

Gernsback Library No. 46

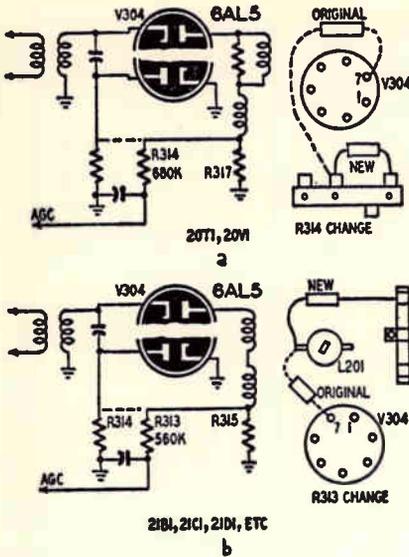
Fig. 3. Changes for fringe reception.

Inadequate reception in weak-signal areas. In weak-signal areas, where the noise level is high, the a.g.c. diode, V304, develops an a.g.c. voltage which is proportional to the peak-to-peak noise voltage. When the high a.g.c. voltage is applied to the controlled stages, the gain of the receiver is controlled by the noise level and not the sync-pulse level. This may result in loss of sync, poor contrast, or low sound level. Correct this situation by using the voltage developed across the video detector load for a.g.c. instead of the normal a.g.c. voltage developed by the a.g.c. diode. This change should *not* be made where strong signals may be received or overloading will result. The circuit diagrams on page 11 show the changes to be made.

Circuit change for 20T1 and 20V1 chassis:

1. Locate V304 (6AL5), video detector and a.g.c. tube.
2. Disconnect R314 (680,000 ohms) from pin 7 of V304.
3. Connect R314 as shown in Fig. a.
4. Remove tuner a.g.c. lead (white) from a.g.c. lug and ground the wire to the chassis.

Circuit change for 21B1, 21C1, 21E1, 21H1, and 21J1 chassis:

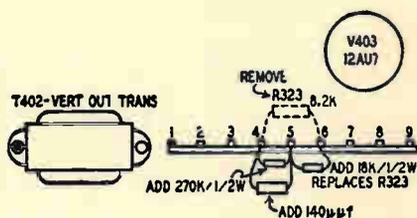
Fig. 4. Improved noise immunity in sync.

To improve noise immunity in the horizontal sync circuit. In some areas where the noise level is high, the noise peaks may affect the sync circuit and cause the picture to shake horizontally or lose horizontal sync. A change in resistor value and an additional filter in the sync circuit has been incorporated to reduce this trouble. The circuit change is effective with run 2 of 21B1 chassis and run 5 of 21C1 chassis.

Early production receivers may be modified by following this procedure and the circuit diagram:

1. Locate the 9-lug terminal strip adjacent to vertical output transformer T402.

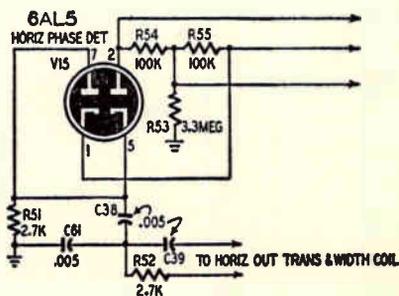
Fig. 7. Circuit for removal of foldover.

Horizontal foldover. When the a.f.c.

control is correctly adjusted, the picture will fall into horizontal sync in-

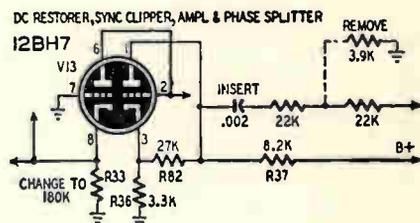
Fig. 8. Changes shown in circuit above will help improve the vertical sync stability.

3. Change plate-load resistor R37 from 3,900 ohms to 8,200 ohms. To further increase the vertical sync stability, insert a .002- μ f capacitor between the 22,000-ohm resistor shown

in the diagram and the plate, pin 1, of the sync amplifier and phase-splitting tube, V13. In conjunction with this change, remove the 3,900-ohm resistor from the junction of the 22,000-ohm resistor to ground. For more vertical sync stability in strong-signal areas, change the 270,000-ohm grid resistor, R33, of V13, to 180,000 ohms. These are production changes.

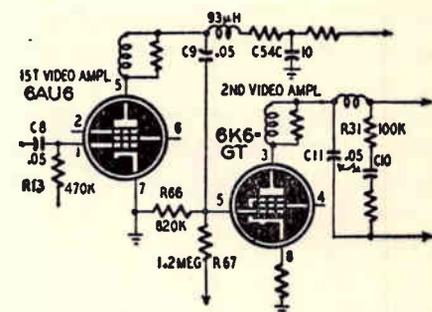
Picture smear. Insufficient bias on video amplifiers, resulting in grid current on video signal. Defective cou-

Fig. 14. Check this circuit for smear.

pling or grid-load resistor. Check R13, R67, R66, R31; C8, C9, C10, C11, C54C. (See illustration above.)

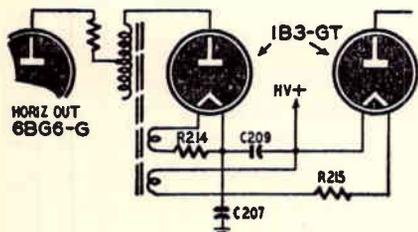
Fig. 13. Circuit check for no high voltage.

No high voltage, no horizontal deflection. Open h.v. winding on horizontal output transformer (terminals 2 and 3).

Defective 1B3-GT (check by substitution; tube may check good, yet be gassy). Open 1B3-GT filament circuit. Shorted capacitors C209 or C207. Open resistors R214 or R215. (See illustration, Fig. 13, shown above.)

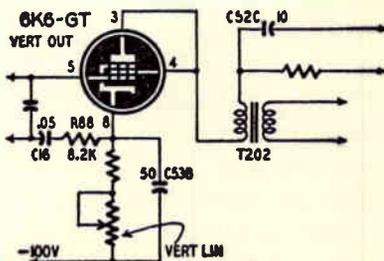
Fig. 15. Checks for vertical nonlinearity.

Vertical nonlinearity. Incorrect adjustment of vertical linearity control. Defective 6K6-GT vertical output. Defective vertical output transformer. Defective resistor R88; capacitors C16,

C53B, or C52C. (See illustration above.)

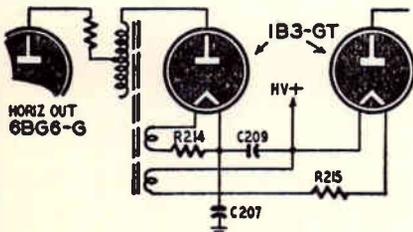
Fig. 13. Circuit check for no high voltage.

No high voltage, no horizontal deflection. Open h.v. winding on horizontal output transformer (terminals 2 and 3).

Defective 1B3-GT (check by substitution; tube may check good, yet be gassy). Open 1B3-GT filament circuit. Shorted capacitors C209 or C207. Open resistors R214 or R215. (See illustration, Fig. 13, shown above.)

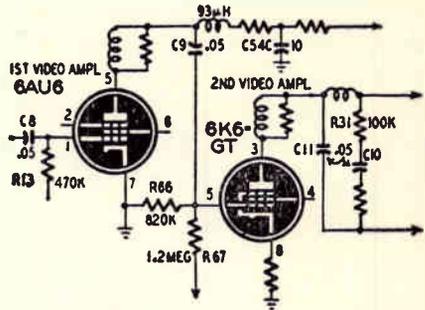
Picture smear. Insufficient bias on video amplifiers, resulting in grid current on video signal. Defective cou-

Fig. 14. Check this circuit for smear.

pling or grid-load resistor. Check R13, R67, R66, R31; C8, C9, C10, C11, C54C. (See illustration above.)

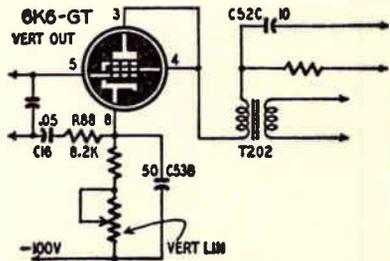
Fig. 15. Checks for vertical nonlinearity.

Vertical nonlinearity. Incorrect adjustment of vertical linearity control. Defective 6K6-GT vertical output. Defective vertical output transformer. Defective resistor R88; capacitors C16,

C53B, or C52C. (See illustration above.)

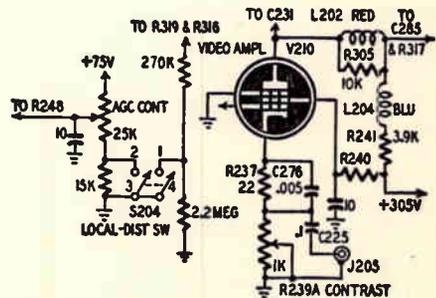
Fig. 21. Video amplifier in RA-112A, -113, -117 receivers.

Improving picture strength in weak-signal areas. In some weak-signal areas it is impossible to obtain a satisfactory picture, even with a very good antenna system. By narrowing the bandwidth and increasing the gain of the video amplifier in these models, it is often possible to obtain a satisfactory picture where one could not be obtained previously. The original circuit is shown

in Fig. 21, modified circuit in Fig. 22 and component location after modification in Fig. 23. The LOCAL-DISTANCE

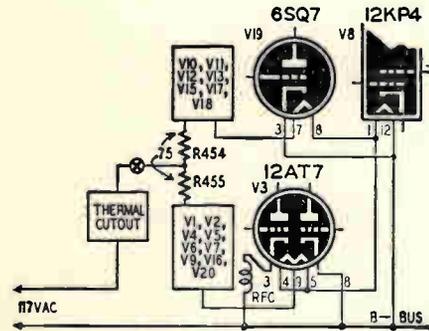
Fig. 30. Intermittent raster test points.

Intermittent raster. All voltages, socket connections, and tube heaters were

checked for intermittents without finding the trouble. The trouble was traced to an intermittent heater-to-cathode short in the 6SQ7, which short-circuited the heater of the picture tube.

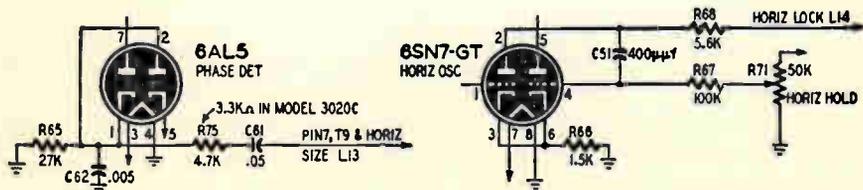
Fig. 34. Check the circuits shown above if the horizontal oscillator stops working or if the horizontal hold becomes critical. If the horizontal hold is erratic, check C61, .05 μf , by substitution.

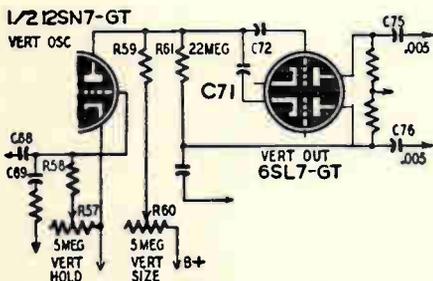
Fig. 37. Check circuit above for vertical non-linearity.

Poor vertical linearity. Defective 6SL7-GT vertical output. Defective 22-meg feedback resistor R61 (vertical output to vertical oscillator). (See illustration.)

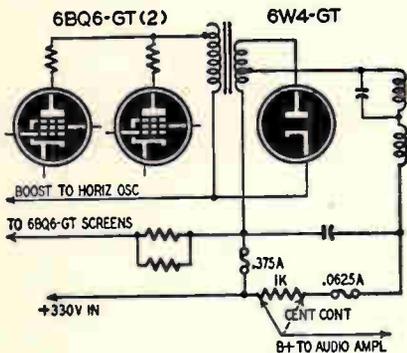
Fig. 47. Horizontal output and centering circuit.

Failure of horizontal centering controls. Under normal operating conditions, with the arm of the centering control in the position shown by the solid line in the illustration, practically all of the current required by the deflection system flows through the $\frac{3}{8}$ -amp fuse while the current required by the audio system is supplied directly from the 330-volt B-plus line through the

arm of the centering control. With the arm of the control in the position shown by the dotted line, practically all of the current required by the audio system flows through the $\frac{3}{8}$ -amp fuse, up through the secondary of the deflection transformer, through the horizontal deflection yoke, through the 1/16-amp fuse, and finally through the arm of the control to the audio amplifier. Assuming a B-plus short occurs in the deflection system, the $\frac{3}{8}$ -amp fuse will blow, and the current for the deflection system will then flow through the centering control which is pro-

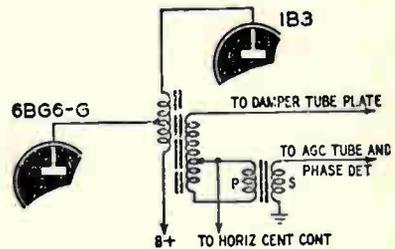
Fig. 48. Loss of sync due to open a.g.c. pulse coil.

Loss of horizontal sync. Loss of horizontal sync in the TC19, TC125, and

similar models is most often caused by an open primary on the a.g.c. pulse coil. This coil is connected across a section of the secondary of the flyback transformer as shown in the diagram. Disconnect one side of this coil from the flyback transformer before checking continuity.

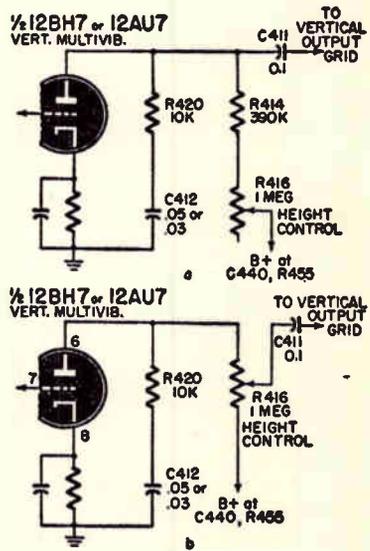
Fig. 53 Modification in height control circuit.

To increase control over picture height. Due to variations in character-

istics of 6K6-GT vertical-output tubes, a change has been made in the height-control circuit of later production models to provide increased control over picture height.

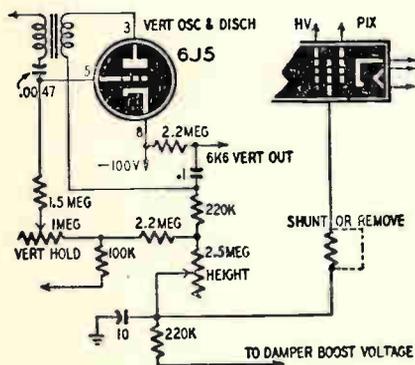
Fig. 55. Circuit to prevent spot formation.

of light that appears in the center of many TV screens immediately after the set is turned off. In most TV sets the picture tube first anode is supplied from some point in the power supply proper. The diagram shows how a
