RADIO SERVICE TRADE KINKS

LEWIS S. SIMON, R.E.

*Manager, Rexall Radio Stores,
Brooklyn, New York*

1939

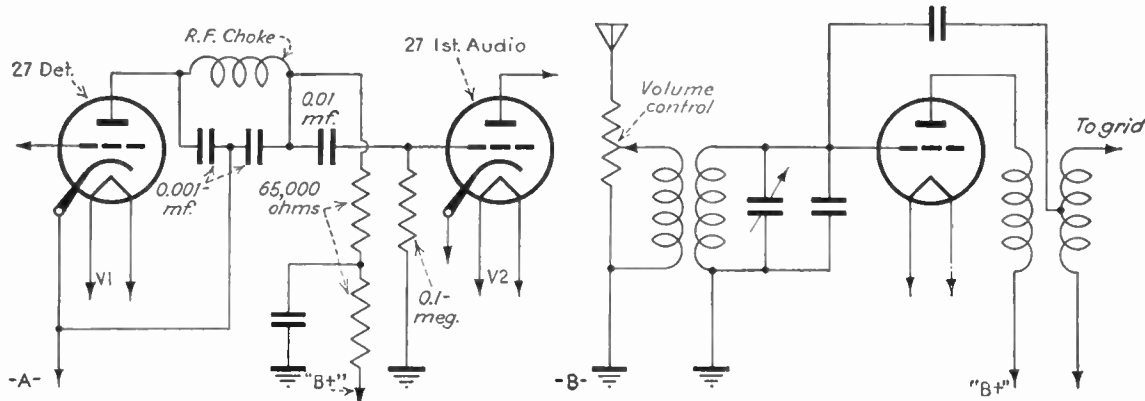
FIG. 7.—A shows a trouble in the Columbia S. G. 9. B, volume-control trouble.

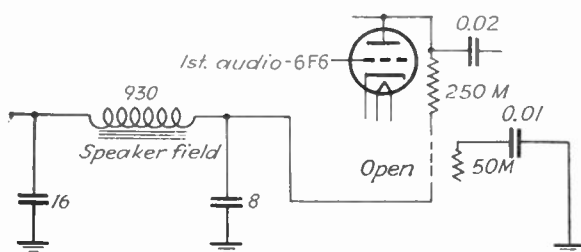
FIG. 10.

Excessive hum in the General Electric A65 receiver can usually be corrected by

making the additions indicated in the diagram shown herewith. Lead between plate coupling resistor and plate supply is opened and a 50,000-ohm resistor inserted. By-pass the resistor with a 0.01 or larger condenser.

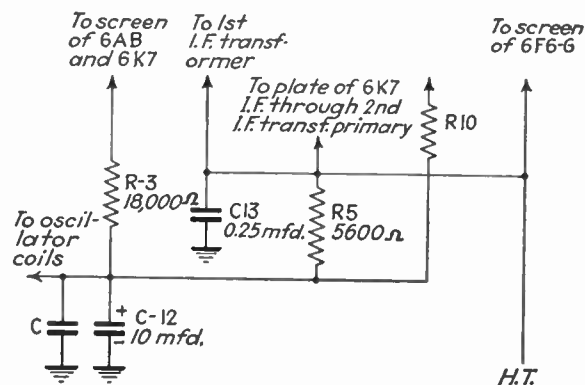
FIG. 16.

Mushy. The reception on the 13-meter band in the above-mentioned models is very mushy, and it was found that this was due to the oscillator frequency being modulated by the power-supply frequency. The trouble was put to an end by the addition of a condenser

of value between 0.002 to 0.005 mf. from the terminal on the oscillator coil where the plate voltage enters the oscillator coil to earth, as shown schematically in the diagram.

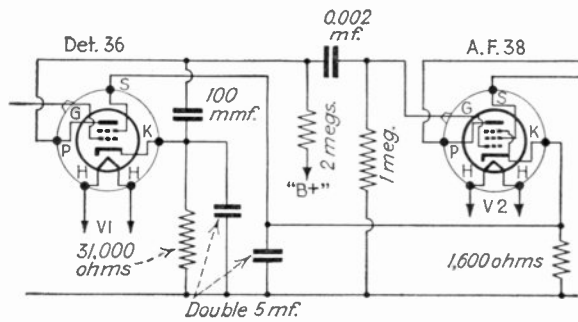
FIG. 17.

A case of low volume in this a.c.-d.c. set was traced to the double 5-mf. electrolytic condenser by-passing the cathode bias resistor in the detector and output stages, as shown in the figure on page 154. The condenser had decreased in capacity and when opened, seemed to have dried out, possibly owing to the heat from the heater-series dropping resistor that is mounted in the chassis near the condenser. However, the same trouble was

later found in a DeWald set of similar design having the resistor in the power cord. In this case, the decrease in capacity had not been so great.

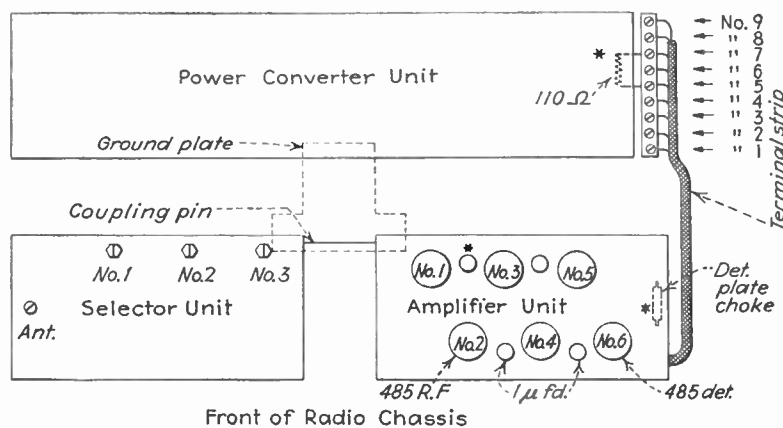
FIG. 21

Front of Radio Chassis
Note: Asterisk * marks location of parts which most often became defective

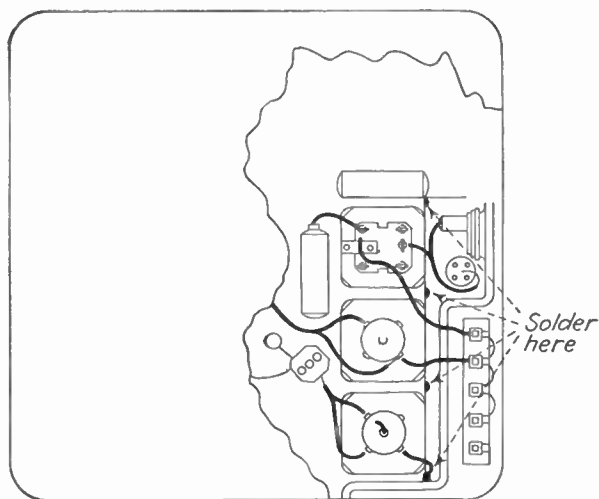
FIG. 24.—Points to be soldered in 1937 Zenith auto sets.
