ACTUAL TROUBLES IN COMMERCIAL RADIO RECEIVERS

1927 — 1934

BERTRAM M. FREED

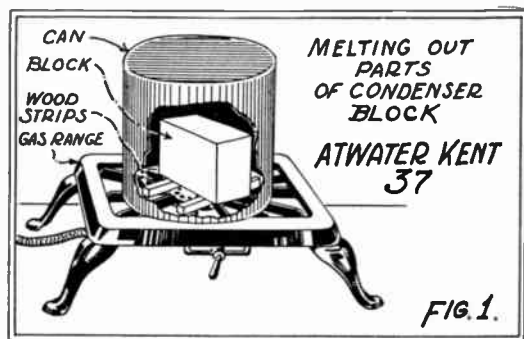
The most common cause for complaint with the Atwater Kent 37 probably is "shot" filter condensers. As these condensers are connected internally to the chokes in the power pack which consists of two sections, the power transformer block and the filter block, the problem of the best method of repair arises. At the time these sets were considered the "last word" in radio receivers, the cost of a new filter block was high, because only the original could

be obtained and that from the manufacturer. However, today, these or replacement blocks can be obtained quite readily and at most reasonable cost. There may be some Service Men, however, who prefer to repair these blocks. This can be done quite easily.

from the pack, it may be inverted upon two strips of wood in a can as shown in Figure I and heated in an oven or over a gas flame. The heat will soon melt the pitch used as a sealing compound, and if care is taken, the filter choke and output choke and small condensers may be saved as they fall out. After the can has been cleaned, all necessary parts are replaced, together with the salvaged parts, and melted paraffin or other insulating compound may be poured into the assembly to complete the job.

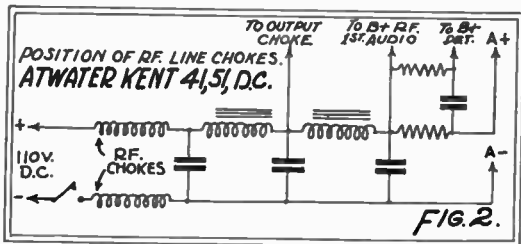
Should the condition be encountered, where the tubes, in this model, fail to light up, the first thought is a burnt-out tube because of the series filament circuit. Although this is usually the case, where it is found that the tubes have tested correctly and that the current supply is available at the receiver, the probability is, that one or both of the R. F. chokes in series with either side of the line has open-circuited. These chokes are wound on small composition bobbins and are located beneath the terminal strip in the power pack. They may be easily repaired by rewinding the bobbins with No. 22 cotton or enamelled wire. A diagram showing the connections may be seen in Figure 2.

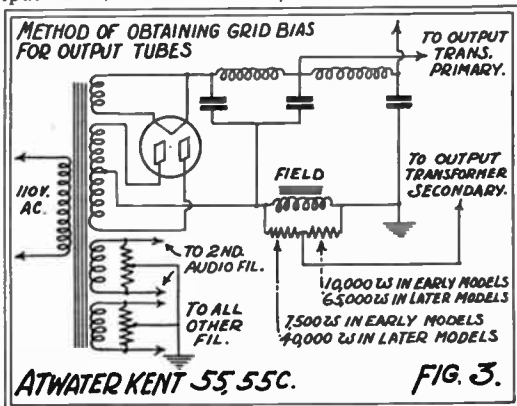
Should the condition of distorted reproduction be observed with the symptoms of unusually high grid bias, usually about twice its normal value, impressed upon the output tubes, the trouble may be traced to one of the

two resistors connected in series across the field coil, dividing the voltage drop across the field to obtain the proper grid bias for the output tubes as shown in Figure 3.

Most often the open resistor will be found to be that connected from the control grid bias tap to ground. In the early models, the value of this resistor was 10,000 ohms, while in the later model a 65,000 ohm unit is employed. This failure may be checked without removing the chassis from the cabinet by means of a point-to-point resistance test, but in order to accomplish this, it is necessary to remove the speaker plug or else an erroneous indication will be obtained.

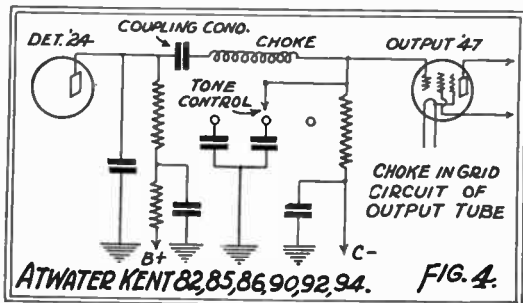
The complaint of low volume and poor tone and especially little response when the tone control is set at the

"bass" position, will be found to be caused by an open R.F. choke in the output pentode control grid circuit.

This failure will not be disclosed by the use of a set analyzer, as all voltages will be intact when this choke open-circuits resulting only in breaking the coupling between the plate of the second detector and the grid of the pentode tube as shown in Figure 4. In some cases, the open circuit in this choke will consist of a break in one of the leads which may easily be repaired as it emerges from the bobbin winding, although shorting out the choke entirely has produced no noticeable ill-effects. Where it is desired however, a new unit may be installed.

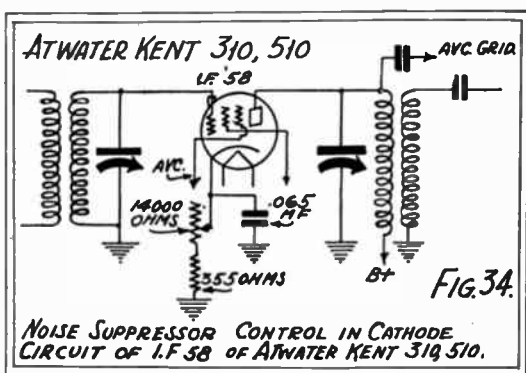
This receiver employs a noise suppressor control in the cathode circuit of the '58 intermediate frequency ampli-

fier as shown in Figure 34. The purpose of this control is that of reducing the sensitivity of the receiver so that a minimum of interference will be present when the dial is rotated from station to station. Where little or no effect is obtained, when this control is adjusted, the trouble

has been found to be caused by the variable resistance. The remedy is replacement.

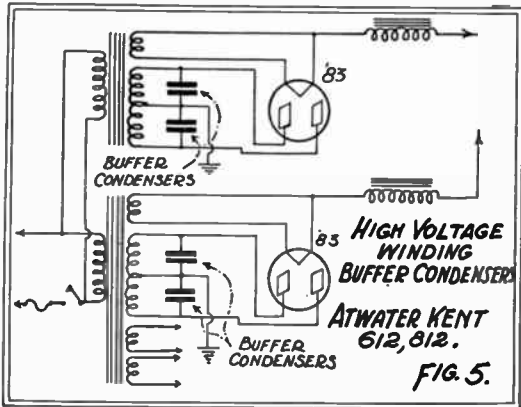
These models have the notorious reputation of "blowing" line fuses. Because of a pair of 83 mercury vapor rectifiers, small buffer condensers are connected across the high voltage windings to filter out noise caused by these rectifiers. These rectifiers break down or become leaky and short that portion of the high voltage winding across which it is connected, thus increasing the load upon the primary and causing the fuse to blow. As there are two power transformers, four buffer condensers are necessary.

They are connected as shown in Figure 5. All four condensers are contained in a single block located on the side wall of the chassis near the 83 sockets. Although the value specified is .07 mf., the capacity is not critical and .1 mf. condensers may be used to replace the leaky or short circuited section, providing its working voltage is over 400 volts.

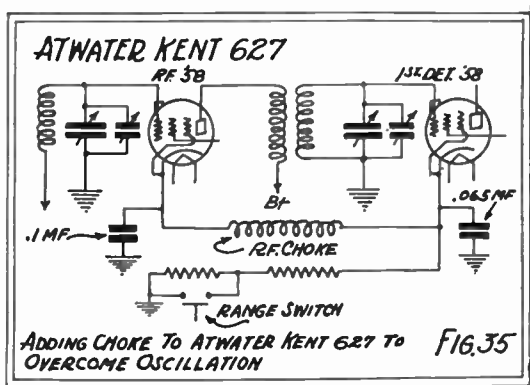
Where the symptoms of oscillation and erratic operation are encountered on this model, which are not caused by open-circuited condensers or incorrect alignment of the tuned circuits, the difficulty has been overcome by con-

necting a small R.F. 85 millihenry choke in the R.F. stage cathode circuit. In these receivers, a common bias resistor is employed for both the R.F. and I.F. 58 tubes.

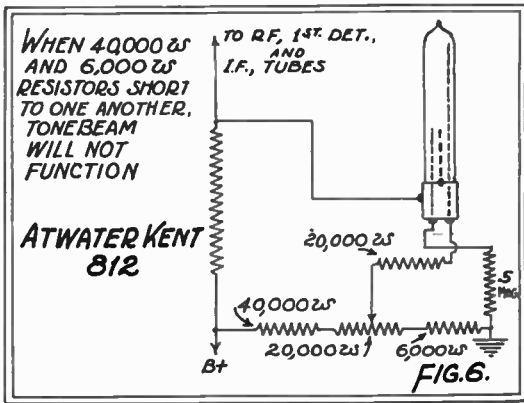
Frequently, the Tonebeam employed in this model is the cause of many complaints, the operation of the beam being very erratic with the light column slowly falling, disappearing and then suddenly climbing, to be repeated several times. This condition is caused by the shorting of the 40,000 and 6,000 ohm carbon resistors in the Tonebeam voltage divider circuit. The two resistors, together with a third resistor which is in the 2nd detector cathode circuit are mounted in an insulating paper container and separated by small wads of pitch. Vibration causes the two resistors in question, due to the fact that the Wood's metal ends are pointed, to work their way

through the pitch and short to one another. The shorting of these two resistors, as shown in Figure 6, shorts the Tonebeam potentiometer out of circuit, disturbing the

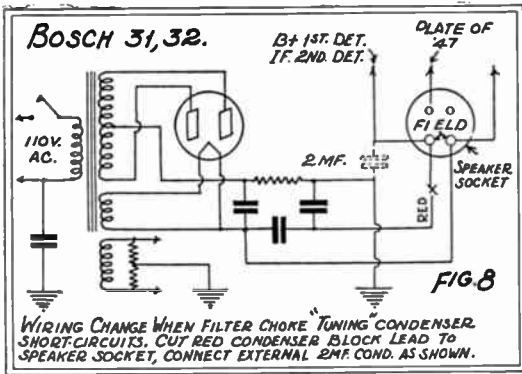
On some occasions, the symptoms of very low reception will be observed with the additional circumstance of no voltage drop across the speaker field coil. If the speaker plug is removed and the field coil is measured, its resistance will be found correct, but if the ohmmeter is connected across the field terminals of the speaker plug socket, a direct short will be indicated. This is due to a short-circuited bypass condenser used to "tune" the field coil. Replacement of this condenser presents its

own problem, for it is located within the filter condenser block and connected internally. However, it is not necessary to replace the entire filter block, which is sometimes

done, to effect a repair, if the procedure outlined in Figure 8 is closely followed.

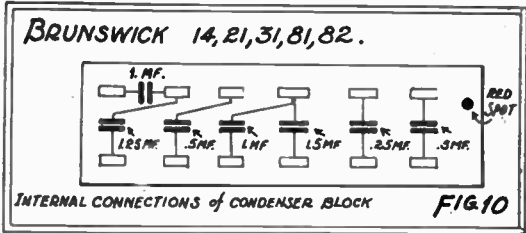
When the condition of hum is encountered on these models, look for one or more open-circuited condensers in the proper pack. This failure is easily checked by shunting each filter condenser with a 2 mf. unit. Because of the fact that a common terminal is not used, the

lug arrangement of the filter block is often confusing. Figure 10 shows the internal connections of the block.

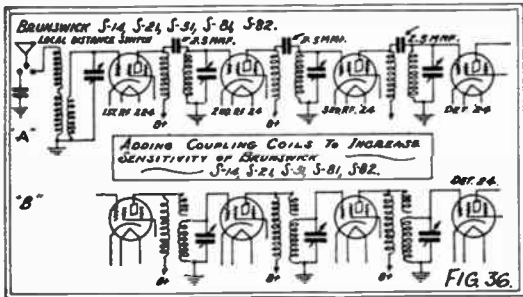
Noisy reception on these models is a complaint fre-

quently due to bad contacts on the local-distance switch. The contact points should be carefully cleaned and the springs bent slightly to secure increased tension. The two screws holding the switch assembly together should be tightened after this is done.

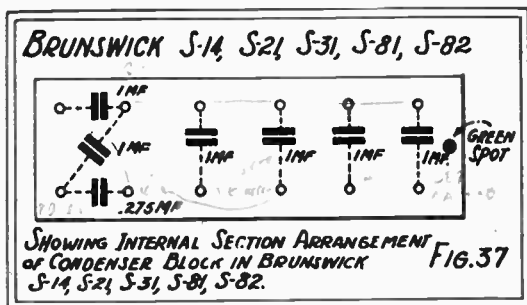
A frequent failure with these models lies in an open-circuited section of the condenser block in the power pack. An open-circuited section will produce the symptoms of hum, and oscillation in some instances. The open-circuited section is most easily checked by shunting each section of the condenser block with a one or two mf. unit, in turn. Similar to the filter block employed with the models 14, 21, 31, 81 and 82, a single common

terminal is not employed, thus making the arrangement of the terminal lugs confusing. The internal connections and the various capacities of the sections are shown at Figure 37.

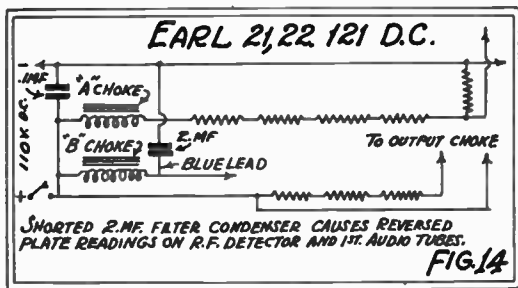
of the 2 mf. filter condenser connected from the negative side of the line supply to the receiver side of the "B" filter choke. This condenser is identified by the blue lead emerging from the condenser block. An explanation for this reversed polarity obtained on the R.F., detector and first audio tubes, lies in the fact that the high voltage impressed on the output tubes is not filtered by the choke, but is obtained directly from the positive side of the line as shown in Figure 14.

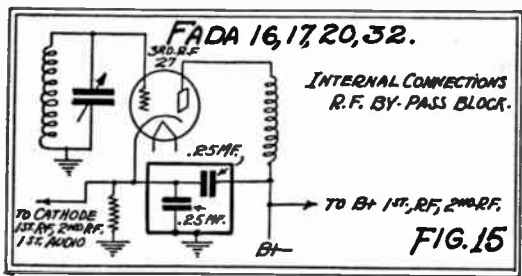
A sharp drop in volume accompanied by oscillation, has been traced on many occasions to an open-circuiting cathode or plate by-pass condenser. Both these .25 mf.

condensers are contained in a single unit, the plate by-pass return being connected to the cathode internally as shown in Figure 15.

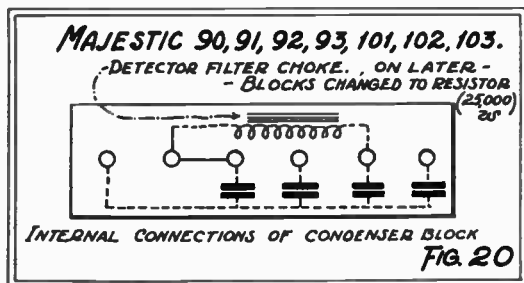
Weak reception, if any at all, with the attendant circumstance of low plate voltages on all tubes, is often due to a leaky or short-circuited detector plate voltage supply filter condenser in the condenser block. Although a new condenser or block may be installed, a repair may be easily accomplished without any disturbance in voltage distribution or increase in hum level by disconnecting and taping the lead to the top terminal lug of the condenser block and connecting this lug to the second lug, after removing the jumper between the second and third terminal lugs. If no detector plate voltage is obtained and the detector plate voltage supply filter condenser checks satisfactorily, look for an open-circuited 2000 ohm choke in the condenser block, connected between the second and fifth lugs. The later production power units employed a

condenser block with a resistor of approximately 25,000 ohms, in place of the choke, connected between the same lugs. The internal connections of this block is shown in Figure 20.

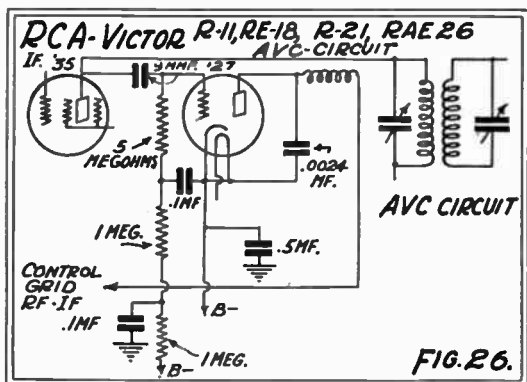
Where the symptoms of low volume and poor sensitivity are encountered, check the two .1 mf. condensers bypassing the grid return of the A.V.C. tube, as shown in Figure 26, for high resistance leakage. A high range ohmmeter will be necessary to test these condensers. If the volume increases when the A.V.C. tube is withdrawn, it is a fairly good sign of faulty condensers.

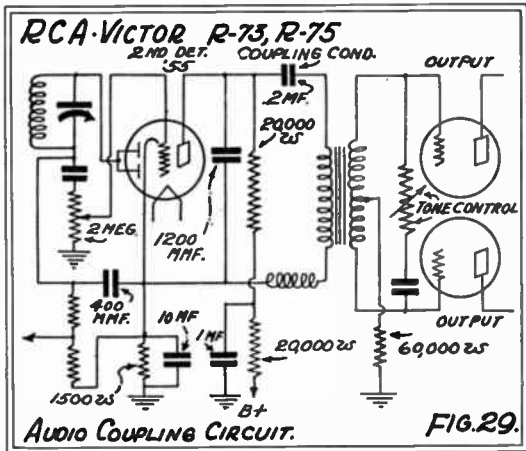
Where the complaint of weak and distorted reception is received, and the usual loud hum cannot be obtained by placing a finger upon the control grid of the 55 tube with the cap connection removed, check for an open-circuited .2 mf. audio coupling condenser. This unit is located beneath the resistor terminal strip and is connected in the circuit as shown in Figure 29.
