SERVICE DATA 1967 NO. T14

KCS 158 CHASSIS—APPARENT "HUM BAR"

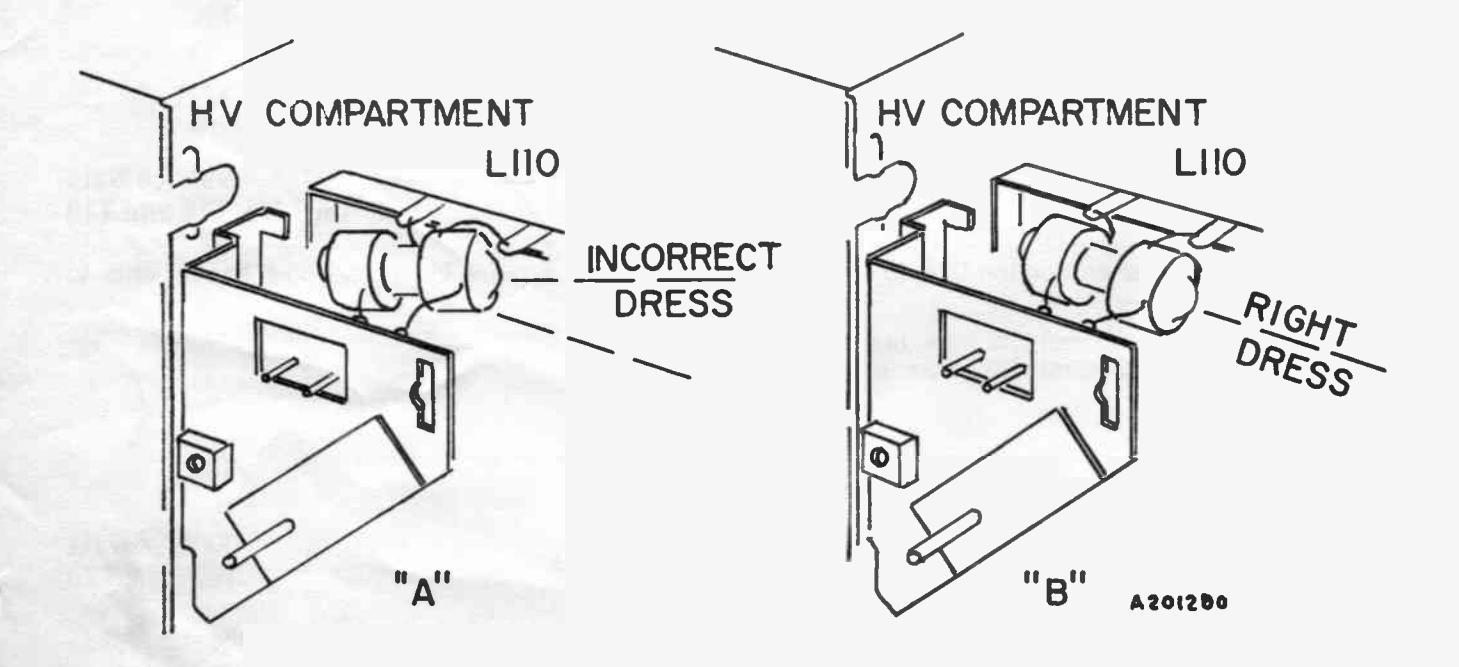
APPROX 3¹/₂" WIDTH

Recent field reports mention an apparent "hum bar" on some KCS 158 chassis. Investigation reveals that L110 positioning can be critical with respect to the yoke position. Where this "hum bar" is evident L110 should be re-dressed as illustrated in "B."
