SERVICING TURRET TUNERS

| DU MONT SERVICE NEWS |

PRODUCTION CHANGES

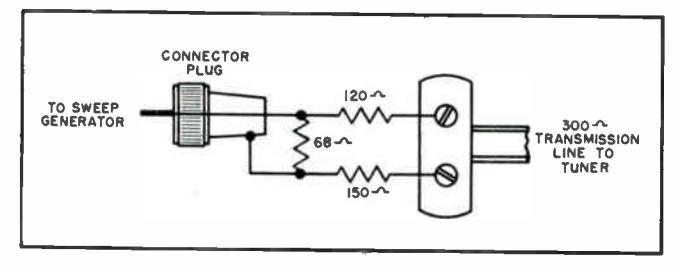
Figure 1. Matching device suitable for tuner alignment work. Keep the lead lengths between the connector plug and the resistor network as short as possible.

2. The sweep generator output *must* be properly matched to the tuner input. A suitable matching device is shown in figure 1. It consists of a connector plug, which fits the generator output and three half-watt resistors.

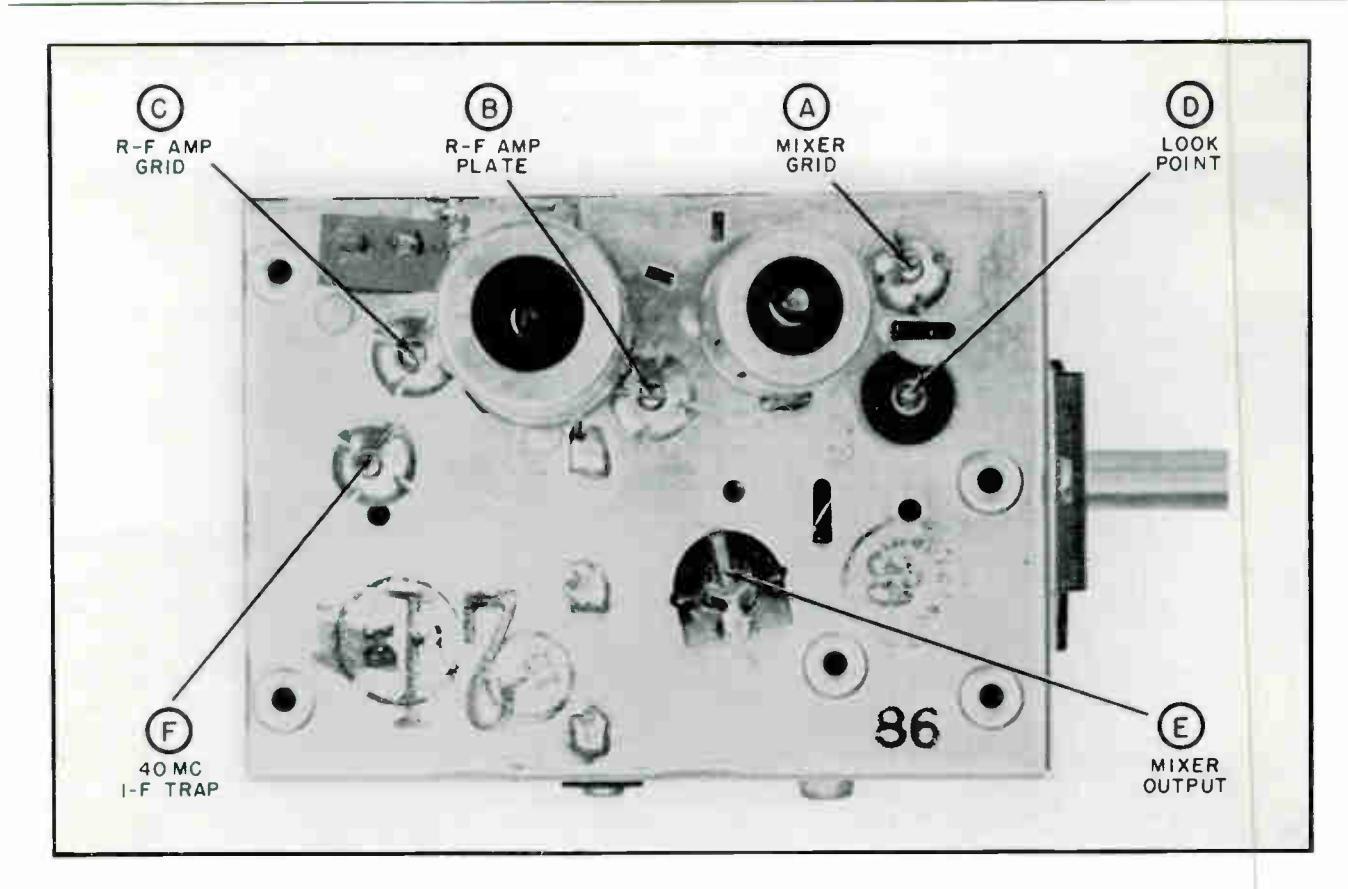
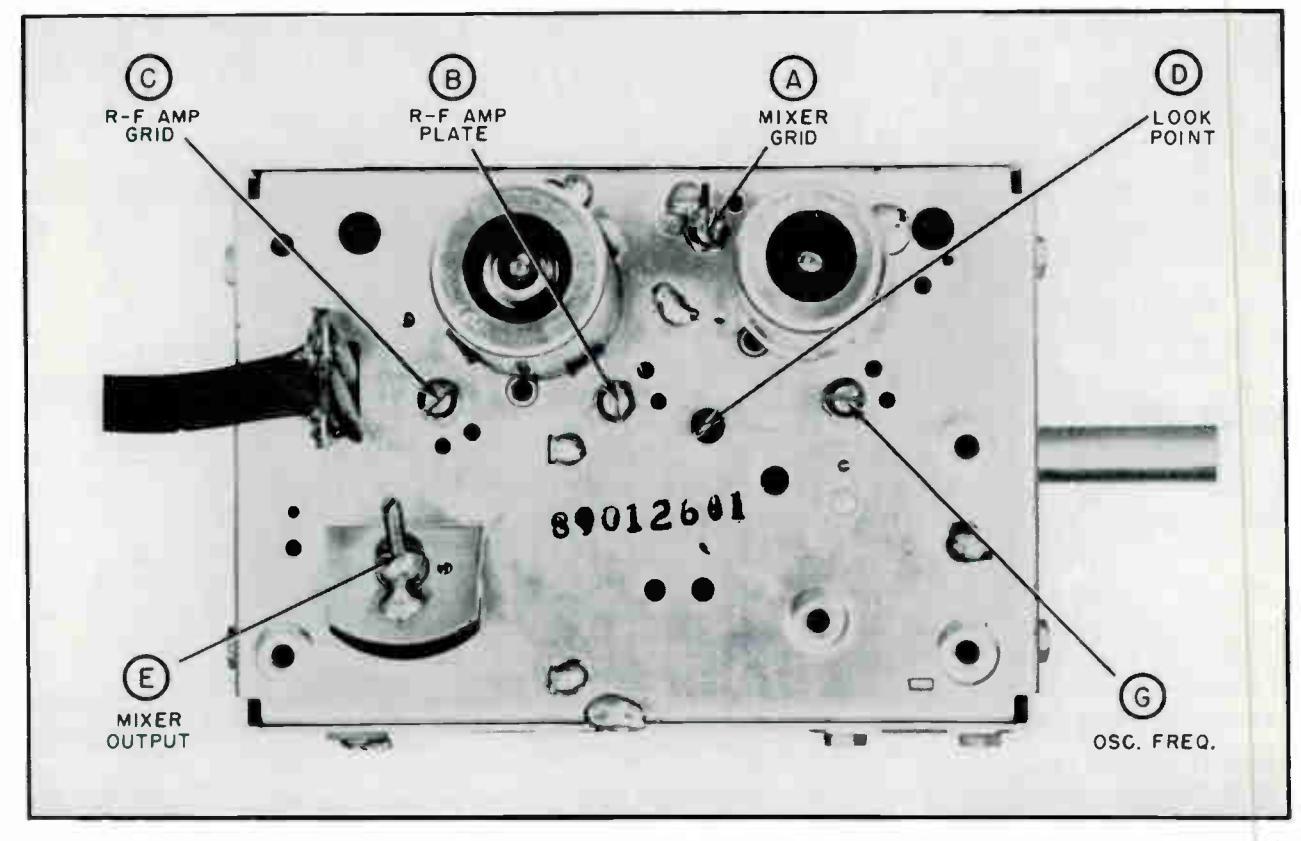
Figure 2. The two basic turret tuners and their adjustment slugs. The upper illustrations is for TU-1, 2, 3, 4, 6, 8 and 10 and the lower is for TU-5, 7 and 9. An explanation of the tuner slug functions will be found on the next page.

Slug A adjusts low frequency side of curve, slug B the high frequency side and slug C adjusts the r-f stage bandpass.

Some tuners have slug F which adjusts a 40 mc i-f trap. This slug may be reset if additional i-f rejection is required. Its adjustment affects the low channel curves slightly.

Some tuners have slug G which adjusts the oscillator frequency. It should be reset only if a channel strip oscillator slug cannot be properly set for its channel.

Failure to obtain the proper curves can be caused by a misadjusted oscilator slug or mixer output coil E. The adjustment of the mixer output coil is included in the i-f alignment procedure.

3. Adjust G (figure 2) for best picture and sound.

to the tuner look point (D in figure 2) using a short length of coax. Connect a 10K resistor between the look point and the center lead of the coax. Ground the coax outer conductor to the tuner chassis.

| STEP | SWEEP GEN. | MARKER FREQ. | ADJUST |
|---|---|--|---|
| 1 | Adjusted to sweep channel 13. | 215.75 mc sound 211.25 mc video | Check for curve shown below. If necessary, adjust A and B in figure 2 for proper band- pass, and C in figure 2 for maximum amplitude with equal peaks. |

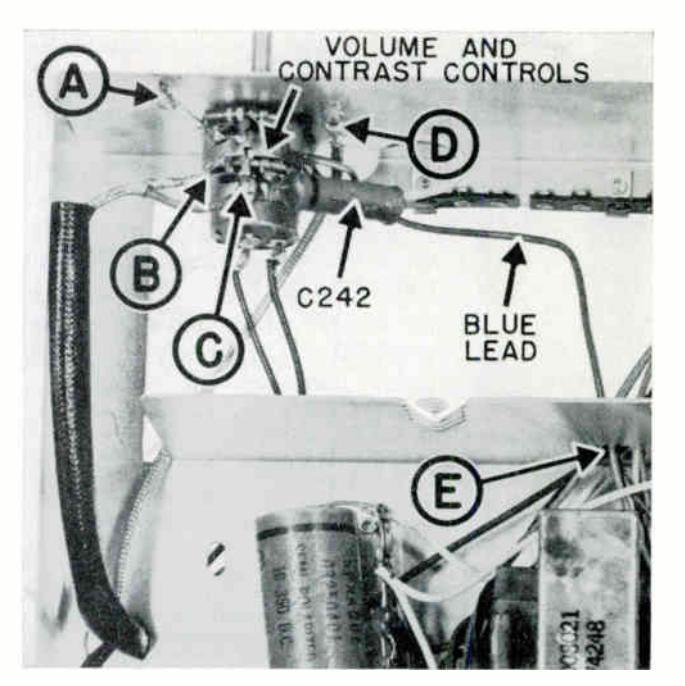
Figure C-3

To eliminate audio buzz, minimize residual hum and improve the sound quality.

1. Remove the shielded leads running between the junction of C241-R252 to C242 (adjacent to the Volume Control, R290A) and from R290A to C244 in the grid circuit of the first audio amplifier, V210. Reroute the leads as shown in figure C-2. Run the lead from C241-R252 through holes A, B and C. Run lead from C244 through hole D, place a 12 inch length of spaghetti over the lead and run through hole B. Fasten leads to chassis at points indicated by E. Connect leads to Volume Control as shown in figure C-3.

2. Run leads around edge of shield. Remove volume control ground wire connected between points A and B (do not disturb the contrast control ground). Connect shield of lead from C244 at point B and center wire to point C. Ground shield of lead from C241-R252 at point D and connect center wire to C242 at terminal board. Disconnect blue lead from ungrounded end of the contrast control (R290B), run through hole E, reconnect and dress lead along front of chassis as shown in figure C-3.
