Techni-talk

COMPLETE ELECTRONIC SERVICING INFORMATION
radio • tv • hi-fi

SEPT.-OCT. 1959

SERVICING PRINTED CIRCUITS III

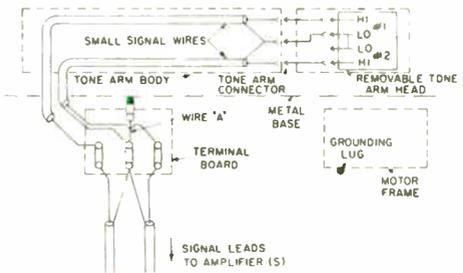
As a trial, the manufacturer's connection method shown in Fig. 1A should be used. If the adverse conditions of power-line current in the signal wiring should exist and hum from this source is encountered, then the minimum modifications shown in Figure 1B are recommended.

Fig. 1A Original wiring changer "A".

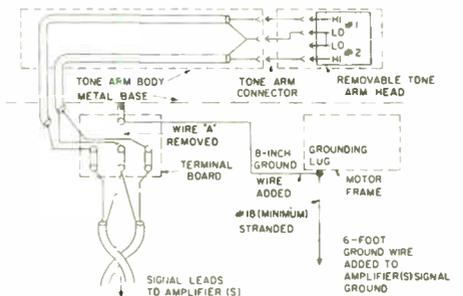
Fig. 1B Minimum wiring changes on "A".

Modification required to minimize hum from AC ground currents:

1. Locate and remove wire braid connecting signal ground lug. (WIRE A)
2. Connect an 8-inch single-conductor ground wire from the ground lug to the motor ground lug located on the motor frame.
3. Connect a 6-foot single conductor ground wire from the motor ground lug to the amplifier grounding point.
4. Twist the two signal leads to the amplifier together before connecting to the amplifier input jacks.
