Techni-talk

COMPLETE ELECTRONIC SERVICING INFORMATION
radio • tv • hi-fi

Vol. 15, No. 3

Fall, 1963

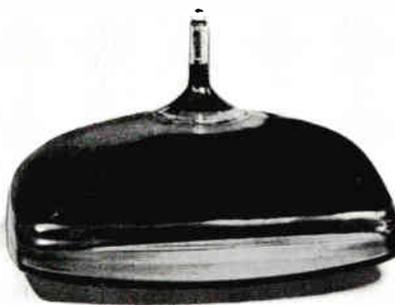
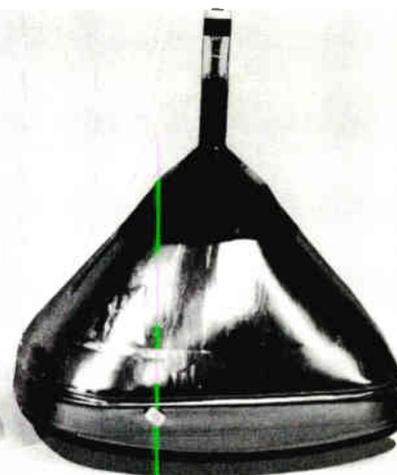
Fig. 1 This shows the difference in neck diameter and overall length between the 23 inch,

114° picture tube at left and the 21 inch, 70° tube at the right.

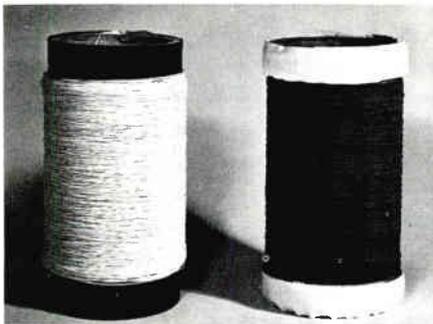
Fig. 2 Small spool of ordinary heater wire at left and new wire with grey "overcoat" at right.

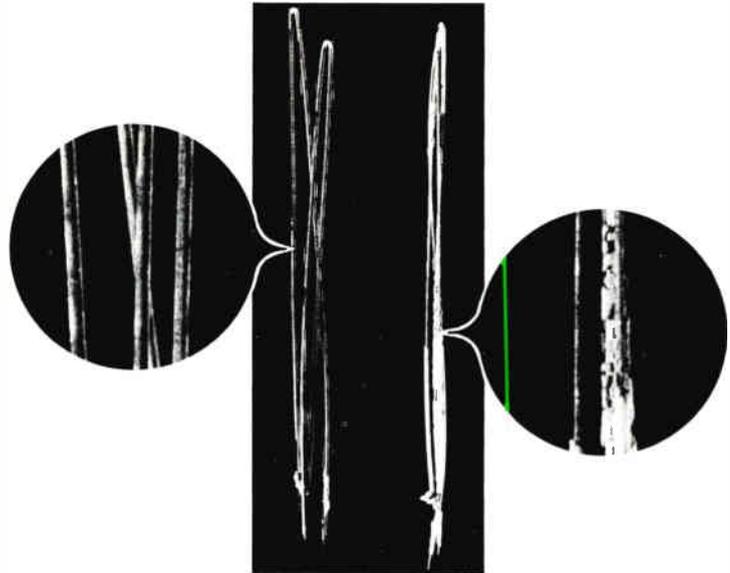
Fig. 3 illustrates just what happened to the insulating coating as a result of this expansion and contraction. The numerous fractures allow the heater temperature to increase wherever the wire is exposed. This "boils" off more insulating material, exposes more heater wire surface, and increases the possibility of an arc developing between the cathode and heater. This arc may be self-healing and intermittently blow the B+ fuse or may be a permanent "short" which will blow the fuse as soon as it is replaced.

Fig. 3 The heater at the left is typical of a heater with the grey "overcoat" after a 7000 hour life test. The heater at the right is a typical heater without the "overcoat" which failed after a 2500 hour life test. Enlargements are shown of each center portion.

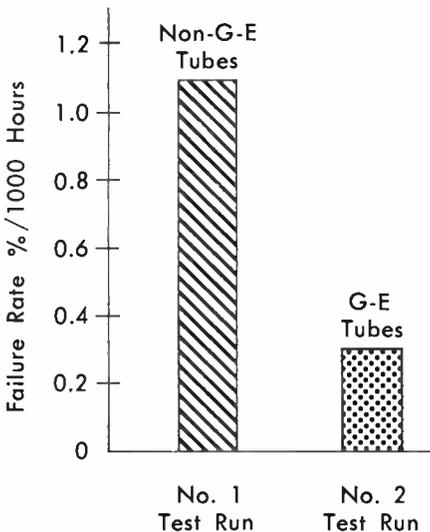
Failure rates, obtained from these test runs, are: 1.07%/1000 hours for Test Run No. 1, Non-G-E tubes; and 0.29%/1000 hours for Test Run No. 2, G-E tubes.

Fig. 1 Average failure rates of 14 tube types, G-E vs Non-G-E Tubes
