Drake R8: More On Improving Image Rejection

Dallas Lankford, 2 II 95

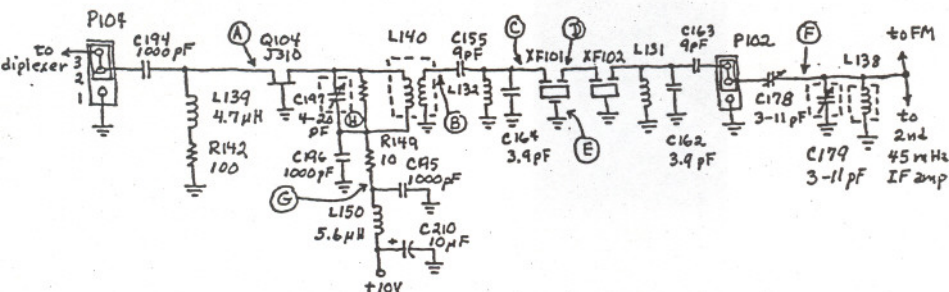
You can imagine my surprise when I measured the 50 kHz image rejection of my R8 RF boards with their pretty new PC board mods and found that the image rejection at ± 100 kHz had fallen off to about 86 dB. This caused me to make additional changes at various points in the 45 MHz signal path to determine why the image rejection was degraded, and how to restore the image rejection to over 94 dB. Based on a number of changes and measurements, which I will not relate here, the 94 dB or greater image rejection which I obtained previously was due in part to circuit layout and parts positions of the prototype PC boards. The solution to this problem, which will be described in detail below, involved removal of header plug P102 and development of a new matching network between the output of crystal filter XF102 and the high impedance 45 MHz IF transformer consisting of C179 and L138.

The original R8 45 MHz IF signal path from P104 to the 45 MHz IF transformer consisting of C179 and L138 is given above. If you compare the partial schematic sketch above with the R8 service manual schematic, you will notice three differences (1) the 4.7 H choke L139 and 100 ohm resistor R142 are reversed in my sketch above, to reflect the actual R8 RF PC board layout, and (2) C179 is shown with a shield, as is the case on the R8 RF PC board, and (3) C197 is also shown with a shield, as is the case on the R8 RF PC board.

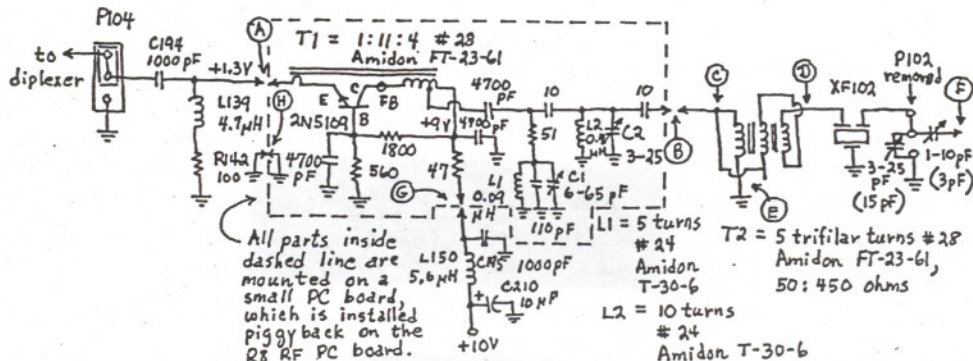
Two R8 RF boards have been modified in the manner described above. For one such modified R8 RF board, the 50 kHz image rejection (at ± 100 kHz) was 94 dB, and for the other R8 RF board, the image rejection was 97.5 dB. Such slight variation in image rejection from one RF board to another is to be expected because of variations in the 45 MHz crystal filters from one board to another.

The final modifications to my R8 RF board (excluding replacement of the RF amplifier, removal of the image reject circuit, and addition of crystal filter XF101 immediately ahead of the 2nd mixer, which were described in detail in the DX News article mentioned above) are given below. Upper case letters A - H are given on both schematics for certain important reference points.

As can be seen, most of the original R8 parts between the junction of C194 and L139 and crystal filter XF102 were removed. C210, L150, and C195 were retained for the positive voltage feed of the new common base IF amplifier. The common base IF amplifier was built on a small PC board and mounted piggyback on the R8 RF board. The 47 ohm resistor shown on the common base IF amp board may alternately be mounted on the R8 RF board. Surface mount resistors and surface mount capacitors were used throughout the common base IF amp board to conserve space. Note that a ground connection from the common base IF amp board to the R8 RF board is required, and labeled point H on the modification schematic above (which is a ground pad for the shield of C197 which had been removed). Points A, B, and G are the other three connections required by the common base IF amp piggyback board. These four connections were made with short (about 0.50 inch) lengths of #22 solid tinned copper wire which had been press fitted into PC board pads of the common base IF amp board (so that the short wires would not fall out when they were soldered to the R8 RF board pads).

The 9 pF capacitors C155 and C163 were not present on my R8 RF board, and there were no PC board pads to accommodate such capacitors. Apparently these two capacitors existed only in some R8 prototypes, and were not included in any production R8's as far as I know.

And the two inductors L132 and L131 and two capacitors C164 and C162 were also not present on my R8 RF board. Instead, three surface mount devices (perhaps capacitors) were used in my R8. These three surface mount devices were removed.

Also, XF101, P102, C178, the shield of C179, and C179 were removed.

T2 was mounted on the R8 RF board in the holes vacated by XF102, a small jumper made from #24 solid tinned copper wire was added between the two indicated holes vacated by P102, a modified Mouser # 24AA0022 3-25 pF ceramic trimmer

capacitor was added between the two indicated vacated holes of P102, a Mouser # ME242-1810 2-9 pF ceramic trimmer was added in place of C178, and a Mouser # 24AA021 2-14 pF ceramic trimmer was added in place of C179. The shield for C179 was not restored. When installing trimmer capacitors which are grounded at one end, be sure that the grounded end is the rotor lug. Drake production line workers did not always adhere to this standard practice, which can make peaking tuned circuits difficult.

Note on the modification schematic above that the 3-25 pF capacitor mounted at P102 and the 1-10 pF capacitor mounted in place of C178 should be set approximately to 15 pF and 3 pF respectively. This can be done before installation with a accurate capacitance meter, or after installation by setting the "plates" about half meshed for the 3-25 pF trimmer, and near minimum capacitance for the 1-10 pF capacitor. If the value of the 1-10 pF capacitor is set too low, C179 will not be able to peak L138 to as high as normal. The value of the 1-10 pF capacitor should be set as low as possible without reduction of signal level when C179 is peaked.
