RADIO RETAILING'S *Tricks of the Trade*

"TRICKS OF THE TRADE"

Practical "bread and butter" tips for radio dealers and service men on how to find and repair the most common troubles peculiar to specific models of receivers.

Published by
RADIO RETAILING
33 WEST 42nd STREET
New York City

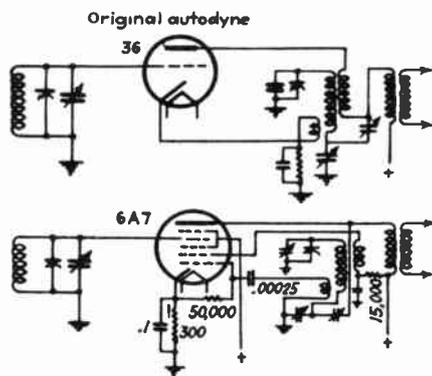
PHILCO 14 (Early). 36 autodyne first detector does not oscillate stably at lower frequencies, changing of oscillator coils and bias resistor does not affect permanent cure. Nor does replacement of tube, mica in tuning gang trimmers or

cloth covered wiring . . . Substitute 6A7 for 36, employing new circuit diagrammed. The same oscillator coil is used, but the various windings employed differently. Slight retrimming of all condensers associated with circuit is all that is necessary when revamping has been done.

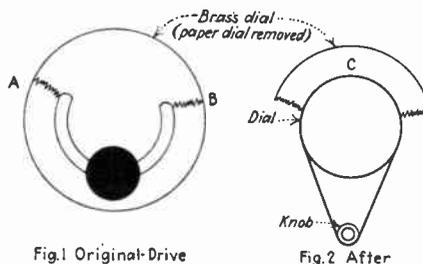
Fig. 1 Original-Drive

SPARTON AC7, 62, 63. Replacing worn-out friction dial drives . . . Remove chassis from set. Remove spring tension arrangement from shaft and replace with brass rod or old variable condenser spacer tube, drilled to fit snugly over shaft. File brass rod down until it is spool shaped, similar to spools used on sewing machines. This may be done by putting the rod of spacer tube on a small bolt, rotating the bolt in an electric drill and holding a file against it. The spool should now be covered with tape and metallic-xed (a cement) in place. It should then be soldered to the knob shaft, easily removed by lifting the spring before the tape is ce-
