# PHILCO TV

## SCHEMATIC DIAGRAMS

MODEL 48-700 THRU 53T2750

# 1947-1953

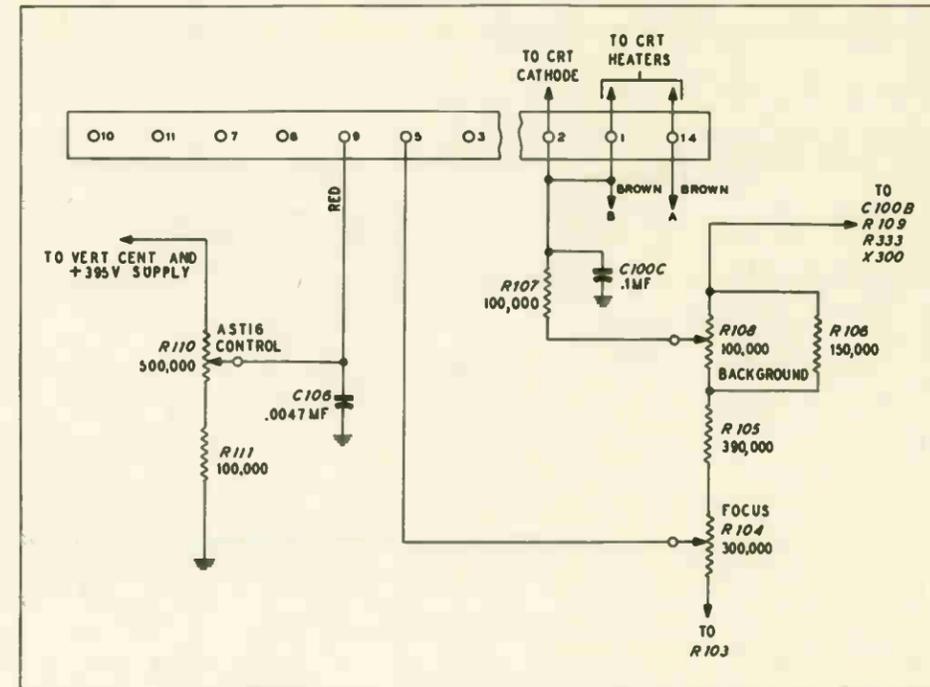
Figure 11. Addition of Astigmatic Control, Run 6

In sets prior to Run 6, the background control, R108, may fail because of transients or surges under certain operating conditions. When replacing this control, it is suggested that the circuit be rewired as shown in figure 11. This change was incorporated in production in Run 6.

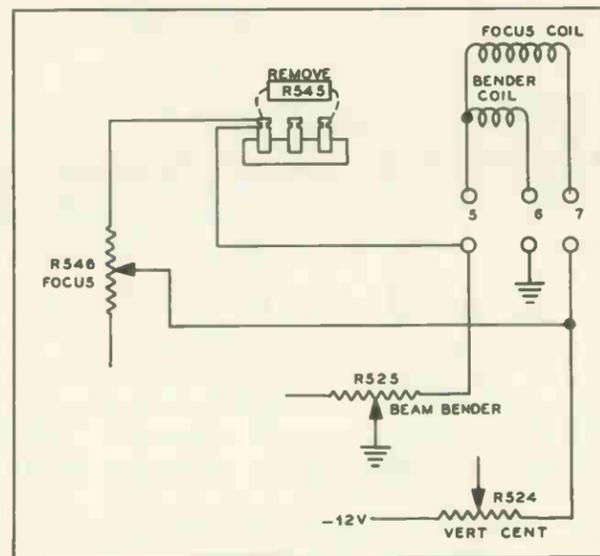
Figure 17. Focus-Coil Replacement

The focus coil for the Model 48-1000, Code 121, is no longer stocked by the Accessory Division. The high-resistance focus coil used in this model and code may be replaced if all the components are replaced (focus coil, focus control) with the corresponding low-resistance focus components, i. e., focus-coil assembly Part No. 76-2622-2 and focus control Part No. 33-5547-2.

- connect the leads to the outside terminals of the terminal panel on the cradle.
3. Remove resistor R545 and the old focus control, R546.
4. Connect a wire from the terminal connection that formerly held R545 and the wire from R546 to pin 5 of J500.
5. Install the new-type focus control, Part No. 33-5547-2, and reconnect the wires as before.
6. Remove the wire connection between R524 and R525 at the R525 end. Reconnect this wire to pin 7 of J500.

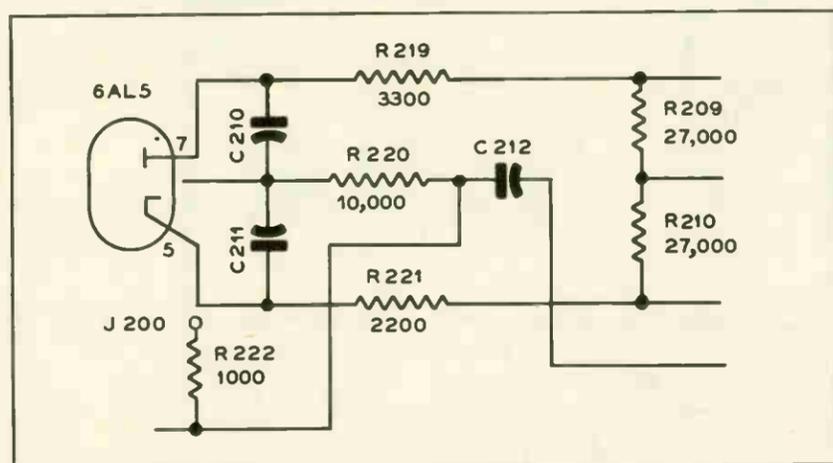
Figure 12. Discriminator Circuit Changes in Runs 4 and 5

Beat patterns may appear in the picture when operating on Channel 7; less frequently on Channels 4 and 11. This condition may be corrected by adding compensating and filter resistors to the FM discriminator

It is recommended that the following changes be made when the chassis are serviced, or when Channels 4, 7, or 11 are adjusted for reception.

- Remove the following parts carefully, as they are to be reinstalled.
  - C218, connected between pin 5 of the discriminator tube (6AL5) and ground.
  - C219, connected between pin 7 of the discriminator and ground.
  - R215, connected between pin 5 of the discriminator and ground.
  - R216, connected between pin 7 of the discriminator and terminal 3 of terminal board TB6.
  - Length of wire, connected between terminal 1 of terminal board TB3 and socket J200.

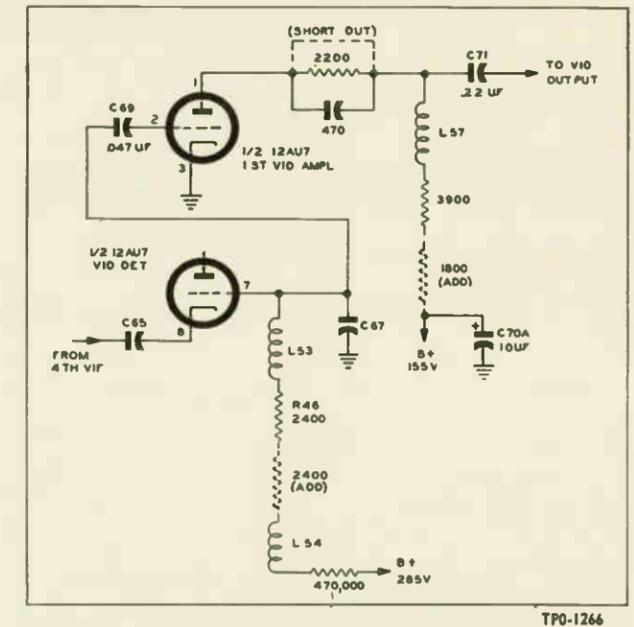
Figure 9. Modification of Video Detector and First Video Amplifier

Greater video gain may be obtained in fringe areas by modifying the output loads of the video detector and video amplifier. As shown in figure 9, a 2400-ohm resistor may be added in series with R46, to increase the value of the detector load to 4800 ohms. This change provides a greater level of signal for the first video amplifier. In the 50-T1400 series, Code 125, Run 6, the 2200-ohm video amplifier plate load resistor and 470- $\mu$ f. shunt condenser may be shorted out. The 3900-ohm plate resistor, in series with the peaking coil, may be increased to 5700 ohms by adding a series 1800-ohm resistor (figure 9). The video output plate load resistor

Another change which can be made is the removal of the "gamma-control" resistor, 22,000 ohms, from screen to ground of the video-output tube. This change gives a considerable amount of extra drive to the picture-tube grid, and consequently, a much blacker picture. In 50-T1400-series receivers of a code and run earlier than Code 125, Run 6, where the sync take-off is from a tapped portion of the plate load of the video-output tube, removing the gamma-control resistor and increasing the value of the plate load may produce sync clipping, and thus deteriorate the general sync performance. This change makes the sync performance extremely dependent upon the position of the contrast control. If, in conjunction with the gamma change and video

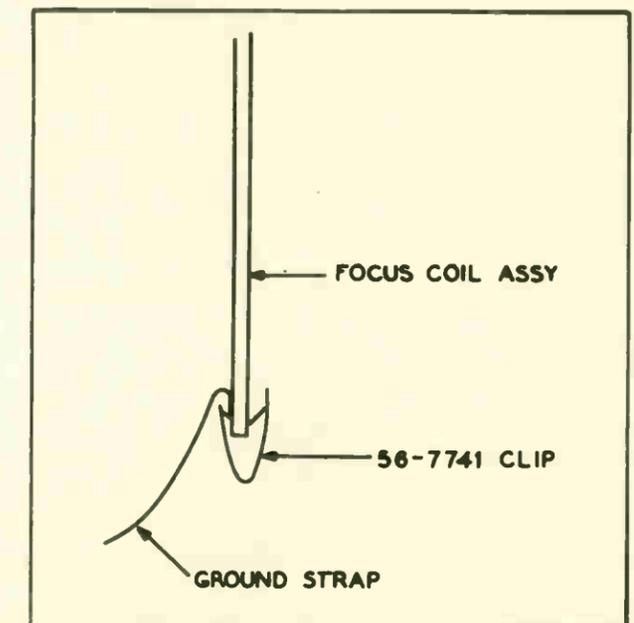
Figure 10. Simple Ground-Strap Repair

In case this strap is broken, it may be repaired by the use of a clip, Philco Part No. 56-7741, as shown below.

Length of Strap	Part No.
3 3/4 inches	76-5472
6 inches	76-5472-1

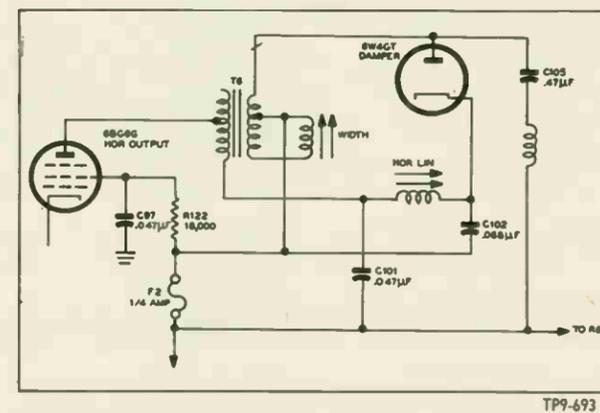
Figure 14. Location of Fuse, First Production of Model 50-T1630

180-microhenry coil (L37) added in series with R61 and R62, between R61 and the sync take-off point.		32-4143-5
F2 removed from position shown in service manual and rewired as shown in figure 14. Value changed from $\frac{3}{4}$ ampere to $\frac{1}{4}$ ampere.	45-2856-10	45-2856-8
