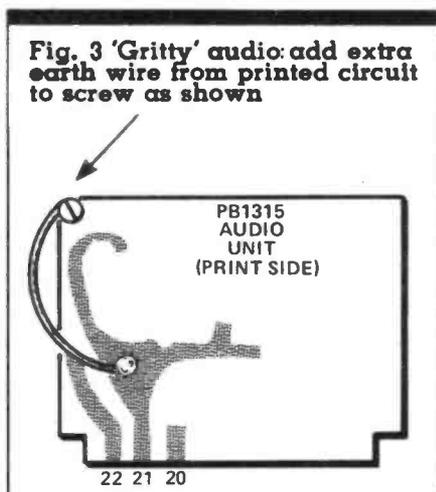
Receive audio quality slightly below par – a bit 'gritty' FT101B Mk2 – FT101E. If you suspect the receive audio quality, try adding an extra earth wire to the audio IC as shown in Fig. 3. If there is an immediate improvement leave this wire in position.

Fig. 3 'Gritty' audio: add extra earth wire from printed circuit to screw as shown
