Radio, Phonograph and Tape Service Tips

Volume XXI Issue 1 January 30, 1970

RS-225B Amplifier Chassis Layout

RS-250A Chassis Layout

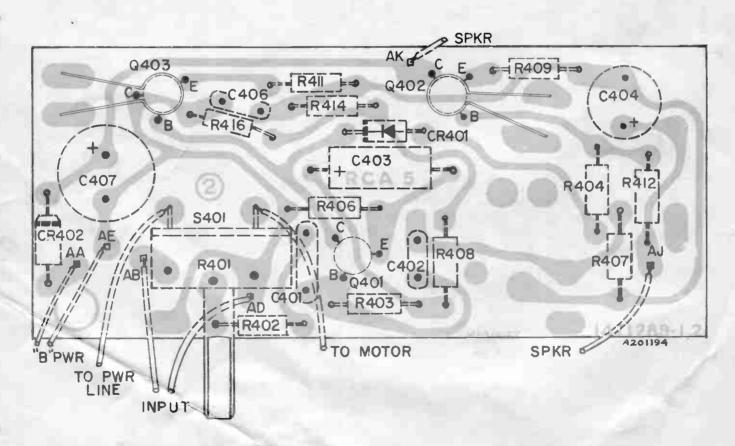
Chassis Layout—Wiring View RS-225B

The chassis layout wiring view has been modified to show components with dotted outline. CR401 diode polarity has been polarized to agree with schematic.

Care should be exercised in replacing CR401 to insure correct circuit operating potentials.

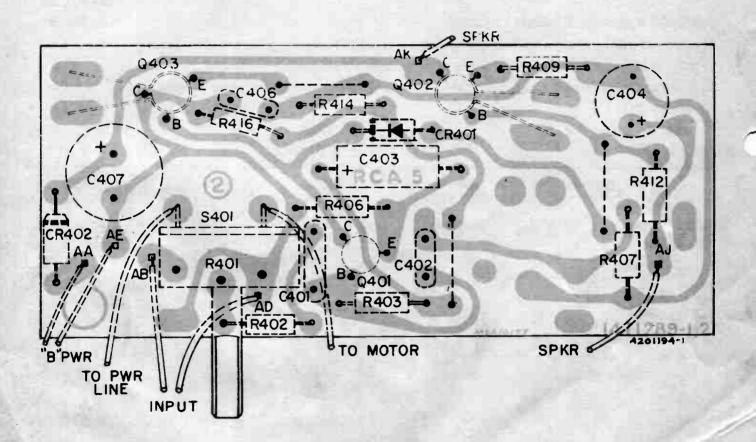
Chassis Layout—Wiring View RS-250A

The chassis layout wiring view has been modified to show components with dotted outline.

CR401 diode polarity has been polarized to agree with schematic.

Care should be exercised in replacing CR401 to insure correct circuit operating potentials.
