T ELEVISION SERVICE TIPS

JULY 10, 1964

KRK 114 SCHEMATIC DIAGRAM CORRECTION

SERVICE DATA - Chassis KCS 148
1964 No. T5

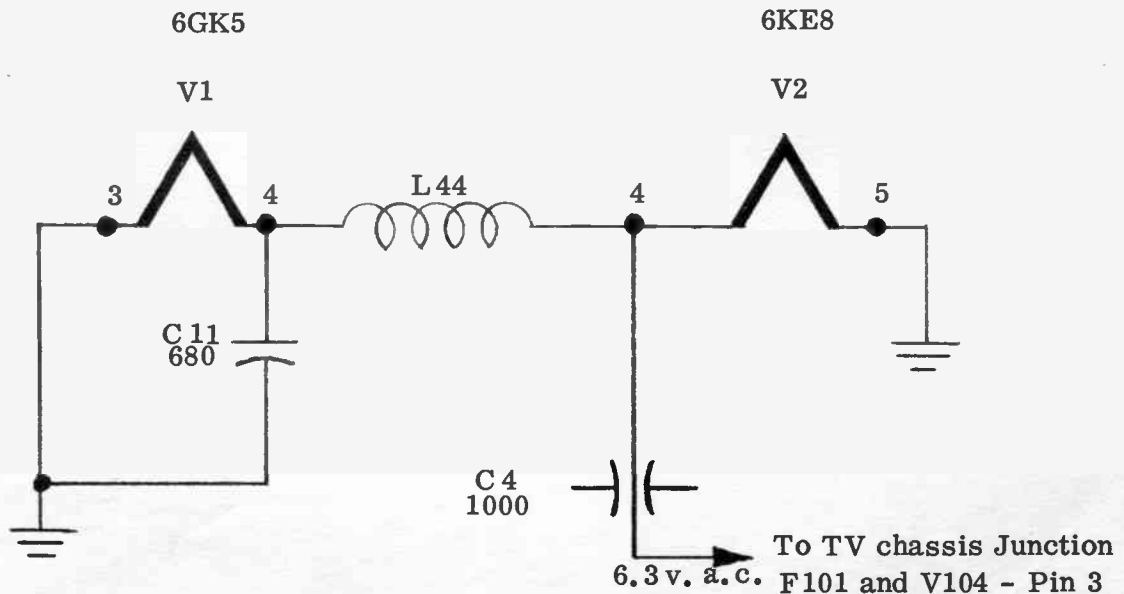
The heater wiring diagram and tube lineup for the KRK 114 schematic diagram on Page 5 of Service Data 1964 No. T5 should be corrected as reproduced below:

Change the tube type of the KRK 114 RF amplifier, shown on page 5, to read 3GK5.
