# Techni-talk

## on AM, FM, TV Servicing

### CONVERSION OF 10 AND 12 INCH

### RECEIVERS TO USE LARGER SIZE PICTURE TUBES

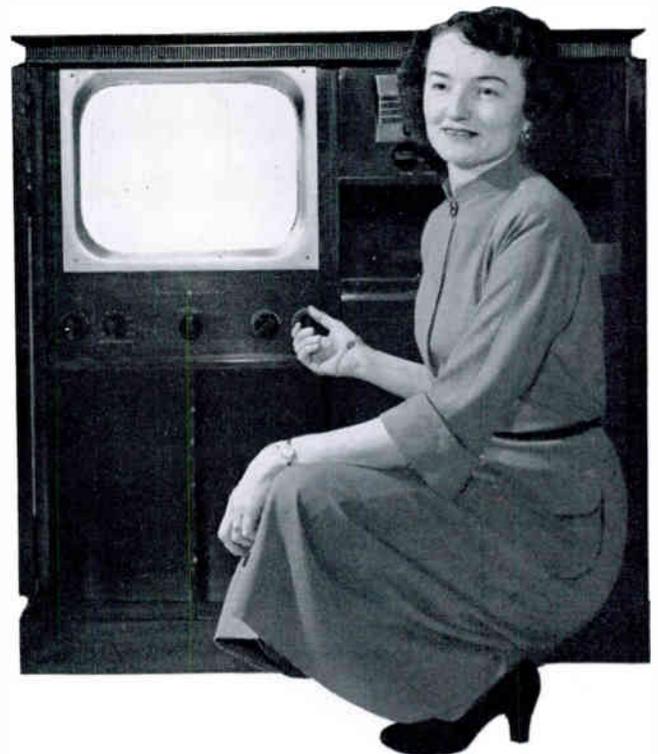
Fig. 2. General Electric Model 820 after being converted to use a 16KP4 picture tube.

A sixteen inch template described in previous issues was used for marking the front panel. The approximate position can be seen in Fig. 2. Due to the front panel being hard wood one-half inch thick it was almost impossible to saw around the new mask area using only a keyhole saw. Therefore an electric drill was used to drill  $\frac{1}{8}$  inch holes about  $\frac{1}{4}$  inch apart along the template mark and a keyhole saw was then used to complete the operation.

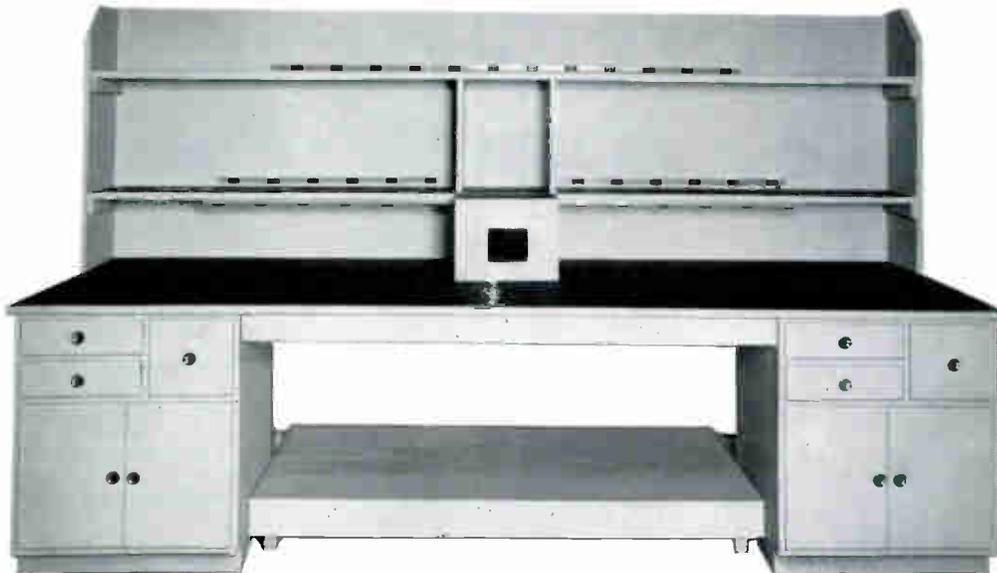
Fig. 1. Front view of completely assembled Service Bench with side cabinets.

The service bench shown in Figs. 1 and 2 was designed to provide the service technician with practical work space as well as adequate shelf space and electrical outlets to accommodate the necessary equipment required to service both radio and TV receivers. The center section will accommodate most Cathode Ray Oscilloscopes. This bench can be constructed with only a hammer and nails providing the lumber is cut to dimension by a local lumber yard. If screws and glue are used instead of nails the bench will be somewhat sturdier.

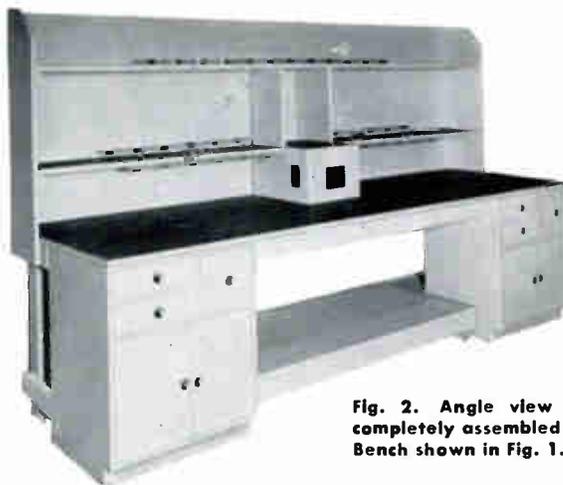
Fig. 2. Angle view of the completely assembled Service Bench shown in Fig. 1.

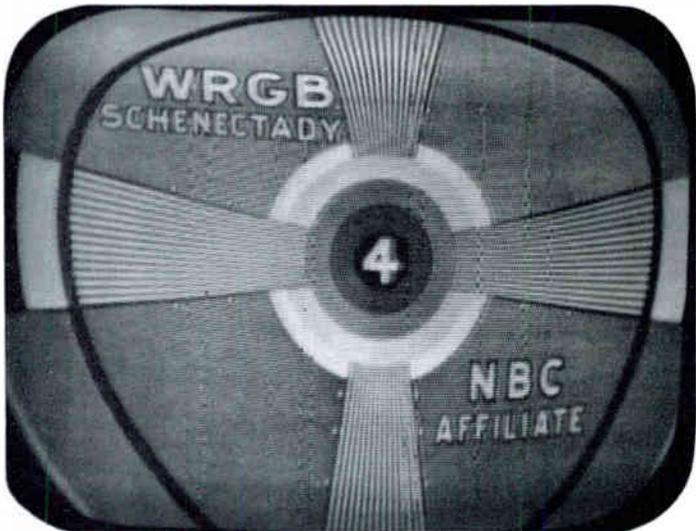
**Tele-Clue No. D-67**—Leakage across C303 in Fig. 13 of three megohms resulted in the top being squeezed which could not be corrected with the height or vertical linearity controls. Leakage of more than three megohms could be corrected by readjustment of the height and linearity controls. Additional leakage resulted in a further reduction of the top half.

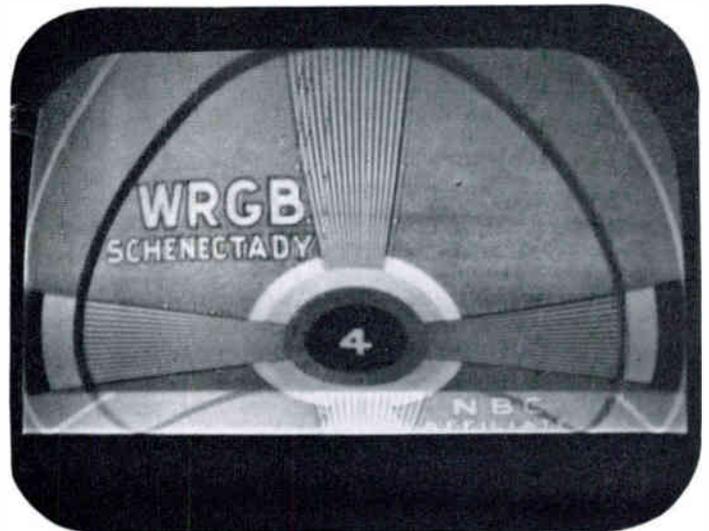
**Tele-Clue No. D-68**—This is commonly referred to as the "curtain raising" effect and may be due to leakage in capacitors C304 or C312 or a reduction in the resistance value of R303 in Fig. 13.

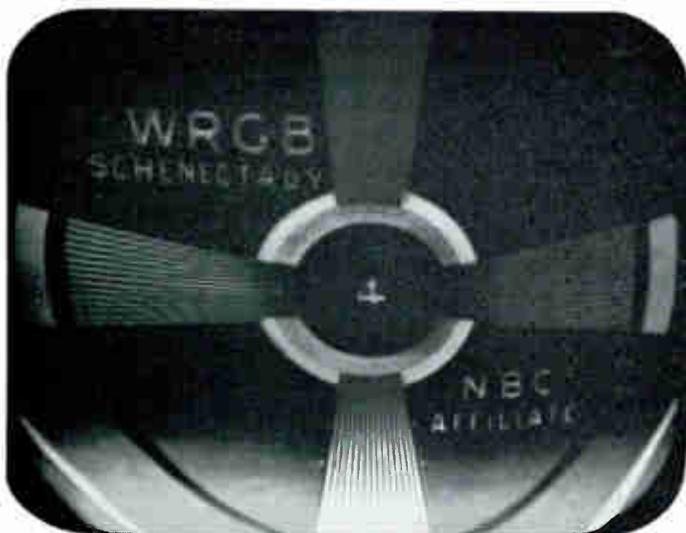
**Tele-Clue No. D-71**—This illustrates the result of one and one-half megohm leakage across C311. The brightness and contrast controls were advanced.

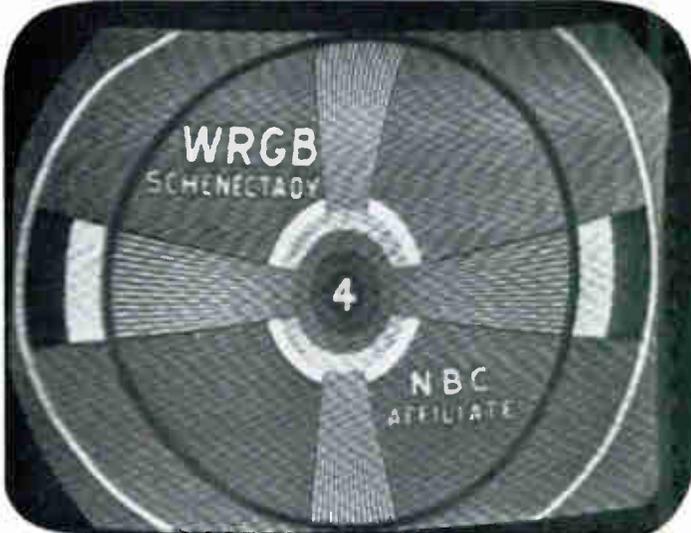
**Tele-Clue No. J-72**—This type of interference known as oscillator radiation is due to the oscillator in some nearby receiver acting like a miniature transmitter and radiating a signal. This signal is picked up by the antenna or lead-in together with the desired signal and amplified resulting in the interference pattern shown above.

It is usually necessary to shield the receiver which is radiating the signal and/or prevent the signal from reaching the antenna by using a "Booster" as close to the receiver as possible.
