Techni-talk

on AM, FM, TV Servicing

CONVERSION OF 10- AND 12-INCH RECEIVERS TO USE LARGER SIZE PICTURE TUBES

This is the fourth of a series of articles on converting ten and twelve inch TV receivers to use fourteen, sixteen or seventeen inch rectangular picture tubes. In this issue a General Electric twelve inch Model 12C101 was converted to use a General Electric 16KP4-A aluminized picture tube and a Stromberg-Carlson twelve inch Model TV-12 series 11 was converted to use a General Electric 14CP4 picture tube.

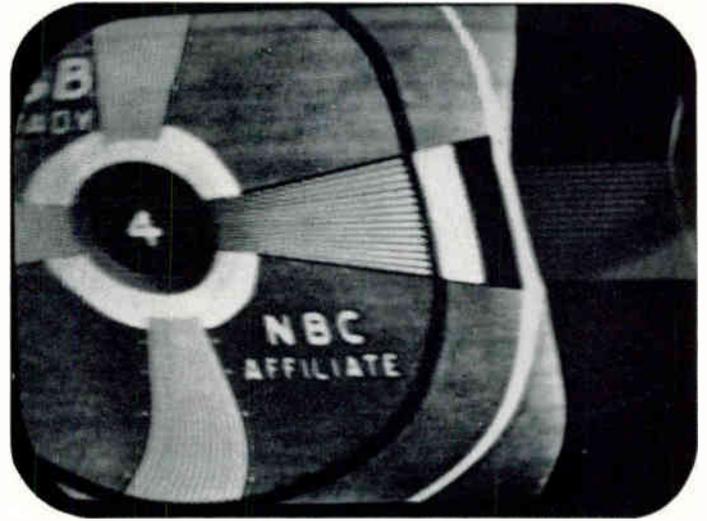
Tele-Clue No. K-74—A short between the cathode and heater in the 6SL7-GT Sync Amplifier and clipper tube used in a large number of General Electric chassis will result in a picture similar to either Tele-Clue No. 74 or 75. The contrast control has little or no effect. Horizontal synchronization is extremely critical with a horizontal jitter or weaving present most of the time.

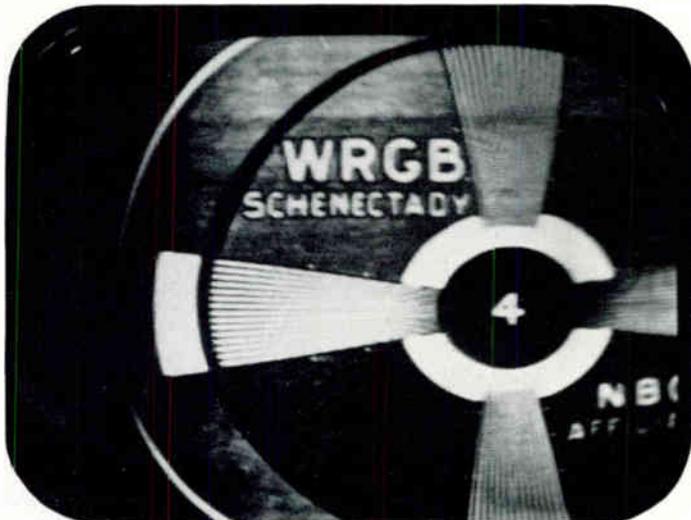
Tele-Clue No. K-75—This is also the result of a short between cathode and heater in the 6SL7-GT Sync Amplifier and clipper tube and the same explanation as given for Tele-Clue No. 74 will apply here. The only difference is that horizontal synchronization occurs so that the black border can be seen at the left instead of at the right of the picture tube.

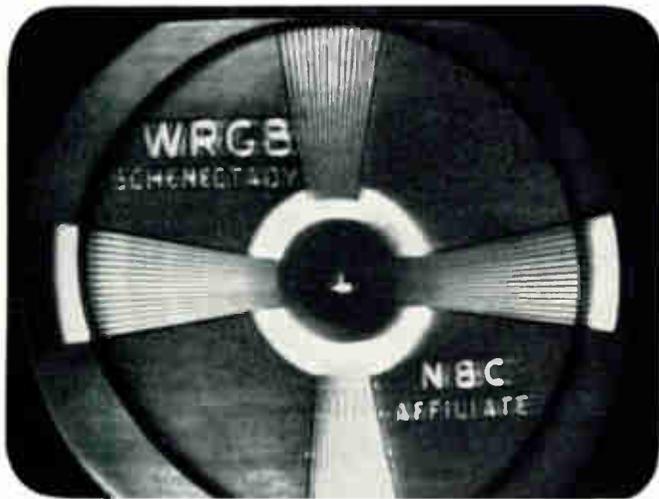
Tele-Clue No. H-77—This photograph and the one shown in Tele-Clue No. 78 illustrate the effect of low emission in a picture tube. The picture with the brightness and contrast controls adjusted for correct balance between the blacks and whites was very dull and had a washed-out appearance similar to Tele-Clue No. H-60. When the contrast control was advanced the color gradation between black and white practically disappeared as shown above.

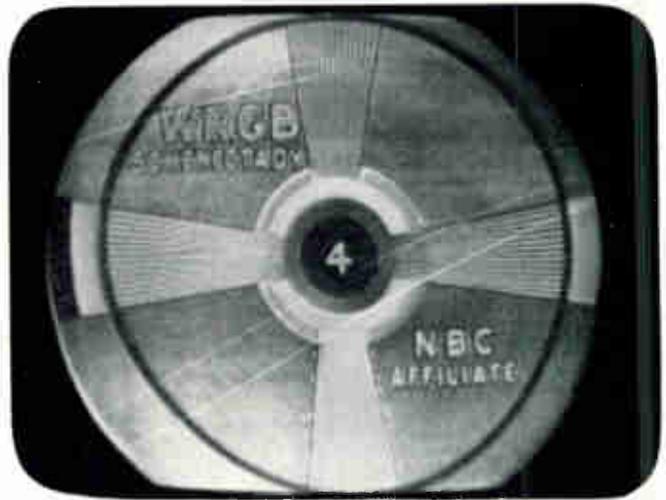
Tele-Clue No. H-78—This photograph shows the result of advancing the brightness control on the same tube used in Tele-Clue No. 77. The contrast control was returned to normal. The five shading rings around number 4 should vary in shading from black in the center to white on the outside. In the above photograph the outer ring is darker than the next inner ring. This is just the reverse of the normal shading sequence.

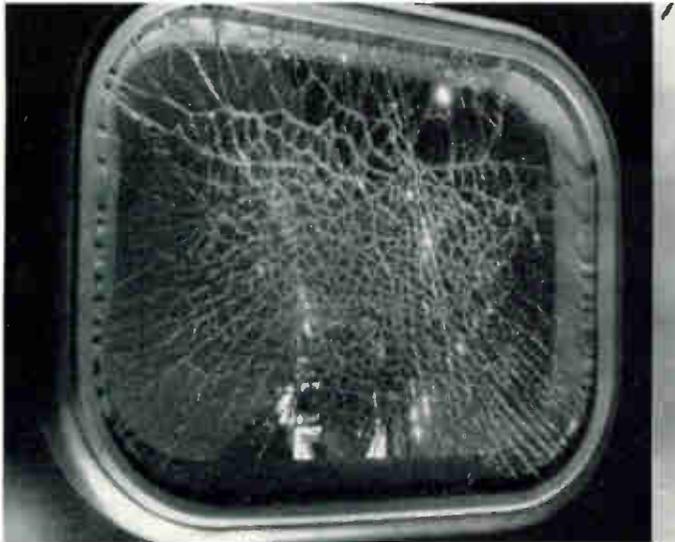
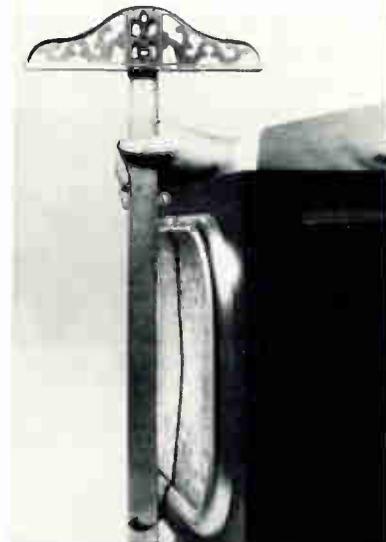
Tele-Clue No. G-79 & 80—These photographs illustrate the result of a fourteen inch picture tube which imploded while in its cabinet. The tremendous force released is apparent from the condition of the safety glass in these photographs. Fortunately this type of glass breakage, which obviously was due to the fracture occurring first in the faceplate, does not occur very often. In one case this did happen sometime during the night to a receiver not in its cabinet. Pieces of glass were scattered all over the service shop and were found imbedded in the walls about twenty feet away.

These photographs illustrate that if an implosion occurs while the set is in the cabinet, damage would result only to the receiver. However, utmost care should be exercised when removing, transporting or repairing a receiver outside of its cabinet. The potential danger is great since a scratch or defect in the glass of the tube may cause an implosion at any time. Therefore it is advisable to use every precaution including the wearing of safety glasses while working around exposed picture tubes.

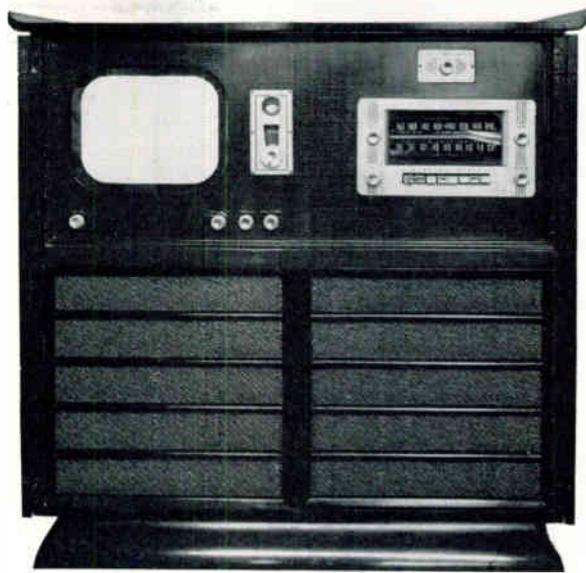
Fig. 5. Stromberg-Carlson Model TV-12 Series 11 twelve inch combination before conversion.

The next receiver converted was a twelve inch Stromberg-Carlson radio-phonograph combination shown before conversion in Fig. 5 and after conversion in Fig. 6. In this model the chassis was recessed to accommodate a portion of the original 12JP4 picture tube, and for this reason there was insufficient cabinet space for a sixteen inch picture tube. Therefore the 14CP4 was the largest size which could be used without major chassis changes.

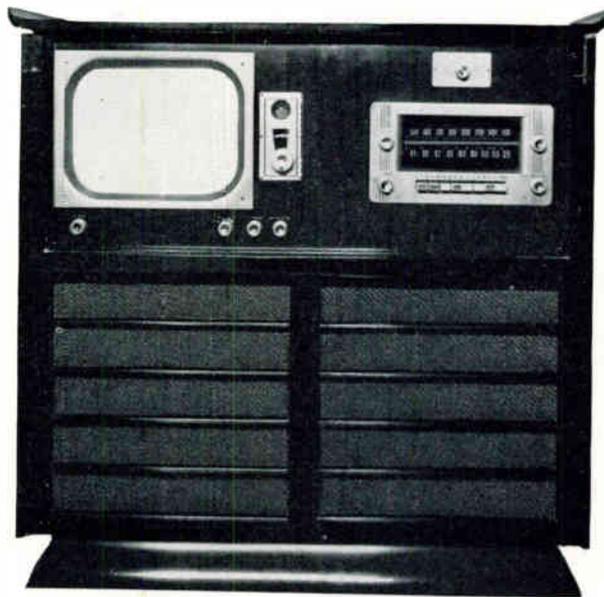
Fig. 6. The same receiver as shown in Fig. 5 after being converted to use a General Electric 14CP4 picture tube.

- 1—400 mmfd mica capacitor.
- 1—1000 ohm 25 watt resistor.
- 1—14 in. plastic mask measuring 10½ in. x 13½ in. outside dimensions. The mask used was a No. 14SG manufactured by the Deitz Miracle Lens Co., 141 President St., Passaic, N. J. (a mask of some other manufacturer may be used, however, the outside dimensions are important as the mask just fits as can be seen in Fig. 6.)

The chassis was placed in the cabinet and the plastic mask was drilled, countersunk and mounted over the picture tube. When the knobs, chassis bolts and cabinet back were replaced the conversion was completed as shown in Fig. 6.
