Techni-talk

on AM, FM, TV Servicing

TWO 10-INCH CONVERSIONS

MAJOR SWEEP AND CABINET CHANGES

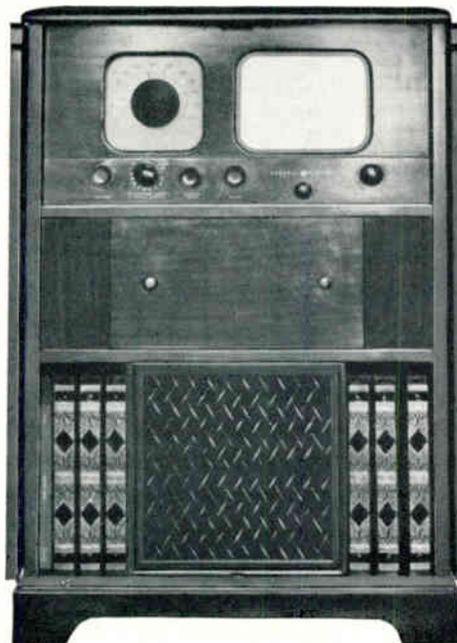
Fig. 1. General Electric ten inch TV combination Model 802 before conversion.

The General Electric Model 802 shown in Fig. 1 was originally a ten inch TV, AM, FM radio combination. This was converted to use a General Electric 14CP4 picture tube which was the largest size that could be used without major cabinet changes. The completed conversion is shown in Fig. 2. It is possible to convert this receiver to a sixteen or seventeen inch picture tube by mounting the tube in the center of the top section which now holds the chassis and picture tube. The phonograph section would then be eliminated and this area used for the chassis only. Due to the amount of cabinet work involved, plus the disadvantage of eliminating the phonograph, it was felt that the fourteen inch conversion would be the most practical. The conversion to a sixteen or seventeen inch picture tube may be described at a later date.

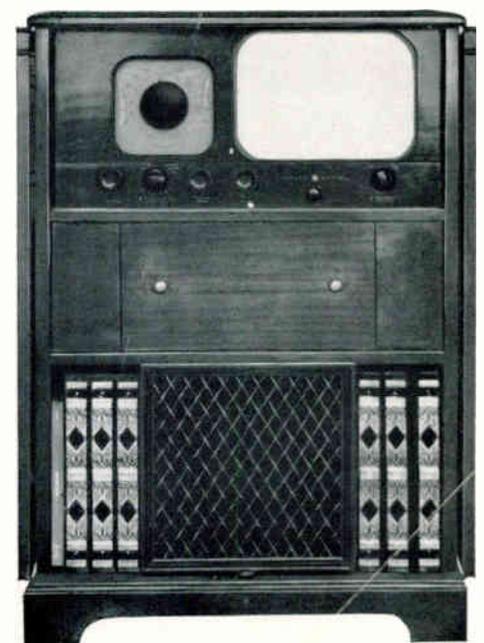
Fig. 2. The same receiver after being converted to use a General Electric 14CP4 picture tube.

The edges of the mask area were sanded, stained and varnished to match the rest of the cabinet. The Royalite mask was then cut with a pair of scissors to the size of the safety glass. The safety glass and mask were fastened to the inside of the cabinet with four S clips, which can be obtained from most any glass company. The completed conversion is shown in Fig. 2.

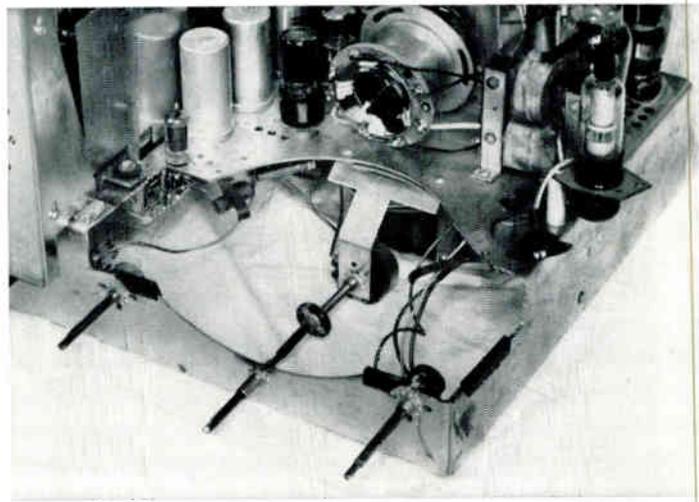
Fig. 3. Chassis of General Electric Model 802 shown after the chassis had been cut out to accommodate the 14CP4 picture tube. The original deflection yoke has been replaced with new 70° coils from a General Electric RLD-024 deflection yoke.

1. The large metal shield over the high voltage and sweep circuits was removed and the picture tube taken out.
2. The chassis was marked one and three-eighths inches down from the top and four inches in from each side. This area was then cut out with a drill and hacksaw leaving the two grounding strips as can be seen in Fig. 3. Three pieces of rubber were used to prevent the picture tube from resting on the metal edges.

which were fastened to the 1B3-GT tube socket were removed, and the third one was used to hold the socket in a position which would not interfere with the picture tube. The photograph in Fig. 3 was taken at this point in the conversion.

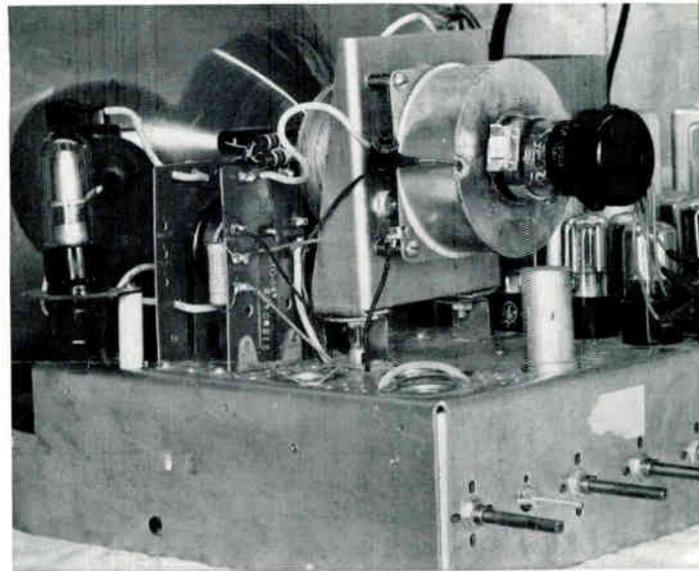
Fig. 4. Chassis of General Electric Model 802 shown after all the electrical and mechanical changes have been made.

4. This assembly should be handled carefully to prevent any change in the position of the coils or core material. This transfer made it possible to use the original focus coil and mounting bracket as seen in Fig. 4.

yoke assembly and also to move it closer to the edge of the chassis. These were mounted to the chassis in new holes one inch in back of the original mounting holes. The mounted assembly can be seen in Fig. 4.

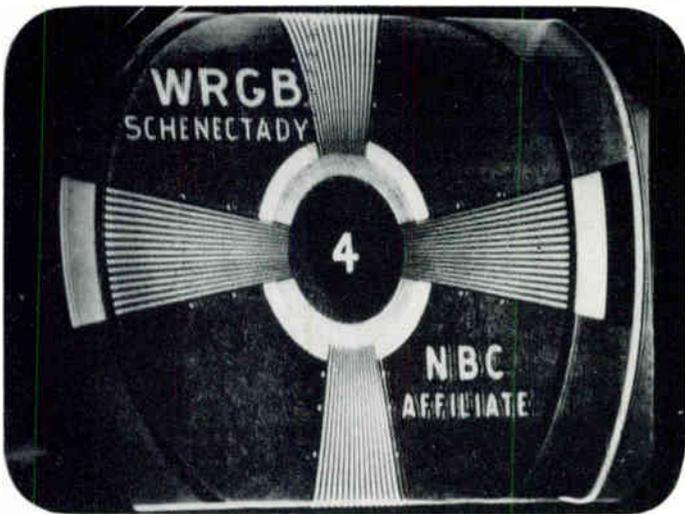
Tele-Clue A81. The vertical foldover which can be seen at the right side both top and bottom was due to a defect in the vertical windings of the deflection yoke on a General Electric Model 802. Several vertical retrace lines were visible near the top and extended about one-inch down from the top. These could not be eliminated by adjusting the vertical hold, vertical linearity or height controls. Ordinarily a short in the vertical coils will result in a keystone effect similar to Tele-Clue No. A-21. This effect was not noticeable in this photograph, however a new yoke corrected the defect.

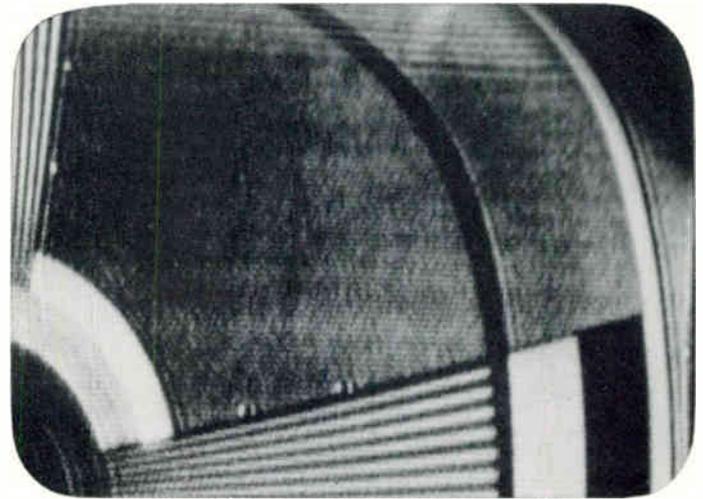
Tele-Clue A82. This is an enlarged view of the top right hand corner of Tele-Clue No. A81 which shows the foldover and vertical retrace lines which could not be eliminated.

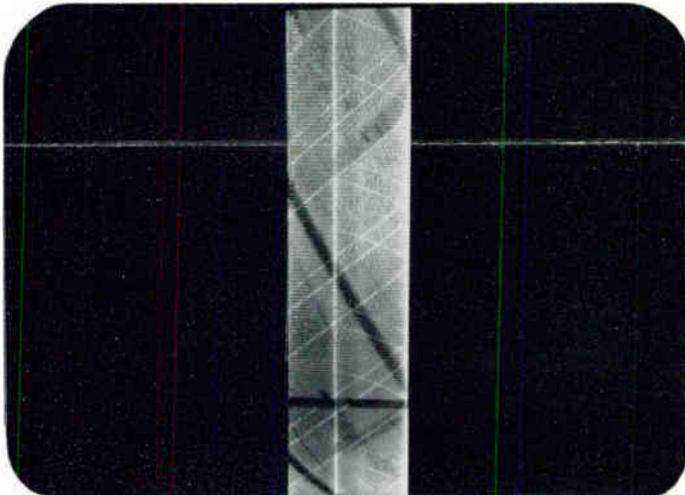
Tele-Clue No. A83. This illustrates another unusual defect in the deflection yoke. In this case the width is reduced and again without any noticeable keystone effect. This photograph was taken of a Westinghouse Model 619T12 chassis V2150-176. This same chassis is also used in Model 617T12. The horizontal output circuit for this receiver is shown in Fig. 1.

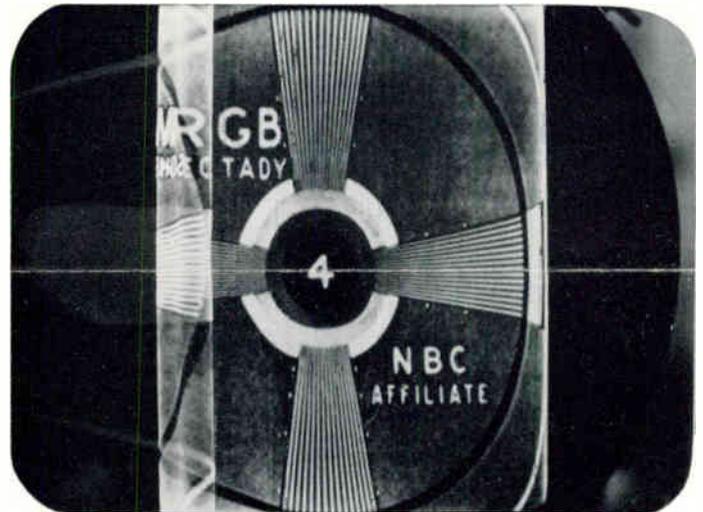
Tele-Clue No. E84. This shows the effect of removing the 6W4-GT damper tube in the circuit shown in Fig. 1. Ordinarily the removal of the damper tube results in a reduction of the high voltage to a point where little or no illumination of the screen is visible. In this circuit however, the high voltage was not noticeably reduced and there was a gradual change which took place during a two minute period after the damper tube was removed. After this period the test pattern appeared like Tele-Clue No. E85.

Tele-Clue No. E85. This photograph was taken about two minutes after Tele-Clue No. E84. There was a gradual change to each side of the test pattern until it looked like the above photograph. The test pattern looked like this as long as the damper tube was out of the circuit.

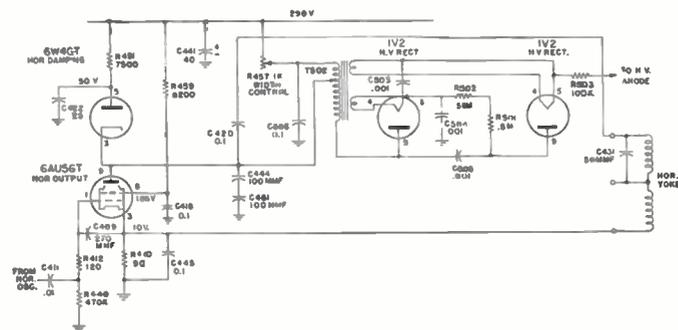
Fig. 1. Horizontal output circuit used in Westinghouse models H617-T12 and H619T12 chassis V2150-176.

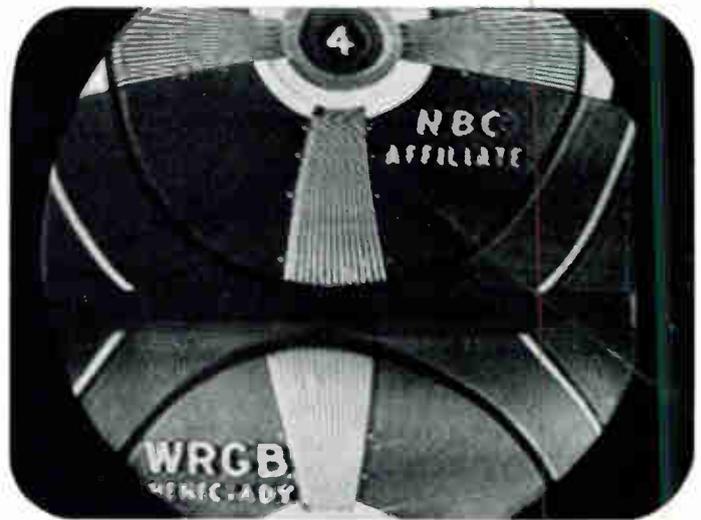
Tele-Clue No. C86. This is a somewhat unusual defect which could take a considerable amount of time to run down. The picture was very dark and looked as if the contrast control was advanced too far. This control however, had no noticeable effect on the picture. The horizontal sync was critical and the vertical would jump a frame quite frequently. This condition was caused by a leaky capacitor C290 in Fig. 2. Because of this a positive voltage (50 V.) appeared on the picture tube grid. This circuit was used in the following General Electric TV receivers:

Tele-Clue No. C87. This is an enlarged view of the area between the frames shown in Tele-Clue No. C86. The vertical sync pulse has disappeared completely. This area should appear like that shown in Tele-Clue No. C88.

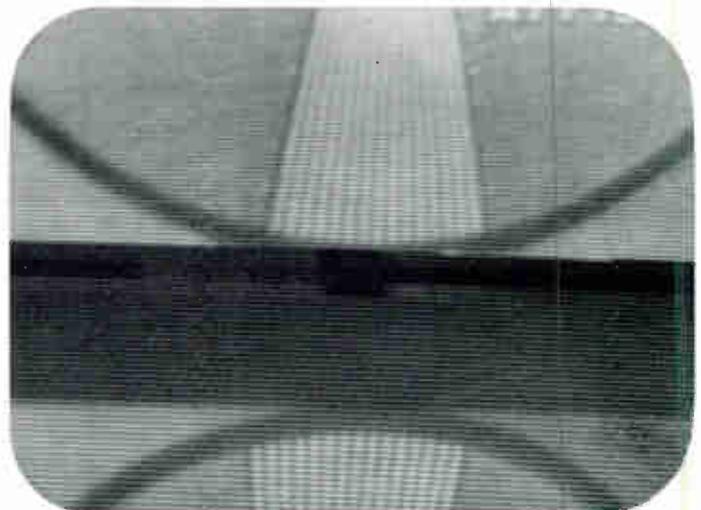
Tele-Clue No. C88. This photograph shows a normal vertical sync pulse as it should appear between frames. If this is compared with Tele-Clue No. C87 only three dots appear in the area where the vertical sync pulse should be. A discussion of the synchronizing pulses and their functions appeared in the Vol. 2 No. 1 issue of Techni-talk.

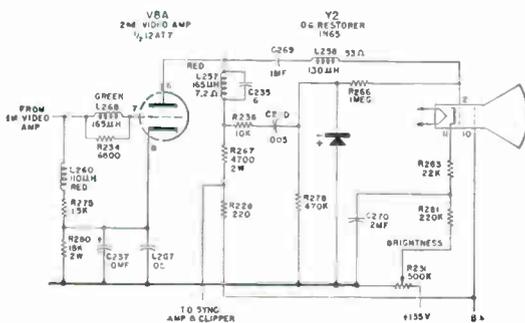
Fig. 2. Video amplifier and d-c restorer circuit used in the General Electric receivers shown under Tele-Clue No. C86.
