# TECHNI-TALK

on AM, FM, TV Servicing

TUBE DEPARTMENT, ELECTRONICS DIVISION

### RCA MODEL 630TS

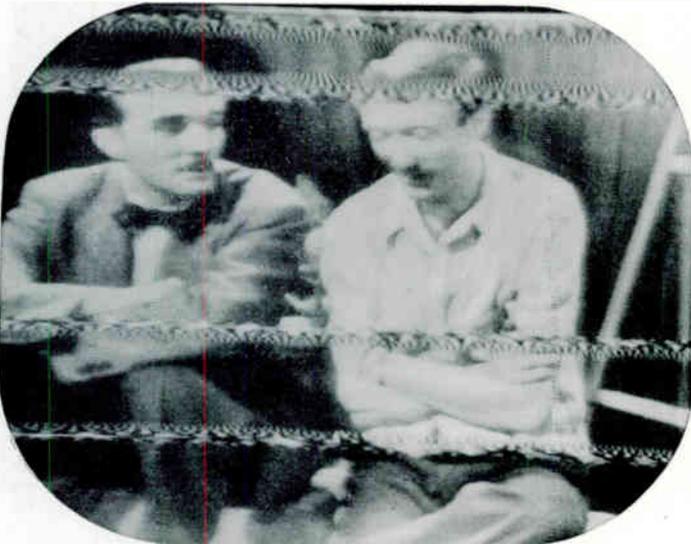
**Tele-Clue Nos. J99 and J100.** Two more interference patterns produced by the type of lamp shown above. The black bands in the photograph on the right are the result of operating the lamp close to the receiver.

The high frequency oscillation in the lamp is not produced by any of the conventional methods. In principle, it relies on what is called the Barkhausen theory.

The Barkhausen theory requires several conditions and a certain geometry of the parts and layout in order to produce oscillations. In an incandescent lamp of the type shown, the ends of the filament wire act as a cathode and then an anode on each successive half cycle of the

alternating current. Assuming one side to be negative, the filament emits electrons which are attracted by the opposite wire which is positive. The electrons accelerate toward the wire, with most electrons passing the anode. The inside glass surface of the bulb builds up a negative charge and as the electrons approach the glass they are repelled. In addition, the anode is still positive, attracting the electrons, and causing them to return in the direction of the anode. On returning to the anode the process is repeated, the electrons overshoot the wire anode and enter a negatively charged cathode field. The electrons take an elliptical path about the anode which creates a high frequency current in the anode.

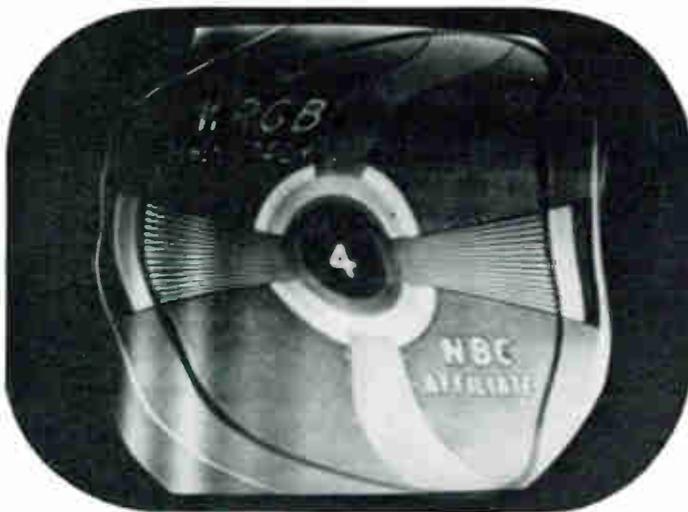
**Tele-Clue No. F103.** This photo indicates a defective component which reduces the output B+ voltage. This reduced B+ voltage will affect both horizontal and vertical sweep and will also give reduced picture brilliance. The ripple and shadow through the picture is due to inadequate filtering at the "B" supply. This was caused by an open C452 in Figure 2.

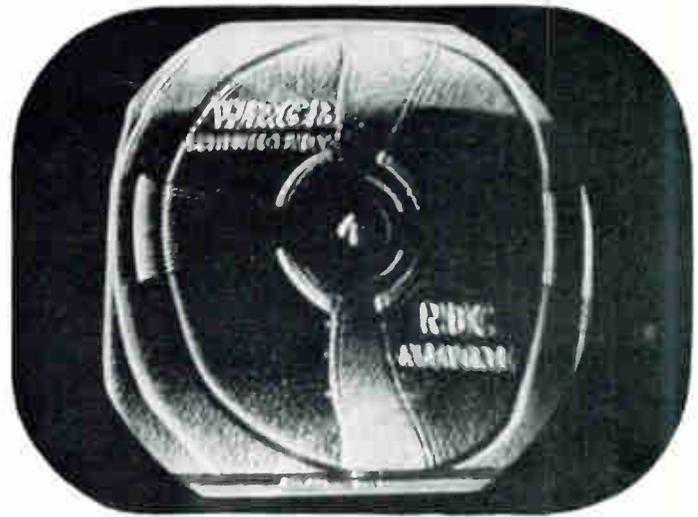
**Tele-Clue Na. M102.** This condition is typical when a component fails in the AGC circuit. It may result in the contrast control having little or no effect on the picture. If the contrast control has little control, it may be due to leakage in one of the capacitors such as C261 or C251. Since the impedance of the circuit is high, leakage in the order of 1 megohm or less may cause trouble. A completely inoperative control may be the result of a shorted capacitor or a ground in the AGC system. This was caused by a shorted C251 in Figure 2, however, a short in C261 or an open in L258 may result in a similar condition.

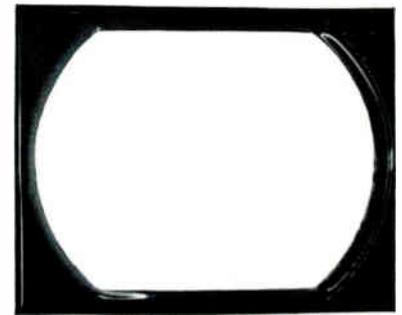
Figure 4. Twenty-four inch plastic mask used to replace viewing screen on General Electric Model 910 receiver.

7. The height was increased with good linearity by replacing the 6SN7-GT (V11 Vert. sweep generator) with a 6BL7-GT.
8. The plastic mask shown in Figure 4 was installed in place of the viewing screen and the 24AP4 picture tube and mounting assembly were centered and placed in back of the mask. This completed the conversion.

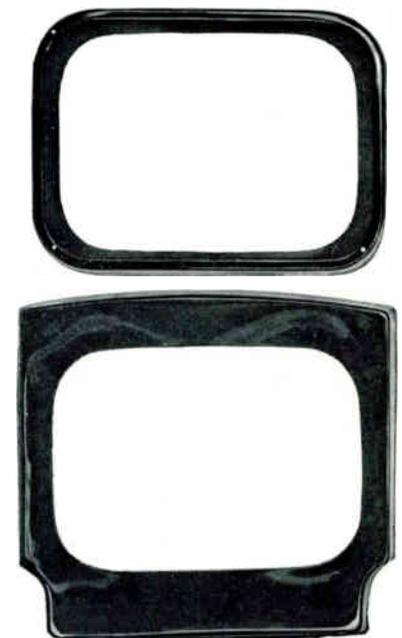
Figure 7. Two plastic masks specially designed for use on 630 type cabinets. The mask on the top is used on flat top cabinets and the one on the bottom on cabinets with a curved top as shown in Figure 5.

- 1—General Electric 14CP4 picture tube.
- 1—General Electric RET-003 ion trap magnet.
- 1—Stancor DY-7, Merit MDF-70 deflection yoke or equivalent.
- 1—14-inch plastic mask shown at the bottom of Figure 7. This mask was designed for use on the type cabinet shown in Figure 5. The mask shown at the top of Figure 7 was designed for use on cabinets similar in appearance but with a flat top instead of curved. Both types of masks are manufactured by the Deitz Miracle Lens Company, 141 President Street, Passaic, New Jersey.
- 1—4000 ohm 10 watt resistor.
- 1—.05 mfd 600 volt capacitor.
- 6— $\frac{3}{4}$ -in. spacers to raise deflection yoke and focus coil mounting brackets. These can be cut from a piece of  $\frac{3}{8}$ -in. or  $\frac{1}{2}$ -in. aluminum tubing similar to that used on the ordinary FM or TV antenna.
