# Techni-talk

### CONVERSIONS—

## GENERAL ELECTRIC MODEL 815 TO 20-INCH AND MOTOROLA VF-102 TO 14-INCH PICTURE TUBES

This is the seventh of a series of articles on converting TV receivers to use larger picture tubes. In this issue a General Electric Model 815 was converted from a sixteen-inch round to a twenty-inch rectangular picture tube, and a Motorola ten-inch FM-AM phono combination was converted to use a General Electric 14CP4 picture tube.

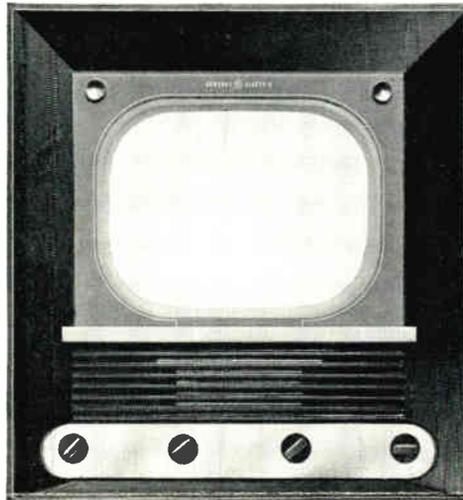
Fig. 1. General Electric sixteen-inch Model 815 before conversion.

The General Electric Model 815 shown in Fig. 1 was originally a sixteen-inch TV receiver with a relatively small viewing area due to the straight sides of the mask. This receiver was converted to use a 20-inch picture tube as shown in Fig. 2. This model was very easy to convert, and in view of the large size cabinet and well designed chassis a conversion should be recommended whenever possible.

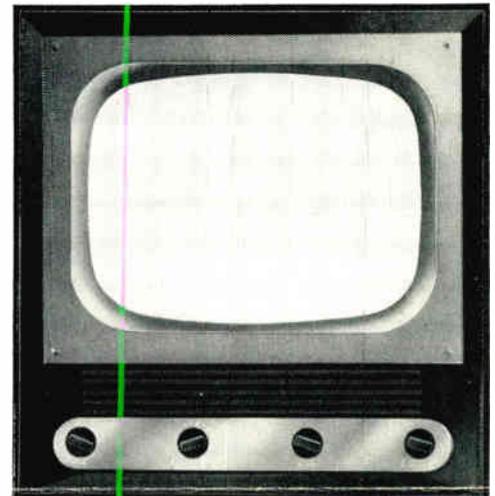
Fig. 2. General Electric Model 815 after it had been converted to use a twenty-inch picture tube.

- A hole was drilled in each corner of the new picture tube mask, and the mask was then fastened to the cabinet with oval head wood screws as shown in Fig. 2.

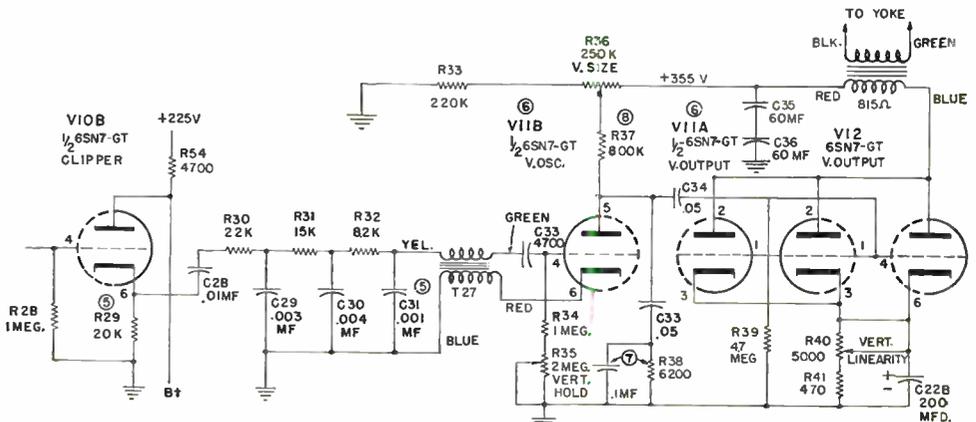
Fig. 3. Vertical oscillator and output circuits used in General Electric Model 815. The encircled numbers indicate a change which is explained in the text following that same number.

changing R29 from 15K to 20K and C31 from .006 to .001 mfd. These changes are shown in Fig. 3.

6. The 6J5 vertical oscillator tube was removed and replaced with a 6SN7-GT tube. One section of the new 6SN7-GT tube was used as a vertical oscillator, and the other half was connected in parallel with the vertical output tube V12 as shown in Fig. 3.
7. R38 was removed and replaced with a 6200-ohm resistor and a .1 mfd capacitor connected in parallel.
8. R37 was replaced with a 800K ohm resistor as shown in Fig. 3.
9. C120 was removed from its original position and remounted below the chassis so that it did not interfere with the relocated speaker.

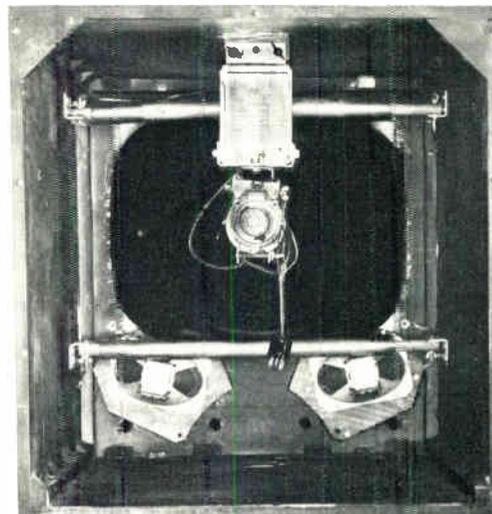
Fig. 4. Rear view of Model 815 cabinet after all changes had been made.

- The wooden block which held the deflection yoke assembly was moved  $1\frac{1}{2}$  in. closer to the front of the cabinet.
- The wooden cross bars used to hold the picture tube in place were remounted as shown in Fig. 4.

- It was also necessary to remount both speakers in a slightly different position as can be seen in Fig. 4.
- The chassis was then placed in the cabinet, and the necessary adjustments were made to obtain a linear test pattern.

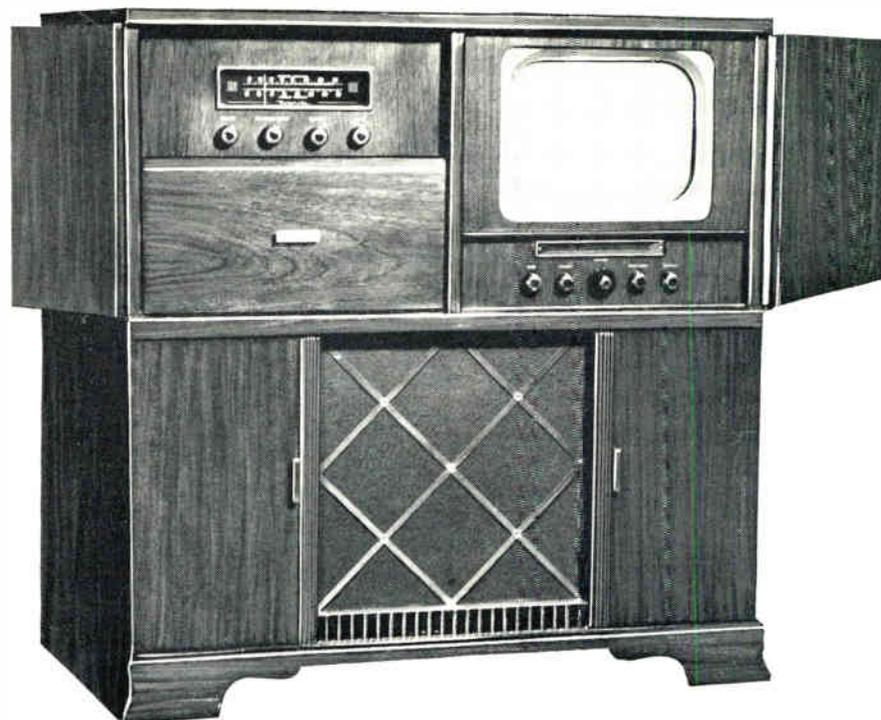
Fig. 5. Motorola Model VF-102 FM-AM phonograph combination after it was converted to use a General Electric 14CP4 picture tube.

The next receiver converted was a ten-inch Motorola Model VF-102 FM-AM phonograph combination. This was converted to use a General Electric 14CP4 picture tube which was the largest size that could be used without major cabinet changes. The completed conversion is shown in Fig. 5. Practically the same chassis was also used in Models VK101, VK101M, VF102A and VF102C and therefore, the same circuit changes should work on these models.

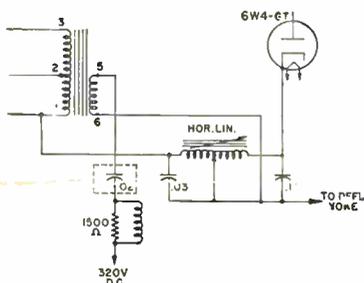
If the 6W4-GT is removed a picture reappears and remains on the screen but the horizontal will not hold and a bright vertical line appears on the left-hand side. After thoroughly checking the chassis I found a shorted .02 mfd horizontal sweep coupling capacitor connected from terminal number 5 on the 4th winding of the flyback transformer. This capacitor is shown in the box on the drawing.

In both cases the defective capacitor had a 400 volt rating and according to Sam's Photofact Folder this capacitor should have a 600 volt rating. A new .02 mfd 600 volt capacitor restored the receiver to normal operation.
