**THE  
TELEVISION  
PICTURE  
TUBE—III**

**Techni-talk**  
on AM, FM, TV Servicing

This is the third of a series of articles on the television picture tube. In the last issue some defects which develop in the electron gun were described together with suggestions for eliminating these defects. The following is a continuation of the same subject.

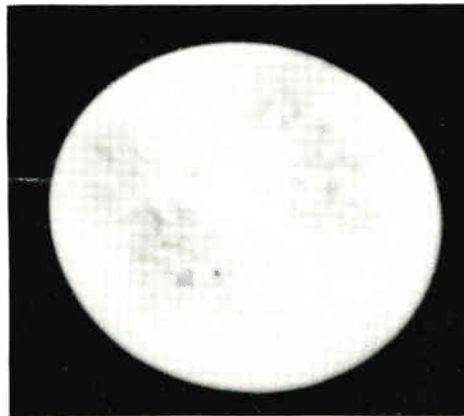
Fig. 3. Cathode image as it normally appears after picture tube has been in use for a period of time.

A new picture tube will produce an image similar to that shown in Fig. 2. After a picture tube has been in use for a period of time, the shadows increase and dark spots develop. Figs. 3 thru 10 illustrate several different stages of cathode deterioration which may occur in various picture tubes. Fig. 3 is a normal image after a picture tube has been used for a period of time. Figs. 4, 5 and 6 have areas which are practically dead and may, therefore, have poor spot size. If an emission test indicates a normal emission level, these tubes can be considered as "good." Figs. 7, 8, 9 and 10 show large areas which are "dead." Tubes which produce cathode images like these usually also have "low" emission and should be replaced. It should be kept in mind that these images represent an enlargement of the spot which scans the face of the picture tube. If this spot is distorted in shape such as Figs. 7 thru 10, the clarity as well as the shading of the picture will be impaired. A re-

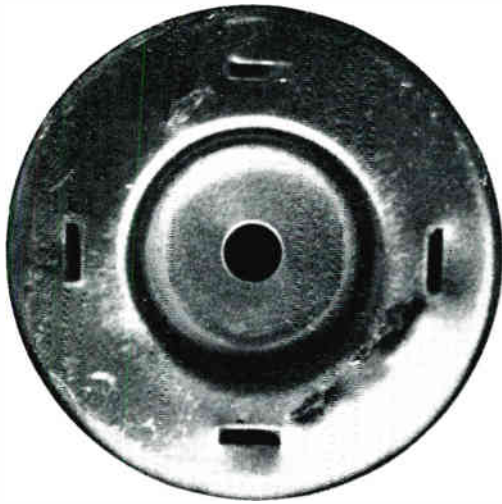
Fig. 11. Normal masking aperture at one end of HV anode cylinder.

The masking aperture on one end of the anode cylinder defines the edge of the electron beam. When the ion trap magnet is properly adjusted practically all of the electron stream is directed through this aperture. Fig. 11 is a photograph of a normal aperture and Fig. 12 illustrates a masking aperture on which the metal was burned due to incorrect adjustment of the ion-trap magnet. In ordinary receiver type power supplies which in most cases have poorly regulated voltages, the metal would not be burned as much as shown. If the ion-trap magnet is not correctly ad-
