Techni-talk

Vol. 14, No. 1

March, 1962

G-E SONIC REMOTE CONTROL SYSTEM III

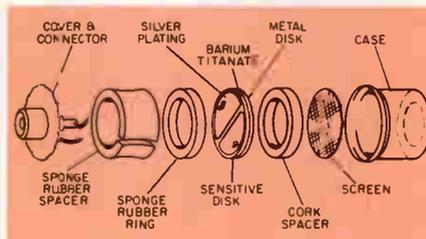
Fig. 1. Exploded drawing of ceramic transducer.

As mentioned in the Vol. 13, No. 5 issue, two versions of sonic remote control were used with the M6 line of television receivers. The first version was designed to use a ceramic type transducer shown in Fig. 1. for both the transmitter and receiver units. During production the circuitry of both the transmitter and receiver was changed to utilize an electrostatic type transducer shown in Fig. 2.

second method of identification of the transmitter is accomplished by externally viewing the transducer opening of the transmitter case. The ceramic transducer is housed in a metal case, and the metal flange of the case is visible as a circular border around the transducer grille. Since the electrostatic transducer is housed in a plastic case, there is no metal flange visible.

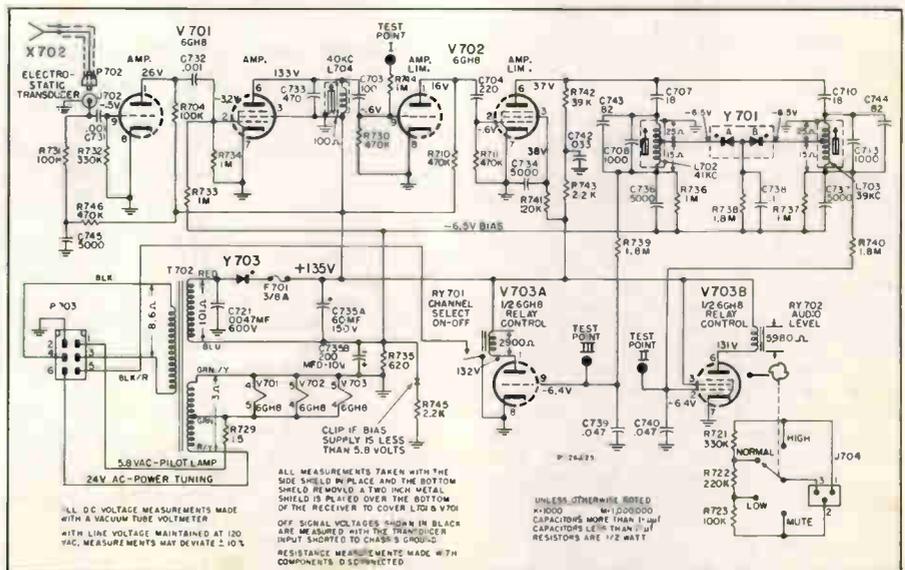
Fig. 3. Schematic diagram of electrostatic type transducer receiver.

Receivers that incorporate the electrostatic transducer, shown in Fig. 3, can be readily identified by the absence of a bias control potentiometer, or by code 047 and above. The electrostatic transducer used with the receiver is distinguished from the ceramic unit in the method by which the cable is attached to the transducer. The electrostatic transducer has the cable fastened permanently, while the ceramic is connected to the cable by means of a jack on the transducer and a plug on the cable.

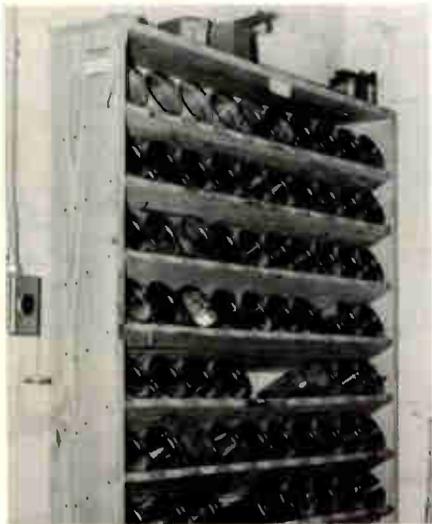
PARTS RACK

A handy parts rack that takes up little space is this unit with shelves sloping downwards towards the rear. Containers are 110 quart cans with the tops cut out, making parts selection and inventorying easy.

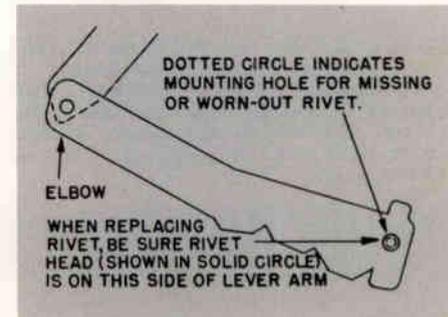
It has been found that defective control of the speeds when turning the 16, 33, 45, 78 RPM speed selector may be caused by a worn-out or missing rivet on the control lever arm. This control lever arm is part of the motor plate assembly.

The rivet can be replaced in the following manner without replacing the motor plate assembly item No. 114:

1. Remove motor plate assembly.
2. File or grind off rivet that is in the elbow joint between speed control selector bar and speed control lever arm (see drawing).
3. Remove lever from slot.
4. Replace the worn-out or missing rivet (see sketch) with replacement rivet, catalog number RS-2116. Mount rivet using a rivet punch to peen over rivet shank, so that it fits tightly to lever arm.
5. Replace lever arm into slot.
6. Connect the speed lever arm and control lever arm at the elbow with another rivet (Catalog No. RS-2116).
7. Mount motor plate assembly back on changer.

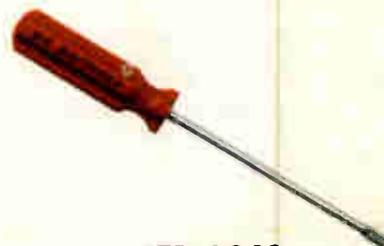
ETR-2968

Here is a new General Electric service aid to simplify the removal and installation of twist-prong electrolytic capacitors.

The hollow tip fits perfectly over the mounting tab. The old capacitor is removed by placing tab adjuster over each mounting tab and rotating until tab breaks off. A new capacitor is installed by inserting tabs in mounting holes. With tab adjuster in place rotate each tab about 45°.
