- Oscilloscope Probes . . . Who Needs Them?
- Further Adventures in TV Servicing

art journal
September/October 1975

OSCILLOSCOPE PROBES

by Harold J. Turner, Jr.

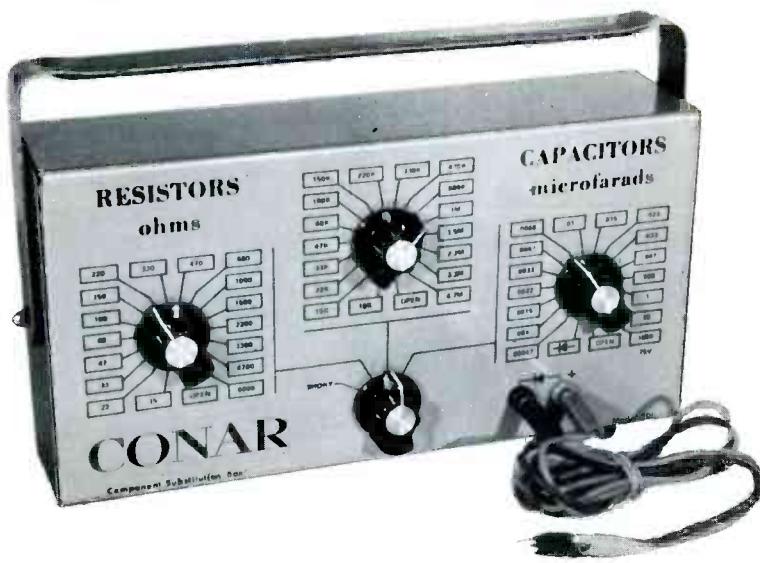
The Model 201 Component Substitution Box

Now you can quickly and easily verify the condition of a suspected defective part—by substitution. With Conar's Component Substitution Box, you can connect any one of over fifty values of the most commonly used electronic components across one end of a pair of clip leads. You can then connect the other end of the clip-lead pair into a circuit to bridge a component suspected of being defective. The Component Substitution Box can be assembled easily in one evening.

Carbon Resistors 10% 1 watt	Capacitors 10% 500 volt min.
15, 22, 33, 47, 68, 100, 150, 220, 330, 470, 680, 1K, 1.5K, 2.2K, 3.3K, 4.7K, 6.8K, 10K, 15K, 22K, 33K, 47K, 68K, 100K, 150K, 220K, 330K, 470K, 680K, 1M, 2.2M, 3.3M, 4.7M.	0.00047, 0.001, 0.0015, 0.0022, 0.0033, 0.0047, 0.0068, 0.01, 0.015, 0.022, 0.033, 0.047, 0.068, 0.1, 0.15, 1000 @ 75 volts.
Diode rated 2 amps at 1000 volts, an "open" position on each of the three component selector switches, a "short" position on the switch selector.

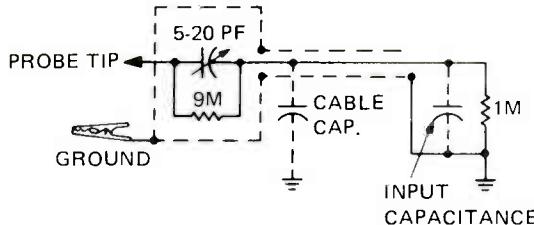
FIGURE 2. BASIC 10:1 LOW-CAPACITANCE PROBE. ADJUSTABLE CAPACITOR IN PROBE IS SET FOR FLAT RESPONSE.

We cannot eliminate this troublesome capacitance, but we can compensate for it. The easiest way to do this is to add another capacitor in series with the probe end of the cable. Then, these two capacitors (the added one and the scope input capacitance, including the cable capacitance) will act as a voltage divider to reduce the strength of the signal applied to the scope input. At the same time, the effective capacitance from probe tip to ground is reduced.

Usually, a probe is designed so that the attenuation factor is 10:1. This means that the input capacitance also will be reduced by the same factor. The added capacitor will be very small, and the effective capacitance will be even smaller. Remember, capacitors in series add like resistors in parallel.

The resistor value is made nine times that of the oscilloscope input resistance, and the capacitor is one-ninth the input capacitance (which is the same as nine times the capacitive reactance of the input capacitor). Thus, the input impedance will be ten times as high as it was with the direct probe, so the circuit loading will be only one-tenth as much. Of course, as you can see, this probe also reduces the sensitivity of the scope by a factor of ten to one, so very small signals may not be observed. Still, this type of probe is the one you will need most often, since it keeps circuit loading to a minimum. Usually scope gain is high enough to offset the probe loss for all but very low-level signals.

The series capacitor on such a probe is sometimes made adjustable to match the probe to the scope. The best way to do this is with a square-wave generator furnishing a 1-kHz signal. First, connect the scope directly to the generator to make sure that the response is flat. Then, connect the low-capacitance probe between the two instruments. Naturally, there will be a 10:1 reduction in signal strength. But the important thing is the waveshape. You must adjust the capacitor so that the square wave looks just as it did without the probe: the top and bottom of the signal

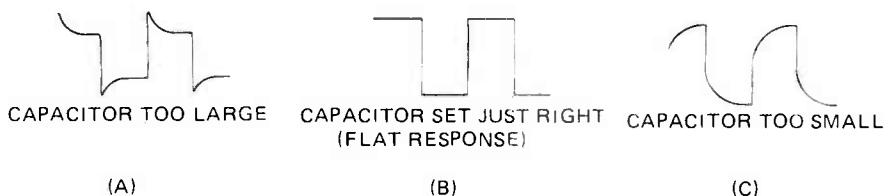
FIGURE 3. WAVEFORMS WITH VARIOUS CAPACITOR SETTINGS.

must be flat horizontal lines on the scope screen. This shows that the overall frequency response is flat; and the scope and its probe do not favor either high or low frequencies. The waveforms you will see when you make this adjustment are shown in Figure 3. Even if your low-capacitance probe does not have an adjustable capacitor, you can still make this check to see if the probe is working properly.

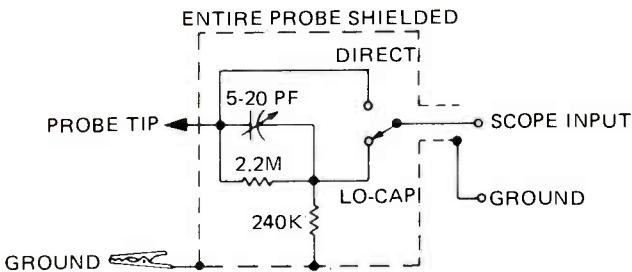
FIGURE 4. A COMBINATION DIRECT LOW-CAPACITANCE PROBE.

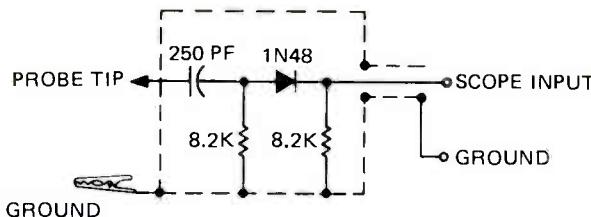
FIGURE 6. A DEMODULATOR PROBE.

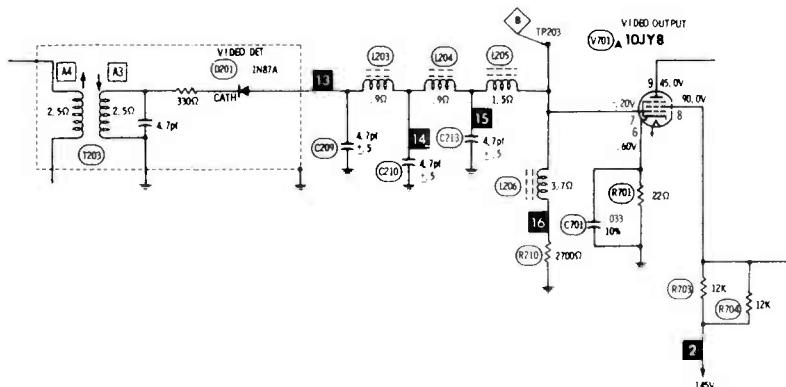
FIGURE 1. VIDEO DETECTOR AND VIDEO AMPLIFIER OF TRUETONE MIC3912B-17.

Since I had good sound, it seemed that the trouble would have to be in the video amplifier stage or thereabouts. The circuit in question is shown in Figure 1. I

removed the video output tube for a check and found it to be an 8JV8 instead of a 10JY8 as shown in the Sams diagram. A tube substitution book showed the two tubes to be interchangeable. However, the tube layout pasted in the rear cover indicated an 8JV8 tube was originally supplied. I don't know why Sams showed the 10JY8 in the schematic, but I didn't worry about it.

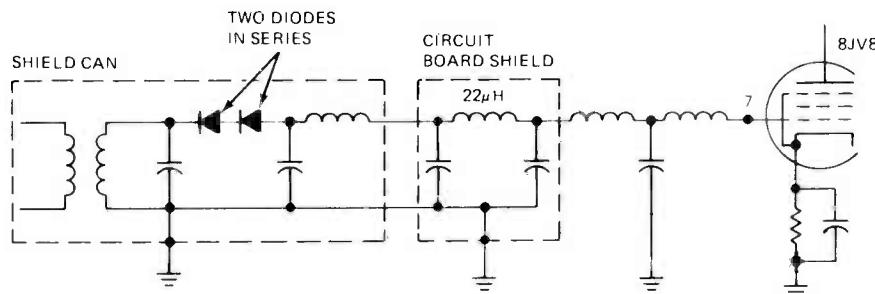
FIGURE 2. ACTUAL CIRCUIT OF TRUETONE VIDEO DETECTOR.

The circuit was not at all like the schematic. Instead, it was like the sketch shown in Figure 2. The thing that got me was that the 330-ohm resistor was missing, and there was an extra peaking coil. In addition, there were two diodes in series for the second detector. From the schematic and parts list, I determined that the damaged coil, L203, had an inductance of $27 \mu\text{h}$. The nearest I could come at the wholesalers was $22 \mu\text{h}$, which I installed. I also replaced the two diodes (they were shorted) with a single diode.

I rechecked the resistance from pin 7 of the 8JV8 tube to the chassis and found it to be an almost dead short, so I removed the i-f can again and found the diode I had installed was shorted. The question immediately arose — why? Also, why did the schematic show a 330-ohm resistor in series with the diode (this is not usual), and why were there two diodes in series installed by the factory? To me, it indicated that the factory engineers had had trouble with diodes burning out, and they were playing it by ear as the sets came off the assembly line. I know that another manufacturer had cured trouble of this sort by using a 470-ohm resistor in series with the diode, so I decided to use a 470-ohm resistor and a single diode.

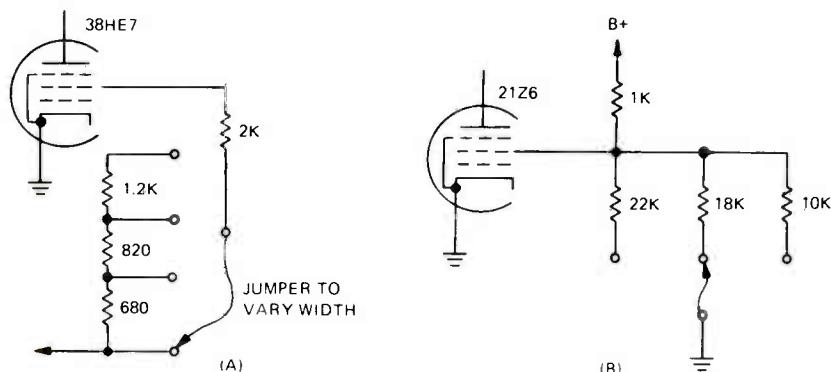
FIGURE 3. WIDTH ADJUSTMENT USING SERIES (A) AND SHUNT (B) RESISTOR.

I thought I was all through with this set and had written it up for the Journal, but a week later it came back with no raster. The horizontal output tube didn't get as hot as it should, so I figured it had little or no screen or plate current. I got out the schematic again and found that while it had been OK for the previous work, the horizontal sweep circuit was quite different, using a 21Z6 instead of the 38HE7 shown on the schematic. I noted from the schematic that the screen voltage was

adjustable to vary the width. The adjusting tap should be an easy place to check the screen voltage, since I assumed both versions used the same type of width control.

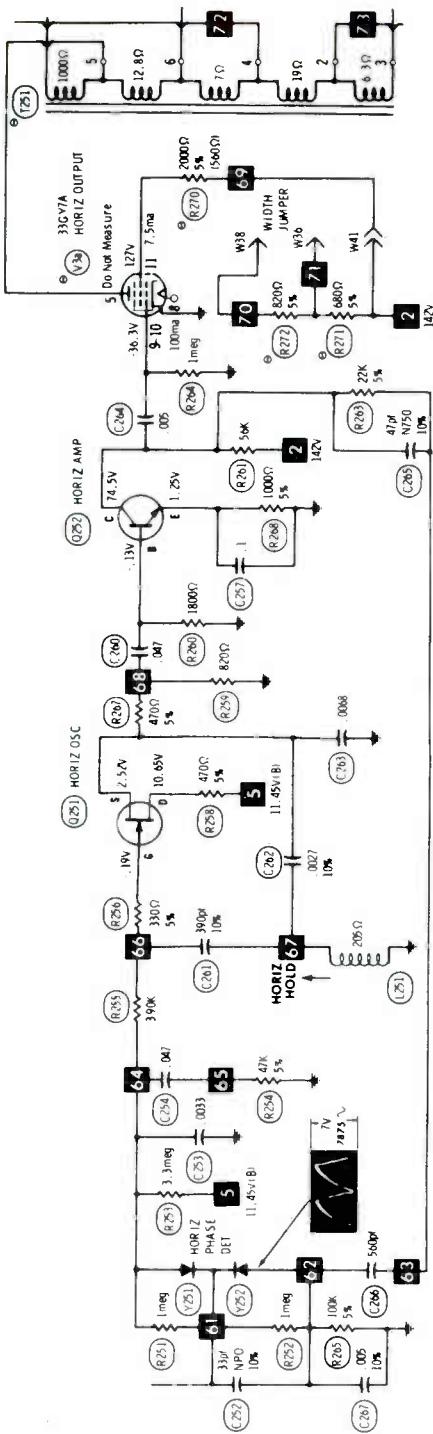
FIGURE 4. HORIZONTAL AND HIGH-VOLTAGE SECTION OF TRUETONE GEC3412A-47.

This set had no raster, and when I found out that there was no high voltage I invested in a Sams diagram. The horizontal and high-voltage sections are shown in Figure 4. Note that the horizontal oscillator and amplifier are transistorized. I had never seen this set-up before. I quickly discovered that there was no grid drive to the 33GY7, so I decided the amplifier transistor had to be at fault, especially since the collector voltage was around 100 volts and there was no base or emitter voltage.

To be on the safe side I bought both the amplifier and the FET oscillator transistors. I installed the amplifier and was rewarded with nothing. Before taking out the oscillator for replacement, I checked its output with my scope and found no output voltage. Again the dc voltages were off, and a check with the ohmmeter led me to believe the trouble might be in the circuit rather than in the FET. The

gate and source voltages were both zero. The drain voltage was higher than normal, indicating lack of circuit current.

The resistances in the G and D circuits were about as expected, but the S to chassis was about 300 ohms. I disconnected (clipped) the lead of the 820-ohm resistor to ground and the resistance from S to ground remained the same. I removed the FET and the resistance from the S terminal to ground remained the same. I looked the circuit over and the only thing I could see that could cause the trouble was a short in the 0.0027 μ f feedback capacitor from the source to the horizontal coil or the 0.0068 μ f to ground. I disconnected one lead of the 0.0027 μ f capacitor and, sure enough, it was just about a dead short.

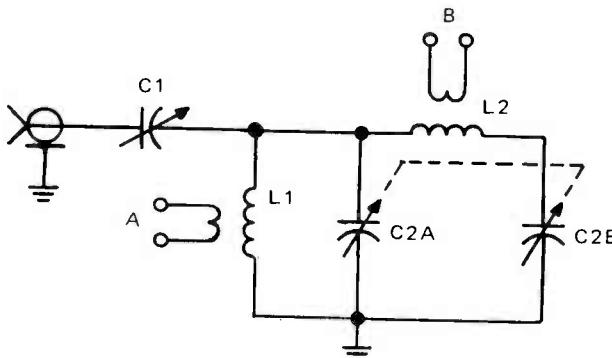
FIGURE 1. MULTIBAND COUPLER.

Then I came upon a coupler in the 1957 ARRL Handbook which was just what I was looking for. This handbook was published in the days when the "multiband" tuners were popular, and someone had designed this coupler around such a tuner. After reading the article, I remembered that I had built a receiver some years ago and had used such a tuner in the front end and it had worked quite well. It had two ganged capacitors and two coils and covered the entire range from 3 MHz to 30 MHz. Figure 1 shows the arrangement as published in the 1957 Handbook.

L1 and L2 were separate coils mounted at right angles to one another to reduce coupling, and the outputs were taken from the A and B links. L1 is larger than L2 and at the lower frequencies L2 can be disregarded, L1 being tuned by C2A and C2B in parallel over the 3.5 to 7.3 MHz range. At the higher frequencies, L1 reactance is very large and can be disregarded, L2 being tuned by C2A and C2B in series over the 14 to 32-MHz range. Outputs for 80 and 40 come from link A, while outputs for 20 through 10 come from link B.

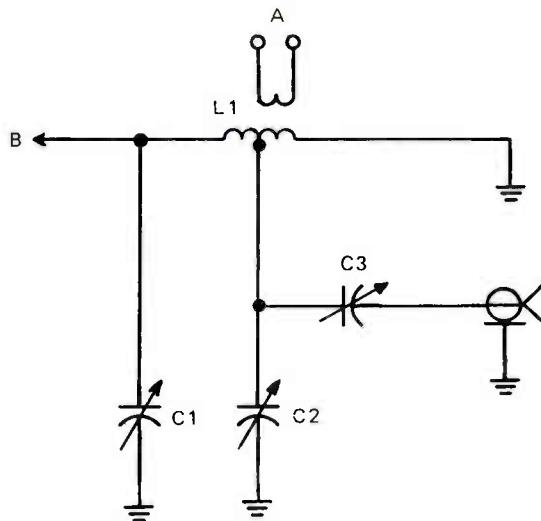
FIGURE 2. REVISED MULTIBAND COUPLER.

I didn't use this arrangement. Instead, I used the configuration shown in Figure 2, originally as a receiver front end and more recently as a transmission line coupler (a more apt name than "antenna tuner"). In the receiver, the link (A) was near the ground end of L1 which is now a single, tapped coil and the B terminal went to the grid of the rf amplifier. C3 was not used. C1 and C2 were two sections of a broadcast variable (about 400 pf maximum capacity) and were ganged together. At any rate, having the two coils of Figure 1 tightly coupled as in Figure 2 did not seem to alter the operation of the tuner in the least, and the mechanical construction was simplified greatly by having only a single coil.

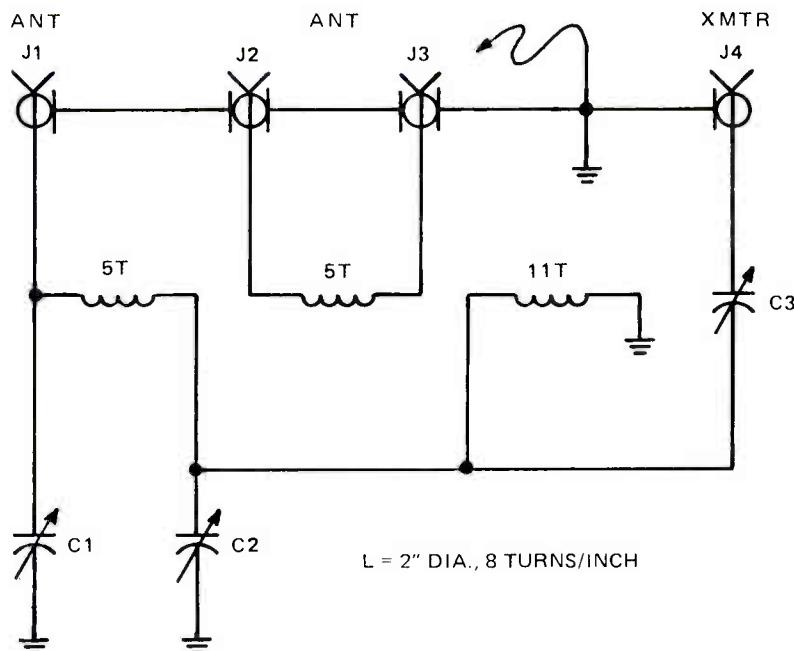
FIGURE 3. FINAL VERSION OF THE MULTIBAND COUPLER.

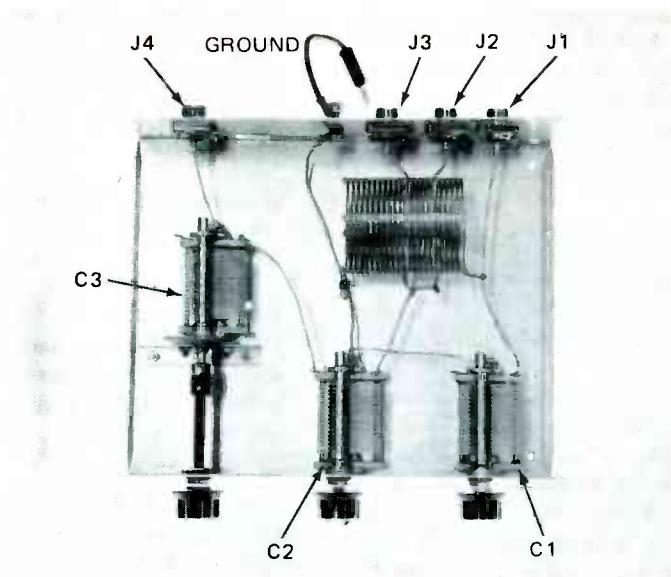
FIGURE 4. PROTOTYPE COUPLER.

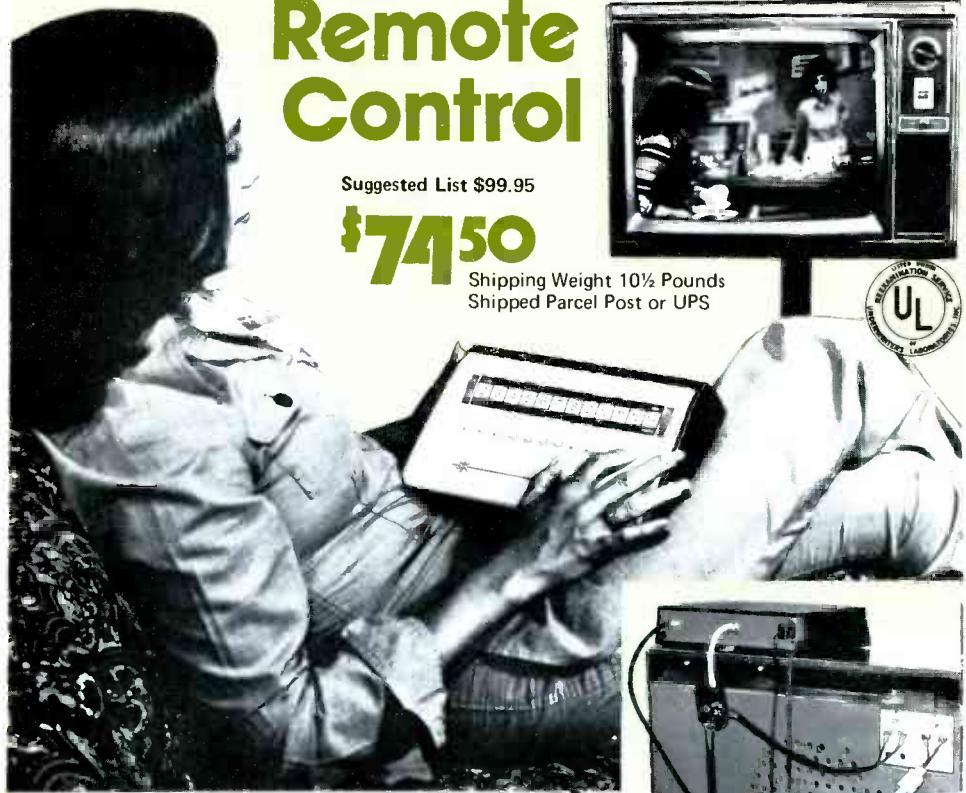
- TURNS TV SET ON & OFF, FINE TUNES, CHANGES ALL VHF CHANNELS INSTANTLY
- INCLUDES VARACTOR DIODE CONVERTER PLUS BUILT-IN SIGNAL AMPLIFIER
- CAN IMPROVE PICTURE QUALITY AND ELIMINATE DIRECT PICKUP GHOSTS
- SAVES WEAR & TEAR ON TV TUNER

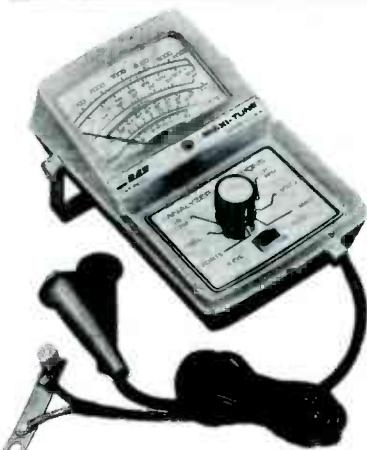
MAXI-TUNE IGNITION ANALYZER

The full capabilities and technical knowledge of the world's most advanced automotive instrument producer has now produced the RAC "Maxi-Tune" Ignition Analyzer. This compact, multifunction, instrument incorporates the latest "state-of-the-art" circuit design (U.S. and Foreign patents applied for). This instrument is NOT subject to dwell or RPM error caused by voltage variations and is NOT affected by "shorted" or "missing" spark plugs because of this advanced circuit design. It contains a 90 degree wide sweep, precision D'Arsonval meter to bring you performance and accuracy on a par with the highest quality professional test equipment on the market today! The instrument performs over 15 basic professional tune-up tests including low (idle) and high RPM, point condition, dwell, dwell variation, idle mixture, power balance, mechanical advance, alternator output, regulator voltage, cranking voltage and air cleaner test. Large 4", precision, highly accurate meter; solid state circuitry; no batteries or power cord required.
