NATIONAL RADIO NEWS

Oscillator Troubles in Superheterodynes
How to Read the Condenser Color Codes
Alumni Association News

Feb.-Mar.
1949

How to Cure Oscillator Troubles In Superheterodynes

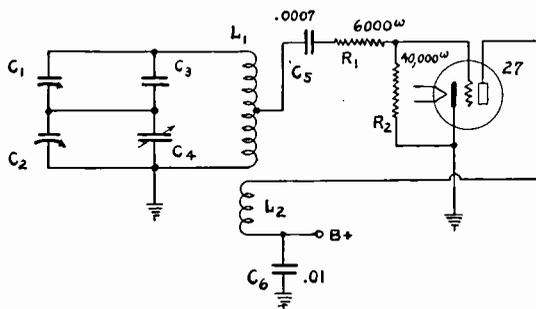
Fig. 1. Triode Oscillator With Tickler Feed Back.

This type of oscillator seldom fails and when trouble is encountered it is usually due to a defective tube, shorted oscillator tuning condenser plates or an open in one of the oscillator coil windings.

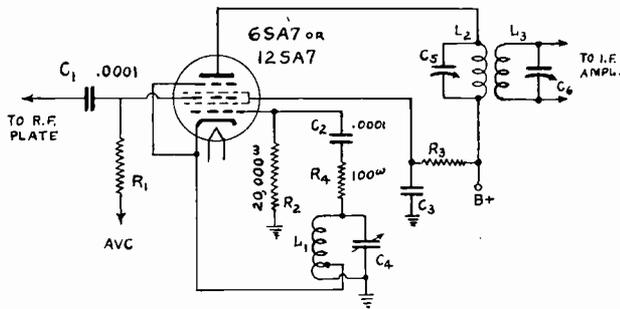
Fig. 4. Pentagrid Type Converter Using Screen Grid as Oscillator Anode.

The circuit shown in Fig. 4 is the one which is currently standard and is found in most receivers. It is quite similar to the one shown in Fig. 3 with the exception that a separate oscillator anode is not used. As you can see this is a variation of the Hartley circuit with the cathode connected to a tap on the tank coil. The screen acts as

the oscillator plate and is effectively kept at r.f. ground potential by condenser C_3 . Opening up of this condenser will result in oscillator failure. Cathode to heater leakage in the tube will short out the lower section of the tank circuit and prevent proper operation.

A reduction in value of the oscillator grid resistor R_2 will also prevent the oscillator from working. A somewhat higher value may be tried at this point when oscillator failure exists. Resistor R_4 is used to prevent parasitic oscillations.

Note that an actual coupling condenser (C_2) to the grid is used instead of the "gimmick" shown in Fig. 3. However, a gimmick may be used with this circuit in some receivers instead of an actual condenser. At times you may find a high value resistor, on the order of 15 megohms, connected between the oscillator grid and the avc circuit. The purpose of this resistor is not to apply avc to the oscillator grid but to make use of the oscillator grid voltage as the minimum (no signal) voltage for the avc controlled tubes.

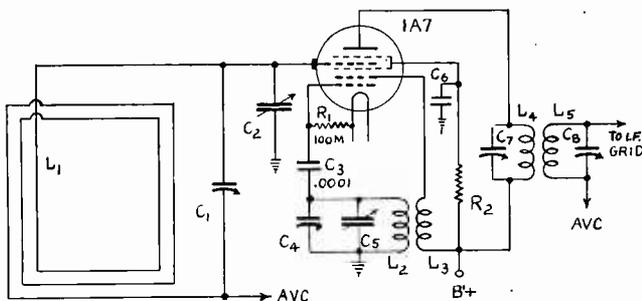
Fig. 5. Battery or Three Way Type Pentagrid Converter.

Fig. 5 is typical of the mixer circuits found in many battery operated and three-way portable type receivers.

Again in the case of oscillator failure you should be on the lookout for lowered oscillator grid resistor values, low Q oscillator circuits and short-circuited tuning condensers.

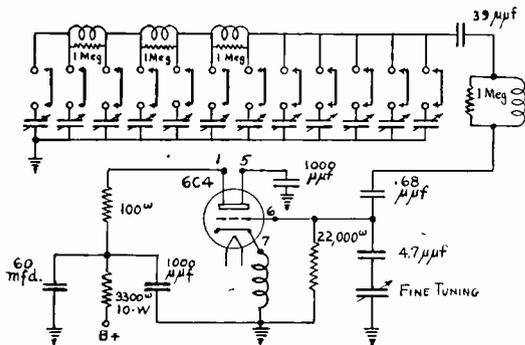
Fig. 6. Hallicrafters Model T-54 T.V. Oscillator Circuit.

This circuit is comparatively free from trouble. However, the 1000 micro-microfarad plate by-pass condenser occasionally breaks down and causes the 100 ohm plate supply resistor to burn out. The oscillator employs an ultra-audion circuit, depending on inter-electrode tube capacities for proper feedback from the plate to the grid circuit. This is a modification of the Colpitts oscillator described in your regular lessons.

Occasionally increasing the capacity of the grid coupling condenser from .68 micro-microfarads to 1.5 micro-microfarads increases the sensitivity on channel number 7.

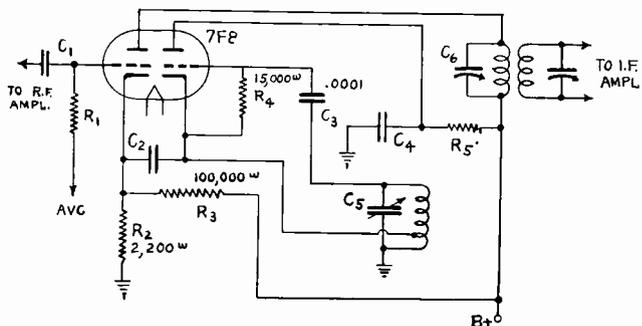
Fig. 7. Dual Triode Converter with Bleeder Bias on the Mixer.

Fig. 7 shows a rather unique mixer circuit found

in some Philco A.M.-F.M. receivers. The oscillator circuit is subject to the troubles we have previously described and is of the Hartley type. The diagram is introduced because some servicemen have encountered considerable trouble with these receivers. The set acts as though the oscillator was not working, yet the correct d.c. voltage may be measured across oscillator grid resistor R_4 and oscillator signals at the correct frequency may be picked up with a signal tracer. Actually resistor R_3 increases in value, reducing the bleeder current through resistor R_3 . The mixer action of the left-hand section of the tube depends upon the bias voltage developed across resistor R_2 and with R_3 increased in value or open insufficient bias for mixing will be developed and this section of the tube will no longer function as a mixer. Consequently no i.f. signal is produced at the output of the tube, even though the oscillator is working and the incoming signal feeds into the input of the mixer.

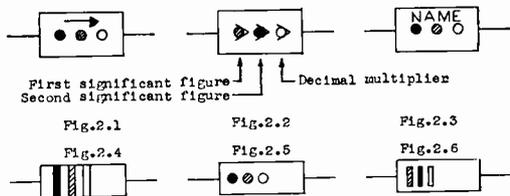
Fig. 2. Aids found in 3-DOT SYSTEM for reading the colors from left to right. Note arrow in Fig. 2.1 and arrowheads in Fig. 2.2. The name is placed upright in Fig. 2.3 while the bands, dots and stripes are bunched at the left in Figures 2.4, 2.5 and 2.6 for the purpose of reading the colors from left to right. The key for Fig. 2.2 applies to all of the arrangements in Fig. 2.

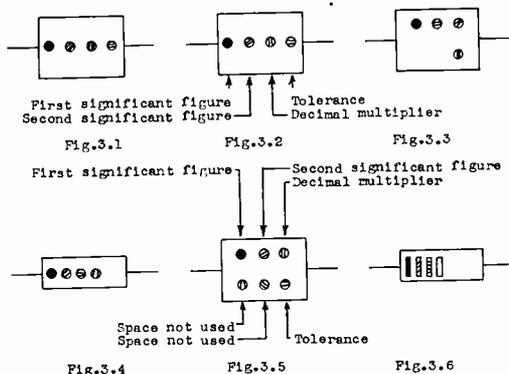
Fig. 3. The same aids used in Fig. 2 are found in this Fig. 3 for reading the 4-DOT SYSTEM from left to right. Although SIX spaces are found on a condenser marked like Fig. 3.5, two spaces are not used. Note the similarity between Fig. 3.3 and Fig. 3.5.

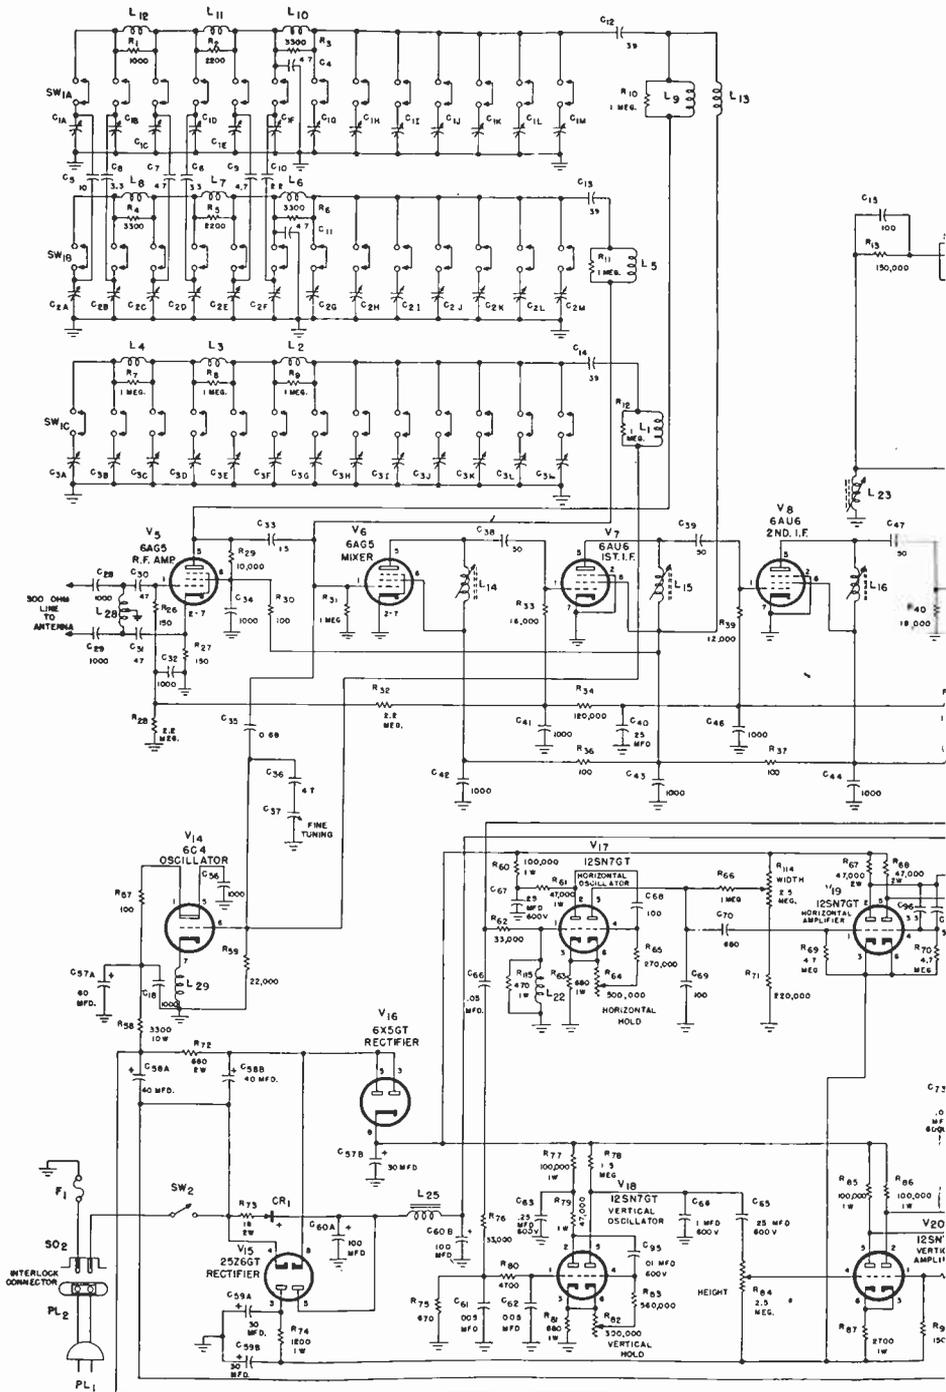
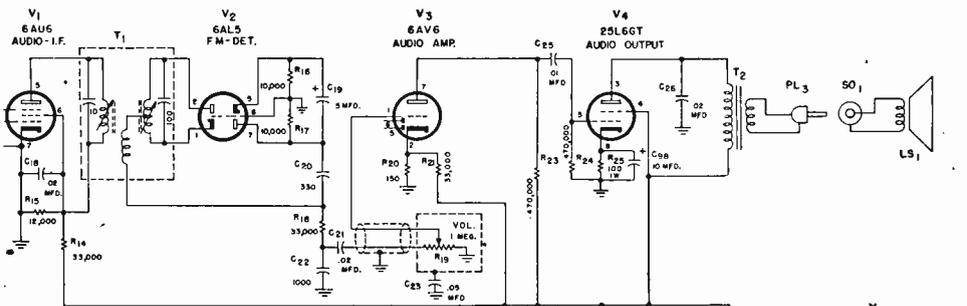
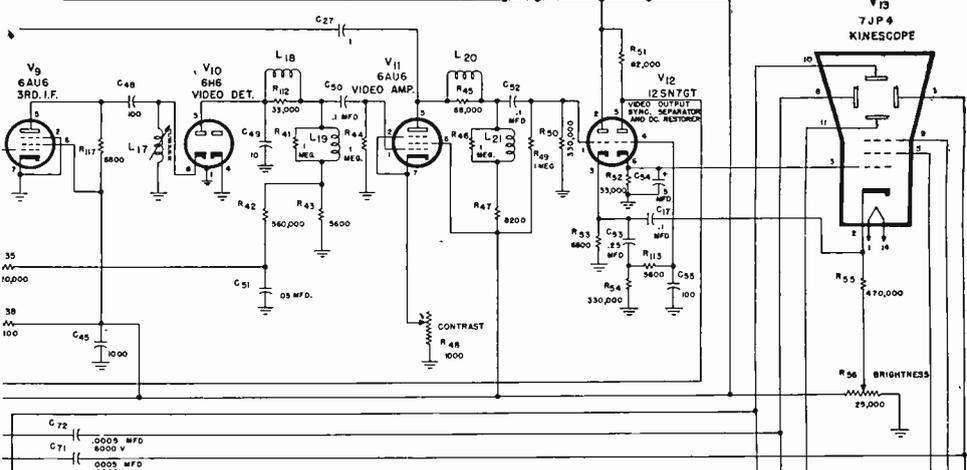
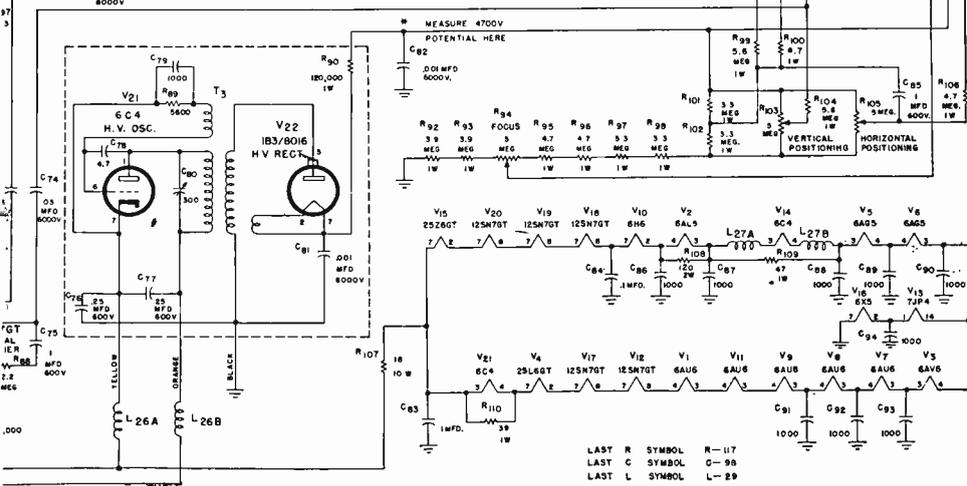
Schematic of the Hallicrafters Model T-54 Television Receiver

receiver is due to the failure of the .001 mfd 6000 volt condensers. There are two of these condensers used in the set and they are marked C_{81} and C_{82} on the diagram. Even a small amount of leakage in either one of these condensers is sufficient to load the circuit enough so the high voltage oscillator will fail to oscillate or so there will be insufficient voltage available to operate the 7JP4 kinescope.

The entire high voltage unit which consists of the 6C4 high voltage oscillator, the coil and the 1B3 rectifier tube is mounted in a metal enclosed case at the rear of the chassis. When C_{81} breaks down it's necessary to remove this entire case in order to replace the condenser.

In addition to tube failure, condensers C_{63} and C_{64} sometimes break down. This can readily be detected by a lack of plate voltage on the vertical oscillator tube when voltage is available at the cathode of the 6x5 rectifier tube.

Some complaints have been received that the receiver lacks sensitivity on the higher channels. The manufacturer has recommended that the .68 mmfd. condenser marked C_{35} on the diagram be changed to a 1.5 mmfd. condenser. This condenser is used to inject the signal from the local oscillator into the grid of the 6AG5 mixer stage.

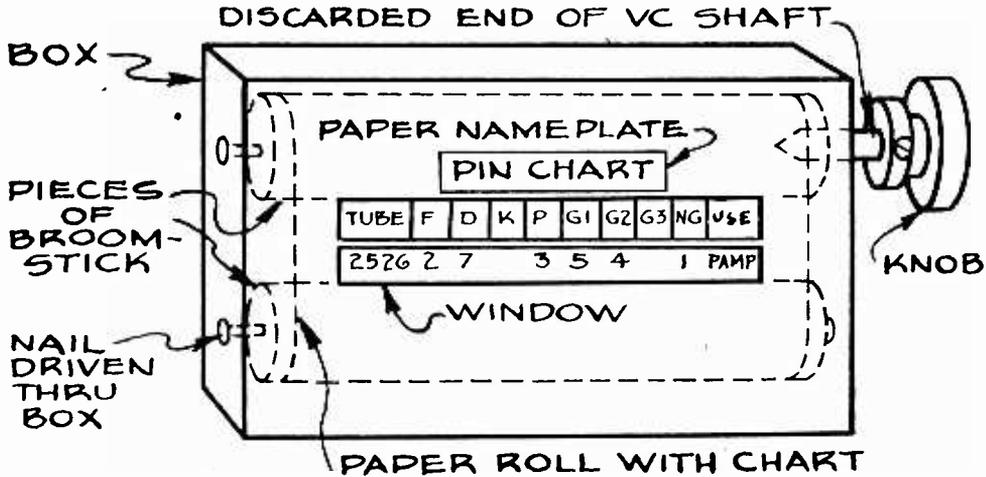
Remer found that he lost time and became irritated now and then because in checking voltages or taking resistance measurements at tube prongs, he had to stop to make sure that he was touching the right prongs. In order to overcome this handicap, Mr. Remer made a simple device which can be used as a quick reference guide to the pin locations of a tube. The sketch above illustrates the gadget. It can be made inexpensively from discarded materials from around your shop.

In the actual working model, one end of each of the rollers was grooved with a round file. A belt made of dial cord and a spring connected the two rollers together, so that both rollers turn simultaneously in either direction. Another scheme would be to construct a knob on one end of each roller. One knob can then be used in turning the chart in one direction, and the other knob for turning the chart in a reverse direction.

Remer also wired a small bulb, switch, and two flashlite cells into the box to illuminate the chart when in use.

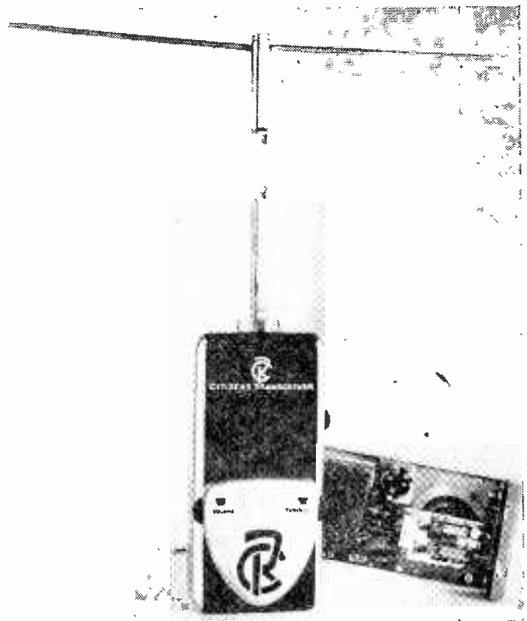
Compact and lighter than a pocket camera this is the new citizen's radio station developed by the Citizens Radio Corporation of Cleveland, Ohio for person-to-person communication. The transceiver has a range of several miles, may be carried anywhere since it weighs only two-and-one-half pounds complete. Receiver and transmitter shown above includes microphone, antenna and four Sylvania subminiature tubes for oscillator and super regenerative receiver.

The transceiver, two of which are required for person-to-person air contact, is housed in a tiny case measuring only 6" x 2 $\frac{7}{8}$ " x 1 $\frac{1}{4}$ " topped by a small folding antenna. This pocket-sized radio station includes all necessary equipment except a tiny headphone and batteries carried in a separate case about the size of a miniature camera.

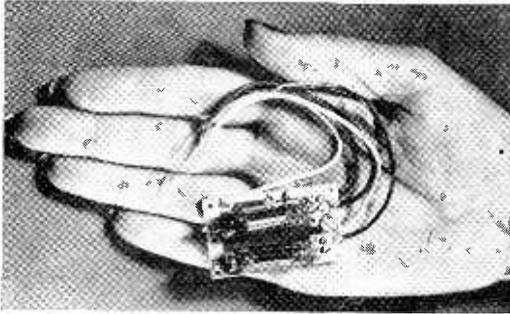
Receiver audio section of new transceiver developed by the Citizens Radio Corporation of Cleveland, Ohio embodies new silver-on-ceramic circuit techniques. This audio section uses two 1V5 Sylvania subminiature tubes.

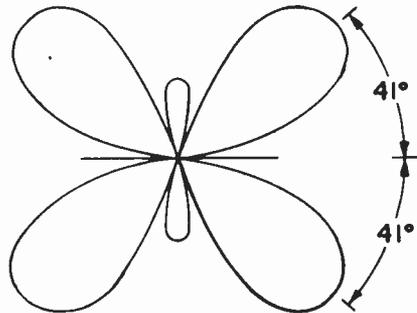
FIG. 2

If there are a number of low-frequency channels located close together so that the relative directions of the signal is approximately the same, orienting the antenna for anyone of these stations will be satisfactory for the others. However, if stations are separated to any extent, a compromise in orientation must be made. Assuming the absence of multi-path reception and the installation is made within the service area, satisfactory signal pick-up for the low frequency channels can be obtained in the majority of cases.

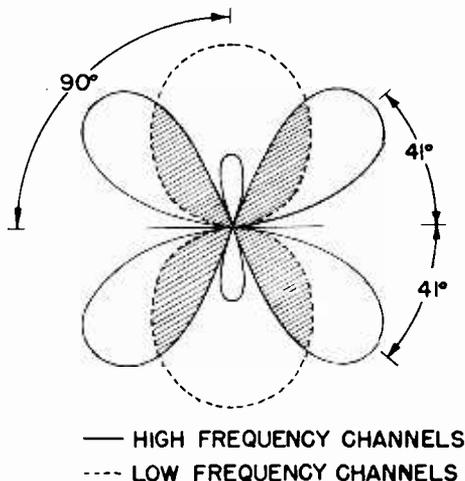
FIG. 3

The majority of antenna arrays are designed for a single, or, at the most, two channel operation. These make use of a matching section between elements of the array which are critical as to frequency and, thereby, limits the frequency range of the antenna.
