National RADIO-TV NEWS

June-July
1950

IN THIS ISSUE
Servicing AC-DC Receivers
Television Servicing Methods
Alumni Association News

Servicing AC-DC Receivers

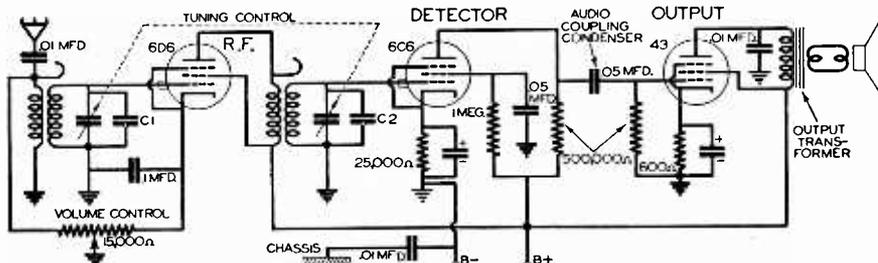
Fig. 1. Signal circuits of a typical universal t.r.f. receiver. Alignment simply involves tuning in station, then adjusting trimmer condensers C_1 and C_2 (mounted on the gang tuning condenser) for maximum output volume.

In Figure 1 is shown the typical signal circuit arrangement of an AC-DC TRF receiver. There are several variations from the standard AC receiver which should be noted; these are: 1, the chassis may not be an electrical part of the circuit, in which case the ground symbols simply indicate that the parts so marked are con-

nected together; 2, the plate and screen of the r.f. tube are operated at the same DC potential; 3, an external ground connection is not used because one side of the power line (which connects to the receiver circuit) is grounded; 4, the small coils connected to the primary r.f. coil windings provide capacitive coupling in addition to the usual inductive coupling between the primary and secondary windings. Often these coils are unshielded, one being placed below the chassis and the other above the chassis to prevent coupling and feedback between them.

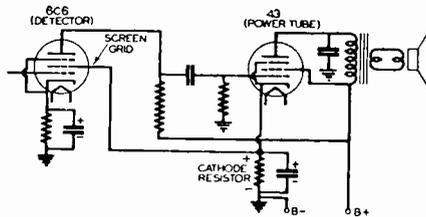
Fig. 6. Detector and output stage of a universal receiver, showing a simple but entirely satisfactory method for getting a low positive screen grid voltage for the detector tube.

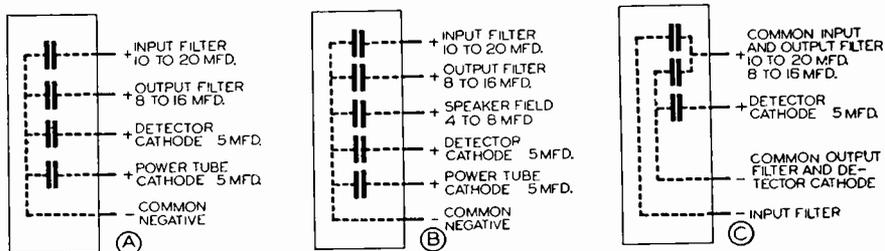
Fig. 7. Typical condenser block diagrams for universal receivers.

the circuit. By this time you will be able to recognize the type of power supply used. Label each lead on your sketch according to the point at which it connects and indicate its polarity. Once you recognize the type of circuit used, you will have no difficulty in determining the polarity of any point with respect to the B- lead and in drawing the internal connections for the condenser sections. Condenser block sketches for the power supply circuits given previously in this article are shown in Figure 7.

When the loudspeaker field gets its current from a separate section of the rectifier there will be a condenser across the loudspeaker field coil, with its negative lead also connected to the on-off switch. In most cases a single common negative lead is used for both condensers. The positive leads for these condensers are easily identified; the positive lead of the speaker filter condenser will go to that 25Z5 cathode to which the speaker field is also connected, while the positive lead of the input filter condenser will go to the other cathode of the rectifier tube.

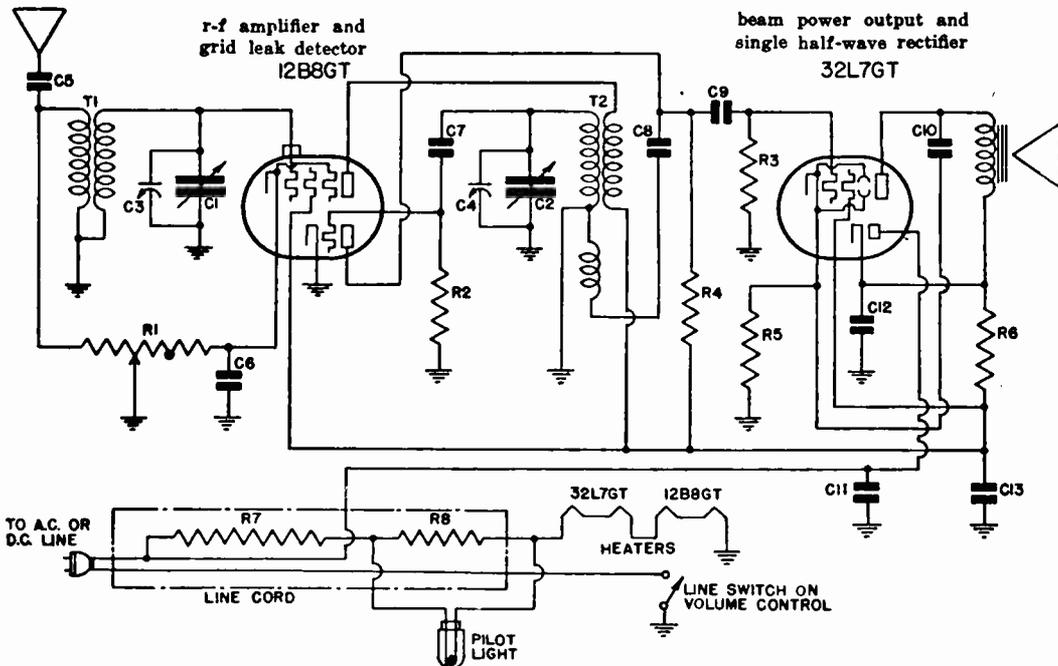
Fig. 8.

Figure 8 shows a variation of the four tube universal TRF receiver. Note that here two tubes perform the function of four tubes. The detector is regenerative, feed-back from its plate being obtained by means of condenser C_8 and the coil which is inductively coupled to transformer T_2 . These sets are serviced in exactly the same manner as previously described. However, if the 12B8 tube burns out you will have quite a problem on your hands since these tubes are not readily available. Sometimes you can pick one up from a large mail order house but in most instances no replacement can be secured. In a case of this sort it is really best to scrap the receiver, but if the customer is willing to pay for your time and labor you can substitute two separate tubes. Miniature tubes should be used since space is at a premium in these chassis. A bracket of some kind to fit over the old socket of the 12B8 must be arranged and on this bracket should be mounted two miniature tube sockets. The r.f. section of the 12B8 can be replaced by the miniature 6AU6 while the triode section can be replaced by the 6AT6. The diodes in the latter tube are left disconnected, only the triode portion being used. The two filaments are wired in series and will replace the filament of the 12B8 electrically. A job of this sort should net you about \$15, and inasmuch as the receiver originally sold for \$9 or \$10 your customer may not wish repairs to be made. Replacements for the 32L7 are still available but even if they were not this would not present too much of a problem since a type 43 or a type 25L6 could be used to replace the pentode section and a selenium rectifier could be used in the power supply.

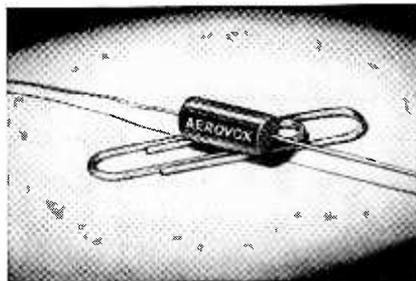
These micro-miniature units, manufactured by the Aerovox Corporation, New Bedford, Mass., measure only 3/16" in diameter and 7/16" in length. This striking bulk reduction is achieved in several ways. First and foremost, metalized dielectric marks a distinct departure from conventional foil-paper and even previous metalized-paper construction. The new dielectric provides both dielectric and electrodes. The unit is impregnated in a case of humidity-resistant molded thermo-plastic.

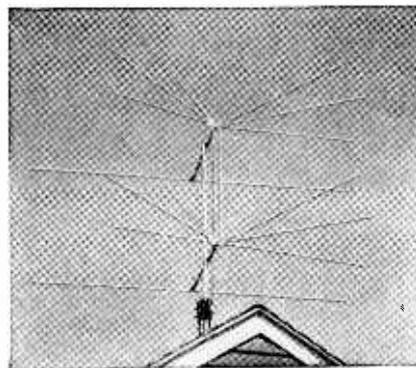
New Taco Tri-X Emphasizes Channels 11, 12, 13

The Technical Appliance Corp., Sherburne, N. Y., manufacturers of TV, FM, and AM antennas, announce a new all-channel high-gain antenna. The Taco Tri-X is offered for areas where the Lazy X does not give sufficient high band gain.

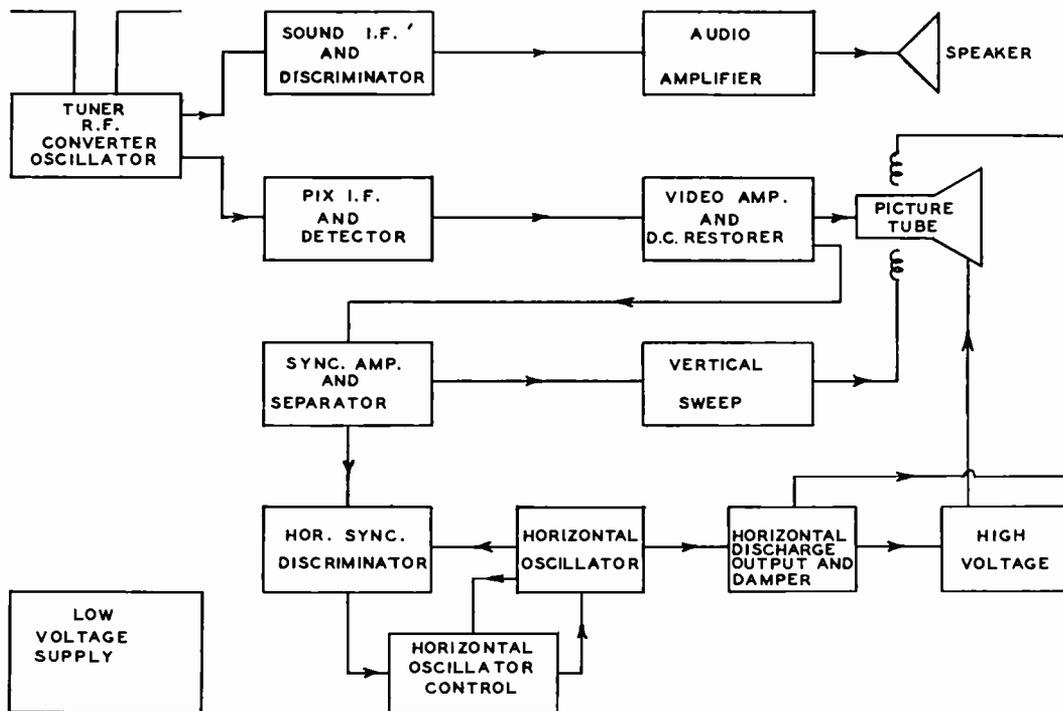
Fig. 1.

By examining the block diagram of this receiver, it is possible to learn a number of things about the set. For example, notice that there are two separate i.f. systems, one for the sound and one for the picture. Therefore, if a defect developed in the sound i.f. amplifier, it's unlikely that it would have any effect on the picture. Similarly, if a defect developed in the picture i.f. amplifier, it would hardly affect the sound. If this receiver, or one having a similar circuit arrangement is being serviced and the complaint is "no sound, picture alright," there's no point in checking any part of the receiver other than the sound i.f., detector, or audio system. The defect could not possibly be in any of the picture circuits, nor could it be in the power supply, since it supplies the power both to the picture and the sound circuits. Similarly, if the complaint is "sound, but no picture," there would be no point in spending time on the sound i.f. and the audio section of the receiver. In addition, the tuner can be

In Fig. 1, the sound and the picture signals are separated at the output of the tuner and are fed to separate i.f. systems. In Fig. 2, the sound and the picture signals are not separated at the output of the tuner, but instead, they are both fed to the first and second picture i.f. stages. Both signals are amplified by these two stages, and then at the output of the second video i.f. stage the two signals are separated and fed to separate i.f. systems. This change in receiver design is important when it comes to servicing a set in which the defect is "sound but no picture," or "picture, but no sound." In either case, we can eliminate not only the power supply and the tuner, but we can also eliminate the first and second i.f. stages as possible causes of the trouble. If these stages are amplifying one signal they will amplify the other, and the defect must be beyond the point where the two signals are separated.

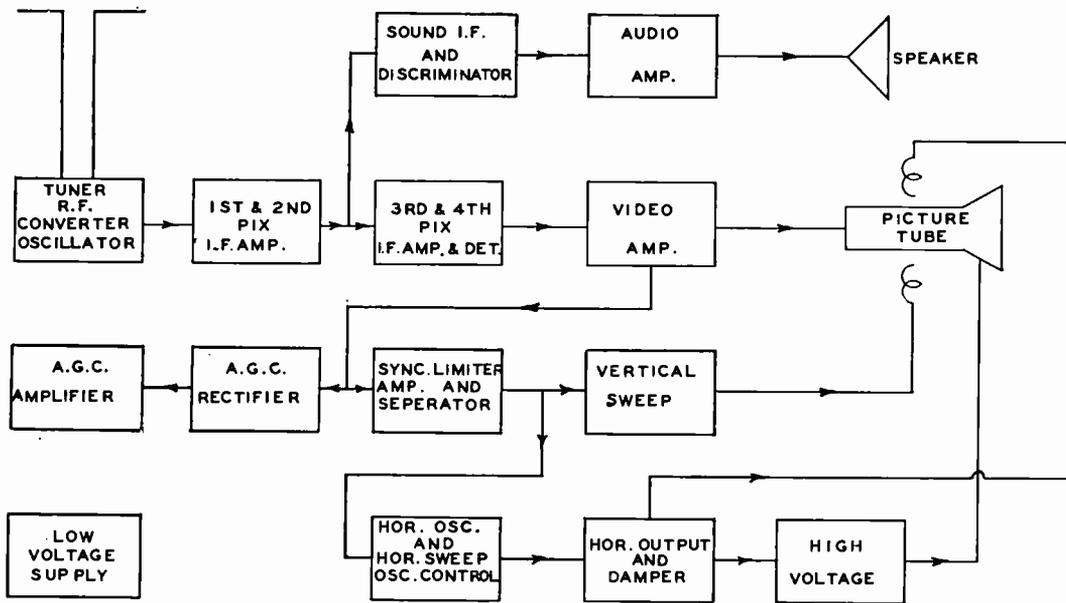
Fig. 2.

Upon further examination of the block diagram shown in Fig. 2 we see that automatic gain control (agc) has been added to the receiver.

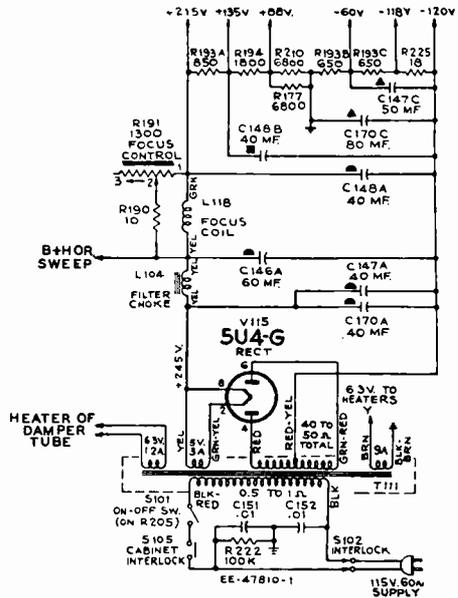
Fig. 4.

In many receivers an electro-dynamic speaker is used in place of a PM speaker. In these receivers the speaker field will be inserted in the power supply in place of the filter choke. The speakers used in these sets differ from the speakers normally found in AM receivers. The speaker field is wound with a large size wire and has a

low resistance. A resistance of about 68 ohms is a common value. In replacing a speaker of this type a replacement having a low resistance field must be used.

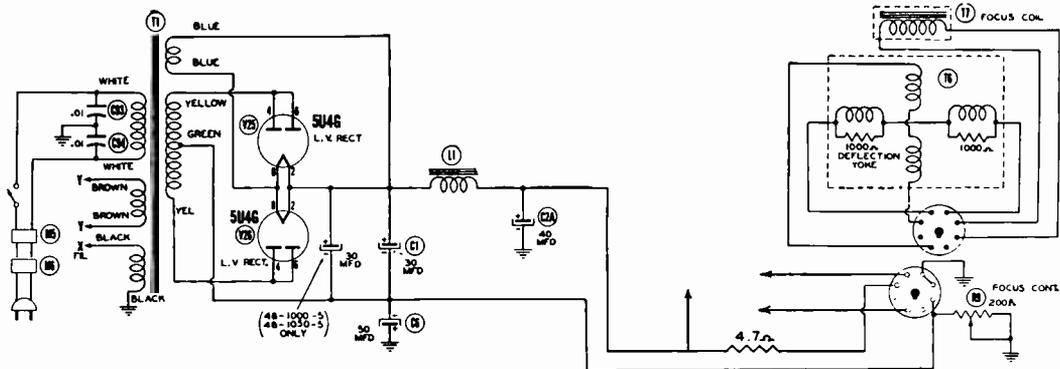
Another typical TV receiver power supply is shown in Fig. 5. This power supply employs two rectifier tubes. Each tube is used as a half wave rectifier. In some TV receiver power supplies using two rectifier tubes, each tube is used as a

full wave rectifier. In this type of circuit, if 5U4G rectifier tubes were used, pin 4 of the two tubes would be connected together and to one side of the high voltage winding, and pin 6 of the two tubes would also be connected together and to the other side of the high voltage winding.

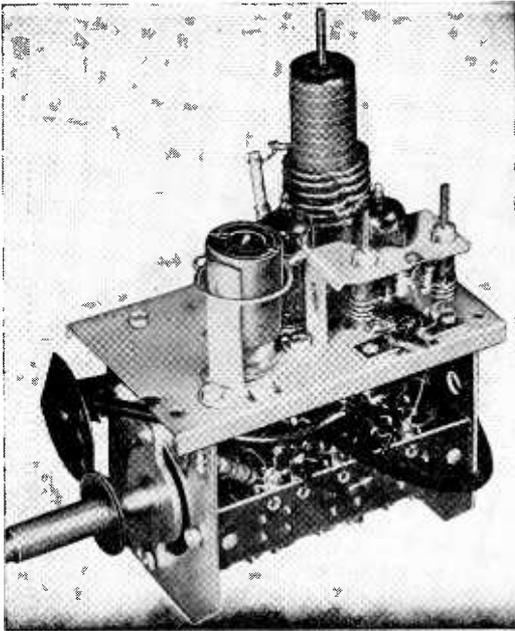
Fig. 7. The RCA Tuner.

A typical example of this type of tuner is the RCA shown in Fig. 7. This particular tuner was used on many of the TV receivers manufactured

in 1947. It has given excellent service, but since the tuner has been in use a number of years, some trouble is being experienced with it now. As far as the electrical performance of this tuner is concerned, very little trouble is experienced from anything other than defective tubes. The tubes may simply burn out or they may become noisy resulting in considerable jumping and tearing of the picture, and also excessive noise in the sound channel. Incidentally, it may be well to point out here that if the oscillator tube burns out, the new tube may have a very noticeable effect on the alignment of this circuit. The inter-electrode capacities of the new tube may be so different from those of the old tube that the oscillator frequency will change enough to make it impossible to pick up any stations. Rather than go to the trouble of re-adjusting the oscillator on all channels, it is far simpler to try several oscillator tubes. The chances are it will be possible to find a tube with inter-electrode capacities close enough to those of the old tube to make it possible to take care of any small differences simply by adjusting the fine tuning. Needless to say, it's far better to spend a little time finding a suitable tube than to re-align the oscillator section.

Next to tube failure, probably the most common trouble with this type of tuner is a mechanical failure. The trouble is usually due to wearing or breaking of the detent used in the switching arrangement. In switching from channel to channel, a rather simple arrangement is used to lock the channel selector switch in the correct position. This consists of a disc with a series of twelve holes, arranged in a circle. Through the center of this circle is passed the shaft of the channel selector switch which mechanically rotates the various contacts. Also fastened to the shaft is the part referred to as the detent. This is a piece of spring steel which has a hole in it located the same distance from the shaft as the twelve holes arranged in a circle around the shaft. The detent is arranged so that the end of it springs up against the disc. A small ball bearing, somewhat larger than the hole in the detent, is inserted between the detent and the disc. This provides the snapping arrangement

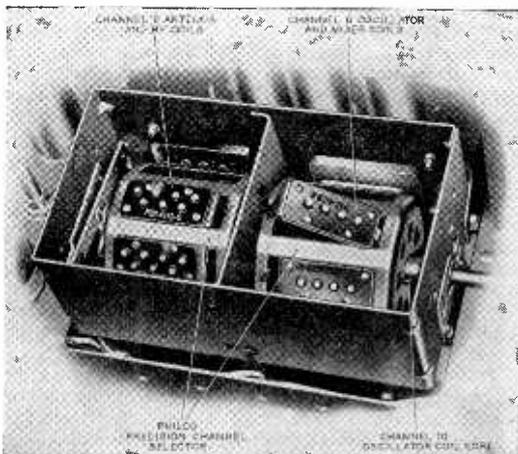
Fig. 9. The Philco Tuner.

In this unit automatic frequency control "a.f.c." is used on the local oscillator. The a.f.c. voltage is picked up from the sound detector, therefore no fine tuning control is necessary. The a.f.c. system will automatically adjust the oscillator for best sound. Sometimes, due to aging of the oscillator tube or some of the components in the oscillator circuit, the frequency of the oscillator will drift so far that the a.f.c. system cannot correct the frequency drift of the oscillator. When this happens the sound does not come in on one or more channels. This difficulty may be easily corrected. Simply remove the channel selector knob by pulling it off the shaft. At one side of the hole in the escutcheon plate through which the shaft protrudes, there is another small hole. By using a thin long screwdriver, the slug inside the oscillator coil can be reached and re-adjusted. After the oscillator has been adjusted, switch off the channel and then back on again

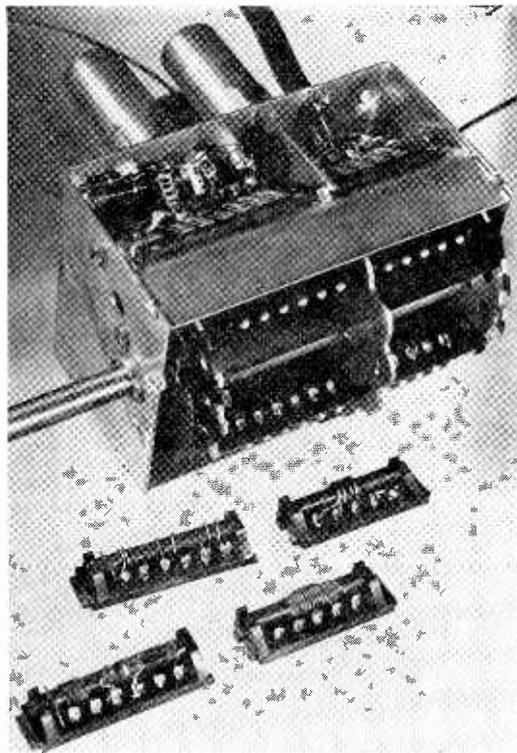
Fig. 11. The Standard Tuner.

Probably due to the fact that the losses in the oscillator circuit used in this tuner are quite high, the oscillator will sometimes fail to oscillate even though the 6C4 tube used may work in some other oscillator circuit. When the oscillator fails to operate, snow can usually be seen on the face of the picture tube and a fair amount of noise is

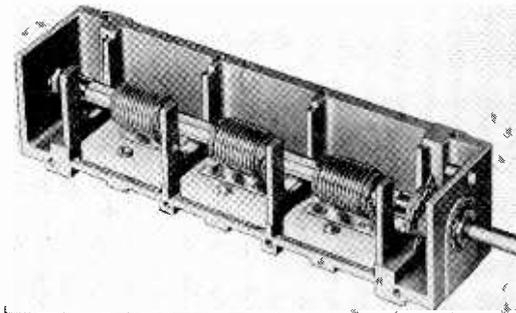
Fig. 12. The Mallory Inductuner.

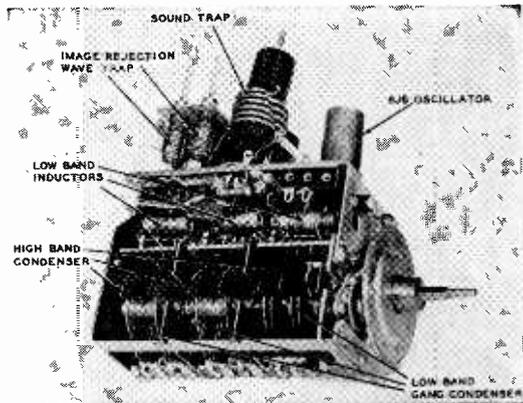
Fig. 13. The General Instrument Tuner.

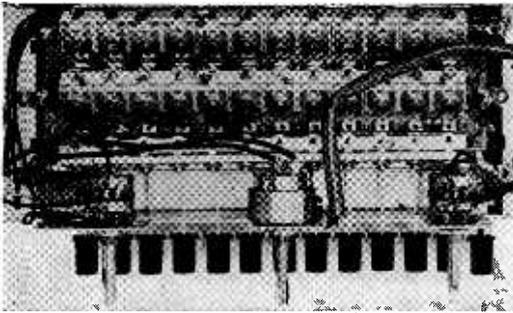
Fig. 14. The Hallicrafters Tuner.

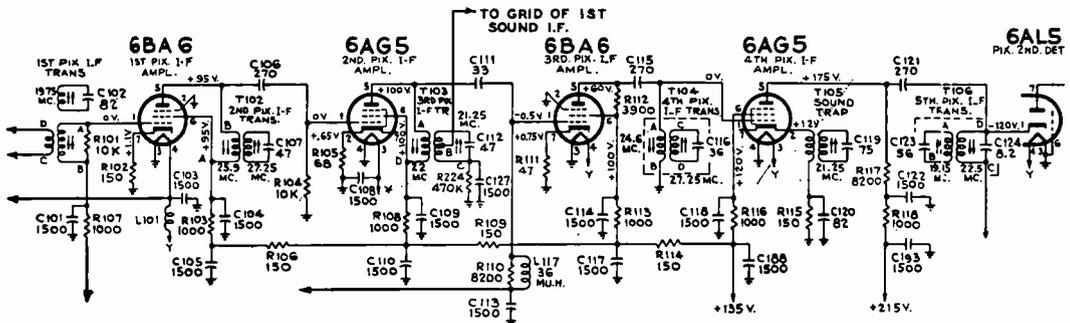
Fig. 15.

the B supply and they will burn up. For example, if the 1500 mmfd. condenser C109 broke down, it would place R108, R109 and R114 directly across the B supply and they would burn up. Therefore if we were servicing this set and found these resistors burned, we would know immediately that either the second pix i.f. tube was shorted or that C109 was defective. Similarly, if we found resistors R109 and R114 damaged, we would know that some component had broken down and placed them across the power supply. In this case it obviously could not be C109 because then R108 would also be damaged. Similarly, it could not be C105 because R106 would also be damaged, and, therefore, it must be C110 that is causing the trouble.
