Call Letter

August 2017

DAVE EATON HRO-60

By David Wise

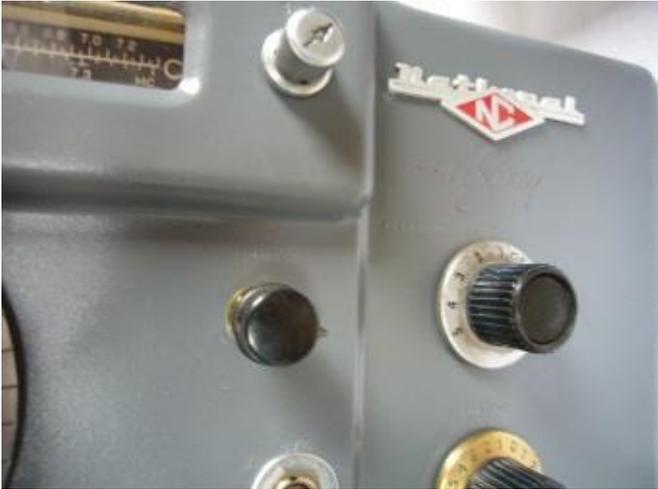
NWVRS member Dave Eaton acquired a National HRO-60 that is complete except it has only one coilset. I won't say the price but I am envious. He had it sort of working, then the fuse blew, and he asked me to step in.

The PO (Previous Owner, generic collective term for everyone who's worked on it before me) replaced the power transformer with something that probably came out of a TV set. Instead of 250-0-250, it has a single 150V winding. He rewired the rectifier socket and made a plug-in solid-state full-wave bridge to eliminate the voltage drop from the old 5V4. The primary has a 110V tap besides 120V, and by using the tap, he got about 230V out, instead of the usual 280V. Until the diodes shorted.

Why? Inrush current. That TV transformer is a brute; the HV winding is only a few ohms DC resistance. If you turn on the power when the AC mains waveform is near the peak of its sinusoidal cycle, there will be a microseconds-long surge of maybe 100A as it tries to instantly charge the first filter cap.

Semiconductor diodes have a surge current spec on the datasheet. For diodes this size (2A), it's a few tens of amps. Poof! We fix it by limiting the inrush current. This can be done several ways. Series resistor, maybe with a cutout relay. NTC thermistor. Zero-cross switching. I noticed that by using the tap, the PO had also been subjecting the heaters to overvoltage. Except he wasn't. The heaters were actually undervoltage, 5.7V instead of the normal 6.3V. The transformer has two 6.3V windings, one light (probably to run a 5U4), the other heavy, and he was using the light one and overloading it. (The HRO-60 pulls about 6A, while a 5U4 only takes 3A.)

This just didn't sit right with me. I wired in the heavy one. Oh oh, 6.8V now. Go back to the full 120V primary, now we get 6.3V out. But if I stuck with the 110V tap and added 10V drop through a resistor, I could kill two birds with one stone, limit the inrush and get the correct heater voltage.

Eight ohms to the 110V tap makes 6.3V on the heaters and 150V on the HV. Theoretical maximum inrush is $21A$ ($\sqrt{2} * 120V / 8 \text{ ohms}$) on the primary side and $17A$ on the secondary. ($21 * 120/150$.) 1N4007's can handle this easily. I rebuilt the bridge using them, but we get only 210V of B-plus instead of 280V. The only fix that's both easy and cheap is a booster transformer. Mouser sells the Bel 241-5-56 (56V), which can handle the 140mA current, for \$12. It's three inches long, one and a half high and wide. We could fit it in a couple places, all awkward. With primary in parallel with the main primary (downstream from the surge limiting resistor) and secondary in series and in phase, boosting 150V to 200V, we will get 280V out just like normal.

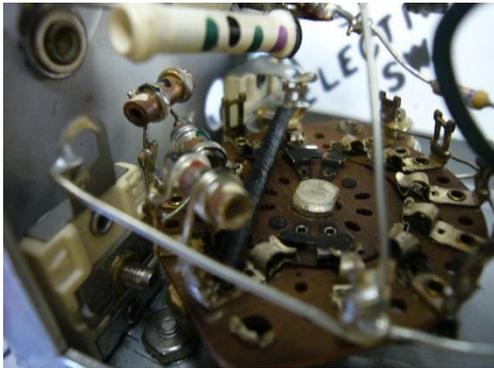
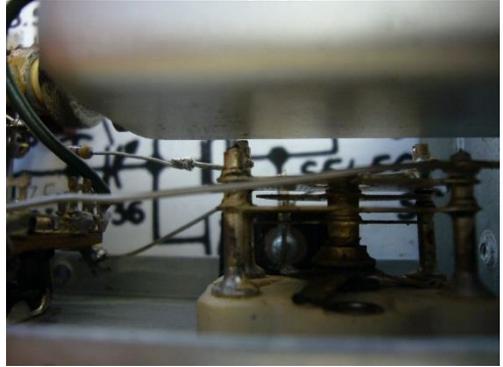
National HRO-60 IF Passband --

Crystal peak at 453.7kHz
Approximate performance, interpolated from a recent spec and screenshot

OFF 3kHz @ 3db, 4kHz @ 6dB, 6.5kHz @ 20dB, 12kHz @ 60dB, shape factor 3:1

1 0.5kHz @ 3dB, 0.7kHz @ 6dB, 3.2kHz @ 20dB, 8.5kHz @ 60dB, shape factor 12:15

0.1kHz @ 3dB, 0.2kHz @ 6dB, 0.6kHz @ 20dB, 7kHz @ 60dB, shape factor 35:1

Using a spectrum analyzer and tracking generator, I swept the filter while twiddling L-13, and I saw something that still bends my head. The broadest response (what we're shooting for in position 1) indeed occurs around 2 kHz above crystal. (Actually about 1.5 kHz on this radio. And on either side of crystal, not just above.) Go further either side and it sharpens up. (And that's exactly what we expect, since advancing the SELECTIVITY switch tunes L-13 down, down, down, further off crystal.) But as you tune closer and closer to crystal, the response sharpens up too, hitting maximum when you are right on crystal. With L-13 set like that, all positions are sharp, and equally so. I am stumped. So I set it back to 1.5 kHz and called it good.
