The
Indiana
Historical
Radio Society

**BULLETIN**

Stringing A Sparton 930 by Ed Dupart

The Philco T-901

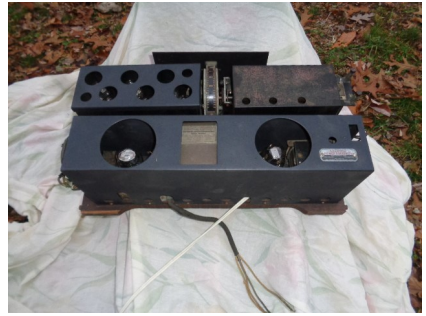
Of course, with superhets this wasn't a problem nor was it a problem with this Sparton. The selectivity rivaled the superhet as well as the sensitivity.

The key to the performance in selectivity of this set was in the pre-selector. For those who have studied tuned circuits, you learned that as you gang tuned circuits together without amplification in-between you will gain selectivity, but the output signal will be reduced.

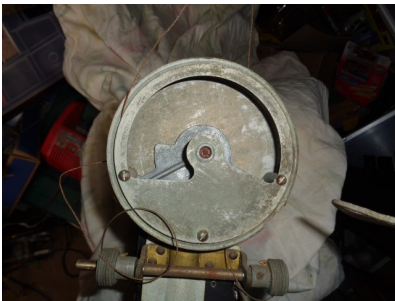
On both radios the stranded wire dial cord was off and I decided to work on

that before I got involved with the electrical problems. The wire dial cord was not broken but it was twisted and bent. I spent at least an hour trying to get that blasted wire dial cord to stay on the tuning drum.

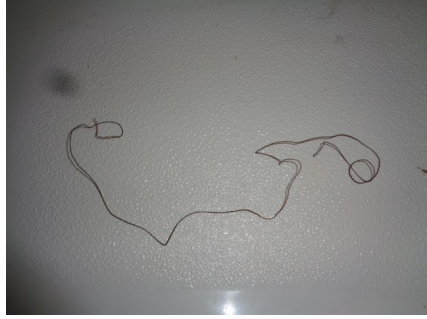
As soon as I tried tuning it, it would pop off. I decided something else would have to replace the stranded wire dial cord, but what? I thought about using string type dial cord. I would want to use springs to keep constant tension, but I saw problems with that. What was needed was something that was strong and **flexible**.

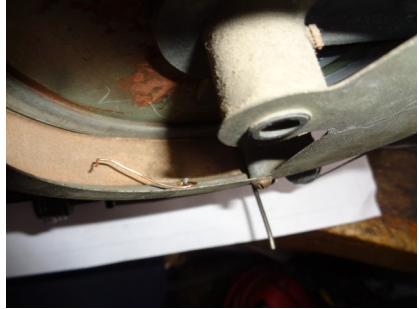
through the hole and there would not be any adjustments at this end. A blob of solder was put on this end of the telephone wire so that it would not slip back through the hole. As the cord unwound off the wheel at least $\frac{1}{4}$ is left on the wheel. It's at this end that the longer piece of wire is attached to the jewelry chain and is fed through the small hole and bent up initially. It's also the end where adjustments will be made to shorten the chain and to keep tension on the chain.

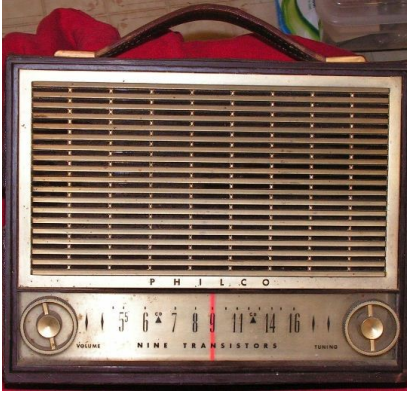
The Philco T901-124, with its tuned RF amp stage, has been on the "low end" of my wanted list for awhile now --just never found a decent one in my price range.

This set showed up with a badly corroded battery compartment, but good-looking front panel for \$7.75--and I got it! Didn't notice until I saw on a larger pic that the plates of tuning cap were also covered with corrosion! Asked the seller for an angled pic of it, which he quickly provided as well and I asked if the tuning moved smoothly. Well, he said that it did, so I was hoping that it'd be fine after cleaning.

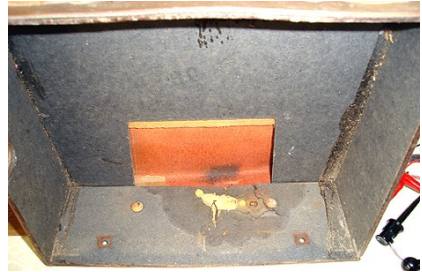
Thankfully the tuning cap wasn't as corroded as I thought. The bottom of the inner case was disintegrating from the battery leakage situation. Glancing up inside through the battery flap, it looked like the PCB is okay.

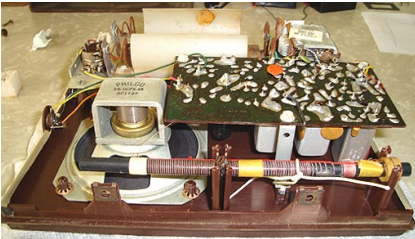
The loopstick almost took a dive because the mounting grommets had shrunk and disintegrated. It had been held secure inside the case by a piece of styrofoam

(I've seen Philco do this in other sets). I like the large IF & RF cans & metal sub-chassis, but the plastic seems pretty cheap. One of the bottom mounting tabs had broken, allowing the lower portion of the tuning dial to pull inside around 1/8". Also was disappointed that the tuning cap was soldered to chassis and not screw mounted.

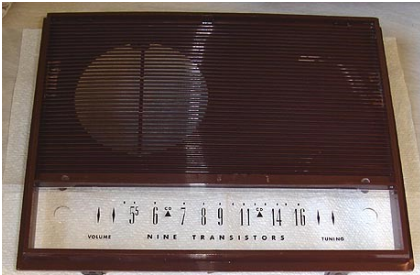
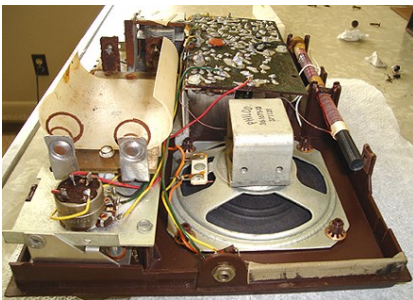
The speaker was held in by circular press-on retainers which had to be broken to remove, so I took an idea from GE and cut four pieces of rubber fuel line hose. They fit the speaker posts snugly. I used the proper size hex-head self-threading screws and fiber washers on top which compressed the hose slightly and ensured a secure speaker mounting.

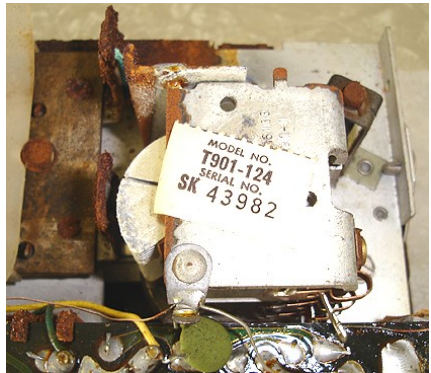
the battery holder, but leakage permeated the "pressboard" base which the contacts were attached to. I removed it and decided to use aftermarket holders in their place at least for a while.
