The
Indiana
Historical
Radio Society

BULLETIN

Westinghouse WR-334

The Emerson DL330

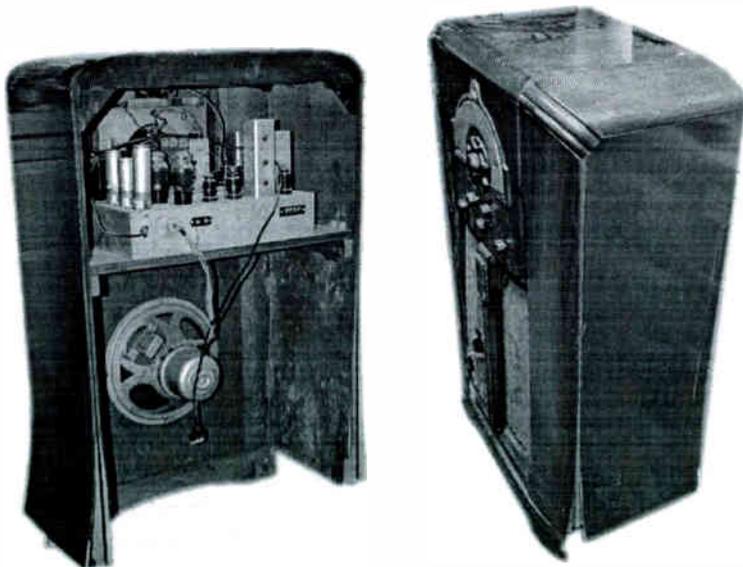
This miserable looking radio was propped up in the corner of the convention center room, next to the silent auction tables. It was attracting a great deal of attention from fellow club members and restorers. Not because of the miserable condition or low price, but because of the high

tube count, well built chassis with triple tuned IF, and the overall rarity of this radio. While many seemed to be impressed by this beast, no one was stepping forward to take it home. The radio was complete, but in several pieces, with several parts damaged. To summarize the eventual outcome, this radio just barely fit in the back seat of my girlfriend's Chevy Impala!

The restoration of the electronics on this radio began with a twist, but ended up being nothing more than routine later on. After a good cleaning of dust and loose debris from the chassis, the first repairs included replacing the filter capacitors and installing a new power cord, which I opted to use reproduction cloth-covered cord. On the first power up, I was greeted by a 60 cycle hum, and the B+ voltages were way off. As some point in time, the power transformer had been replaced, and it was a sloppy job at that. Many other capacitors, controls, and resistors had also been replaced over time. With a schematic in hand, I was quick to notice that the center tap on the power transformer was not connected to the proper place. The way everything was connected, the filter capacitors were essentially doing nothing at all!

With the nasty looking repairs of the past, I decided to clean the wiring up and check out the rest of the power supply section. On the second power up, the hum was gone, but after several seconds of warming up, the ammeter on my power supply would begin to jump around. That is when I noticed arcing inside one of the 6V6 power output tubes. Testing both of the 6V6's on my B7K 747B tube tester revealed shorts in both of them. Further testing of tubes revealed three more with internal shorts, and the 6C5 inverter showing no grid emissions. All of the tubes in this radio were RCA branded with matching date codes. The large number of bad tubes seemed rather odd to me, the most that I have ever encountered in a radio. The mis-wired CT of the transformer must have been the cause. It had been connected to a point that shared a connection with the cathodes of the 6V6 tubes. Perhaps this created some kind of crazy voltages inside of the tubes, thus causing arcing and eventual shorts.

With the replacement of the bad tubes, on the third power up the receiver was working much better. The paper capacitors were then replaced, testing out the receiver after replacing two or three at a time. This way if I make a mistake, it is much easier to retrace my work and find the problem. Once the capacitors had all been replaced, the controls were cleaned and the alignment was checked. The resistor in the eye

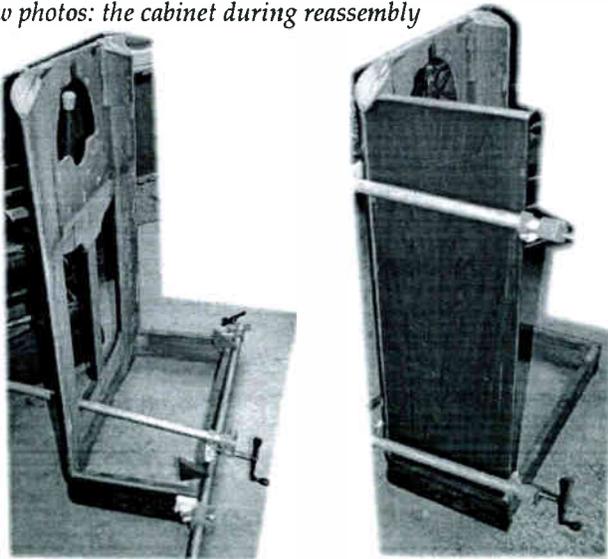
Below photos: the cabinet during reassembly

tube base was way out of tolerance, so it was also replaced. Two small modifications were then made to the radio circuitry. A fuse was added to the hot side of the AC line voltage going to the primary of the power transformer. I also added a thermistor on the 120V AC. The thermistor is around 200Ω when cold, and once warmed up, drops to just a few ohms. With the addition of the thermistor, this supposedly decreases "thermal impact" of the tube filaments and other components by letting the voltage slowly rise. Another result of using a thermistor is that it knocks down the AC line voltage by a few volts, effectively causing the power transformer to run a little cooler. As you can see in the above photos (page 4) from before the restoration, the cabinet was in several pieces and needed quite a few repairs. Luckily, all of the pieces were accounted for, including some of the larger veneer chips. The cabinet restoration began by disassembling the remainder of the cabinet, and building it up from there. The sides, with a top layer of veneer and several sandwiched layers of a cheaper wood, had to be completely re-glued. The base was reattached/ glued to the front panel. The repaired sides were then attached, followed by the top. There were several veneer repairs needed, mainly on the curved section where the top meets the front panel. Due to the cabinet falling apart, there was a large crack present in the

curve. A combination of some veneer and stain-able wood filler was used to patch the various small chips and cracks in the veneer. I like to preserve the original finish if possible on a radio, but I had my doubts on this one. I used some mineral spirits and a scrubbing pad to clean up the cabinet once everything was glued back together and all other repairs were made. The cleaned cabinet looked rather promising, so I decided to try my method to touch up the old finish.

To blend in the chips/scratches/ bad spots in general, I wiped the entire cabinet down with "Special Walnut" colored stain. This was followed by wiping the cabinet off with a clean rag to remove the excess stain. The result of this looked very good. A few of the repaired areas required some additional touch-up using various colors of Minwax stain sticks. After the stain had dried overnight, it was time for some new lacquer. The entire cabinet was wiped down with a tack cloth, and final touch ups with the stain sticks were performed. Using a "Crittter" spray gun, I then coated the cabinet with several layers of thinned gloss lacquer. The cabinet was wet-sanded in between coats with 400 grit wet/dry sandpaper. The final coat of lacquer looks pretty good to me, so I didn't both rubbing it out or anything.

The final repairs included replacing the grill cloth, patching the hole in the tuning knob, and making a new dial cover. The knobs were all polished using some brown shoe polish.

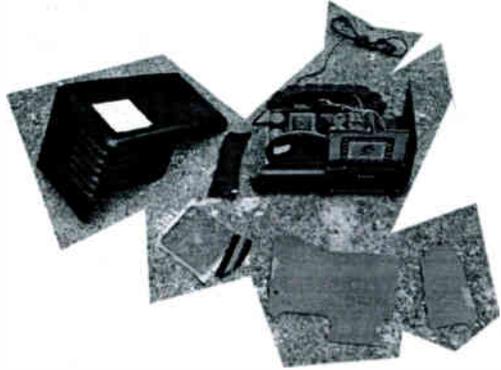
This radio belongs to John DenHartigh and was a radio he really liked, but somehow it got dropped and like most Bakelite radios, it broke. Boy, did it break! Over the years he would tell me about this radio and I told him I probably could put it back together. Amazingly, he saved all the pieces, but the problem was finding them. This year he found them in the process of getting ready for his big radio auction. He handed me the box and I told him it would probably be a winter project, but I looked it over and I decided to put this puzzle back together this summer.

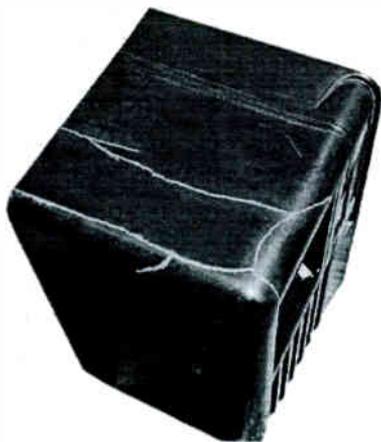
Once I had the radio glued back together and the joints sanded, I took 409 to the entire cabinet and got all the years of tobacco stains, slime and goo off the cabinet. I have been using 409 for several years for cleaning cabinets, knobs and dial lens and it does a pretty good job at removing grease, grime and tobacco stains and it did a good job on this radio. There are other cleaners on the market, but this is easily obtainable for me in this area. You are probably wondering why I didn't do this at the very beginning. I did not want to contaminate the breaks in the plastic with any kind of cleaners and I didn't want to risk breaking off any tiny pieces along the breaks, so I just went ahead and superglued all the broken edges and the broken pieces fit together very well. Once the cabinet was superglued together, I then sanded all the broken joints, which removed any surface contamination and then I applied the JB Weld over the breaks.

On past radios and cars I have used Bondo, but Bondo can shrink, so I decided to use nothing but JB Weld. JB Weld is much harder and more difficult to sand so I used a small square orbital sander with a built in vacuum cleaner. This reduced the sanding time incredibly and eliminated any waviness. Of course, hand sanding with a block eliminates waviness, but the electric sander was so much faster.

After the JB Weld hardened, then I proceeded to clean the rest of the cabinet. At this point, the cabinet is about as strong as when it was new and could take a lot of rubbing and scrubbing.

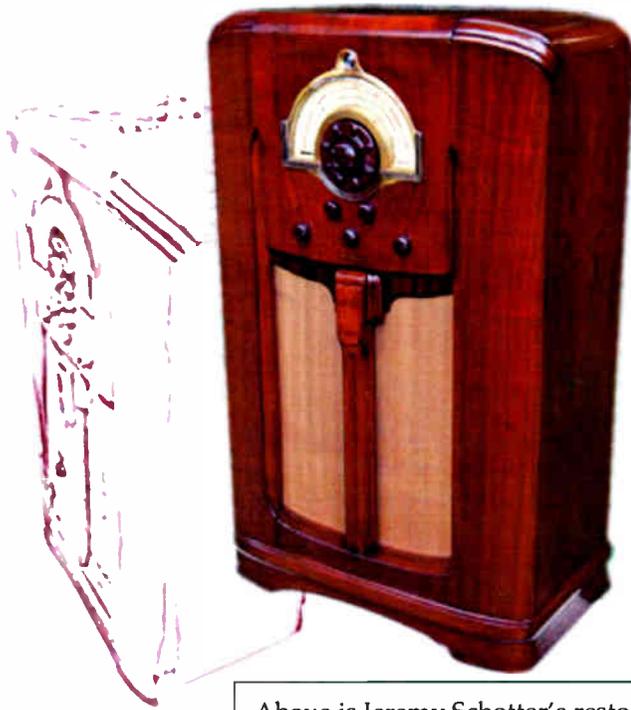
Above is Jeremy Schotter's restored Westinghouse WR-334. (page 6)

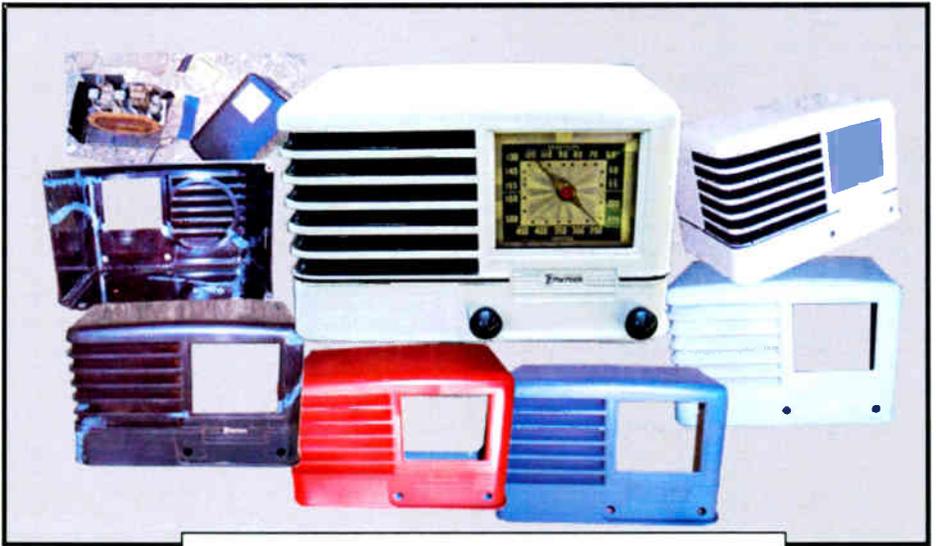
- The cycle of repair from disaster to showcase – an Emerson restoration by Ed Dupart (page 10)

Finally, I can put it all back together. I thought this radio came out really well, even better than the Zenith I recently did. The black and white contrast, I feel shows what the cabinet designer really wanted people to see in his creation. The original all brown Bakelite cabinet looks so drab in comparison. I know if it was 1940 again and I was shopping for a radio, I definitely would prefer the painted version to the plain brown cabinet. *(See page 16 for a picture review of the Emerson restoration.)*

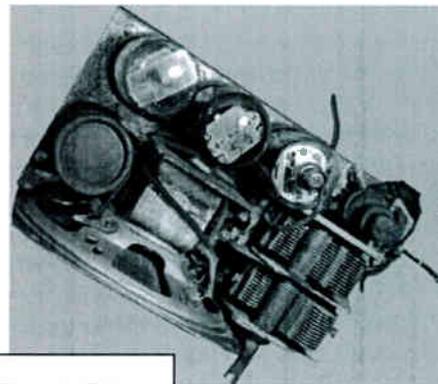
Chassis RE-55 on the right is from a Kent radio – manufactured by Arvin.

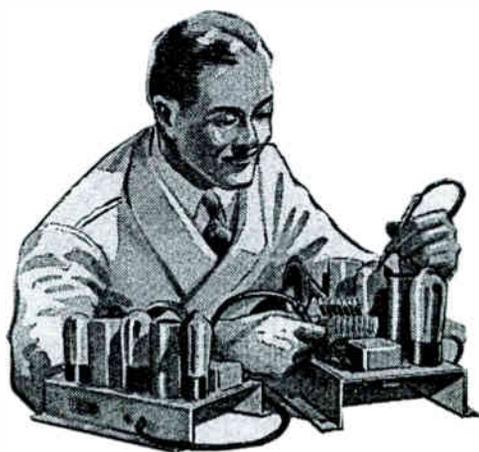
I removed the antenna coil. No change. Tested all the tubes. No change. All voltages were within tolerance. I began to think this is one radio I'll never fix because I didn't know what to try next. Finally I disabled all circuits forward of the 12BA6 IF amplifier. No change! Things seemed to point to the 2nd IF x'fmr itself. Oh Boy! Most

reluctantly I removed the IF x'fmr and disassembled it being extremely careful not to break the hair-thin wires. A bit nerve wracking.

I discovered that the three capacitors, 2 tuning and 1 by-pass, were printed on a common quartz wafer at the bottom of the assembly. I couldn't see it very well because the thin wires restricted opening the bottom where the capacitor wafer made compression contact with the terminals....no solder. Knowing from past experience that silver can migrate as well as tarnish and cause shorts or intermittencies I decided to bite the bullet and remove the wafer. To do that I had to split it in two places. It was black in some places and dull silver in others but I made no other attempt to examine it. I was anxious to reassemble the x'fmr before I snapped one of the wires. A very delicate job.

With the x'fmr reinstalled I applied power and the radio was quiet! Did I screw something up?? I checked the audio stages with my mini 1kHz oscillator and they were still OK. I attached the antenna coil with clip leads and found I could receive the local radio station weak but clearly. Weak because the 2nd IF was completely detuned since I destroyed the tuning caps.
