The Indiana Historical Radio Society Bulletin

July 2017

Detrola 295-1

The Steinite Cathedral, a CRC model 24-27 by Fred Prohl

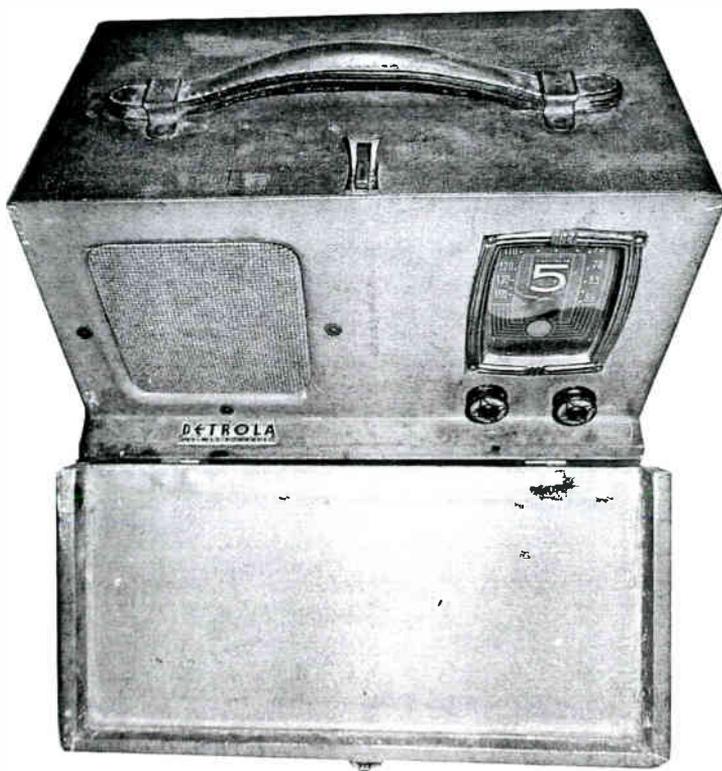
A friend of mine who knows I like Detrola radios gave me this 1940 Detrola 295-1 and he knows I have a soft spot for battery radios. The case was in excellent shape, but had a brown dingy look to it and I didn't know for sure if that was the original color or cigarette stained. The case is the typical cloth covered wood cabinet popular with portable radios of that time period. I finally got around to restoring it for an upcoming radio show that is having a contest for AC/DC battery radios.

Upon opening it up I found it to be very clean with zero corrosion. I took it apart and took a paintbrush to it and vacuumed it. It has an aluminum chassis and looked very nice and shiny. All the tubes were original and checked good. Looking at the bottom of the chassis told me it had never been serviced before and the curtain burner cord was like new, so this radio had been stored in a dry area for years. I'm guessing, but I think the people bought the radio or it was given to them and they decided they didn't like and put it in a cor-

My next step was to replace all the capacitors and they were the blue Solar types that just about always go bad, so I replaced every single last one of them. Even the electrolytics were made by Solar. After that I cleaned and lubricated the tuning capacitor and the volume control. I plugged it in and it worked and with a little tweaking of the IF alignment it was working great. So, electrically it is done.

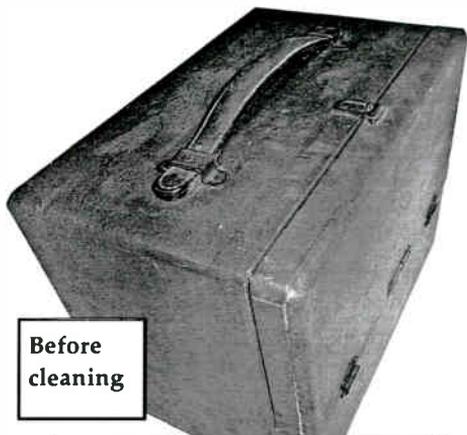
Before cleaning

Cleaning the cabinet was a job in itself and 409 wouldn't cut the cigarette stain by itself so I used a soapy steel wool pad with the 409 and that worked. With a lot of el-

"I used a soapy steel wool pad with the 409 and that worked. With a lot of elbow grease"

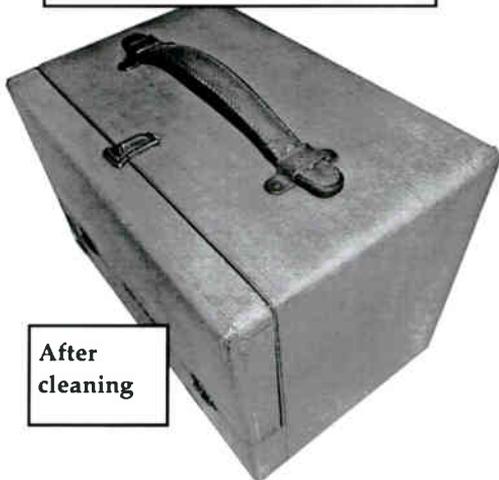
After cleaning

under the bezel matches the cleaned up cabinet. If someone has a better way to clean up cloth covered cabinets let me/us know.

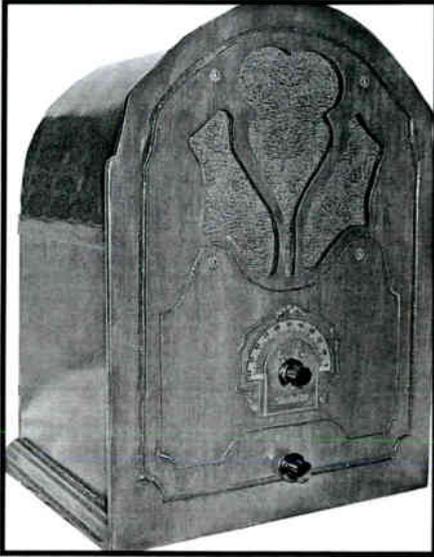
A couple decades ago, while at an IHRS Meet in Elkart, I purchased this small (roughly 12x9x7 inches) Steinite cathedral. It was in bad shape, painted brown, with a 2"X2" dent in the cabinet, close to the top of the round, left side. The dent was not a hole, but daylight passed through. I've never been able to claim much success with cabinet repair so it was late in the day, the radio not yet sold, the price was sufficiently reduced to convince me I should buy the Steinite and give the repair a try. Besides, it was a Fort Wayne, Indiana radio. Right?

The removal of the paint was fairly easy with applications of an alcohol/mineral spirits mix and a rough cloth. The dent repair began by applying a damp cloth

against the rise of the dent inside the cabinet. The cloth was held in place with a weight , applying pressure against dent. It required several applications of the damp cloth and weight before a noticeable change. Eventually the plywood settled back into the curved shape of the cabinet plywood. Since the damage created splitting as well, several applications of a wood filler were required—sanding between applications. Staining the cabinet body was not a problem. Several applications of stain along with a fine steel wool rub were required to help cover the repair. The Steinite face was a different story. After removing the paint the face was a pale tan—and would not take a stain. After attempting to get a decent color to the face unsuccessfully I asked experienced “finishers of radio cabinets” what was happening? Evidently the face is made of a pressed wood material—giving it a non-porous surface. My solution was to layer stains of two different color tones, giving the cabinet face a wood grain look. The entire cabinet was finished with a spray satin polyurethane.

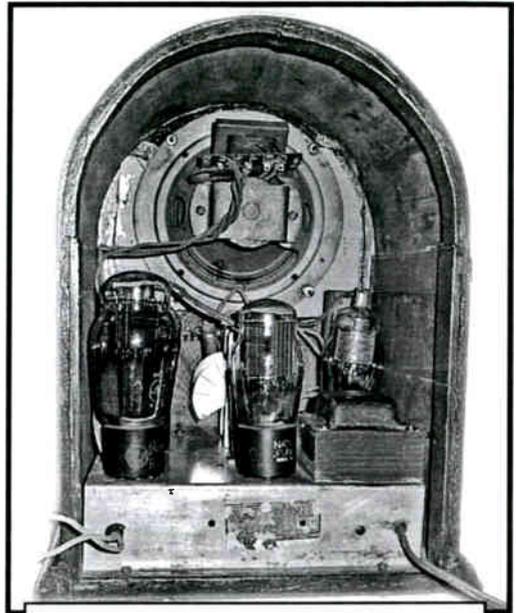
Inside the Steinite model 24-27

After a short period of operation one of the new electrolytic capacitors (nicely stored in the chassis mounted can), failed. The second set of filter caps are now mounted under the chassis.

chassis mounted electrolytic can, the Steinite worked, not well, but it worked. The previous owner had replaced most of the circuit capacitors with what appeared to be pulls from another circuit. I replaced all these capacitors. The most significant improvement on audio volume was the removal of a .02microfarad capacitor that connected the plate of the 47 tube to ground (across the audio transformer primary), effectively coupling the audio to ground. None of the 4 schematics show any ca-
