The
Indiana
Historical
Radio Society

BULLETIN

Fall 2018

The Indiana Historical Radio Society Bulletin

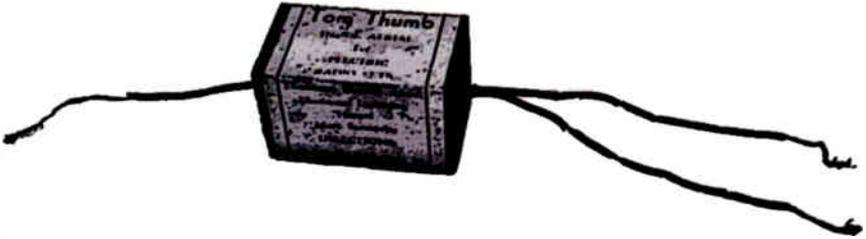
Tom Thumb

INSIDE AERIAL

Eliminates Outside Aerial

DIRECTIONS

Attach Red wire to Aerial post of set. Attach Green wire to Ground post of set. Hook Black wire to good ground, such as water pipe, radiator, etc.

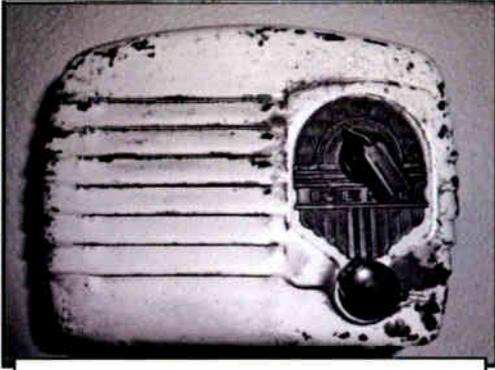
Kent Metal Case Receiver
(Arvin model 402A)

I recently acquired a nasty looking Arvin/Kent 402A radio of 1939-40 vintage that has only 3 tubes. Radios with few tubes and metal radios fascinate me so I couldn't resist picking this one up. How I restored this radio will come later; right now I want to discuss the safety aspect of the metal radio.

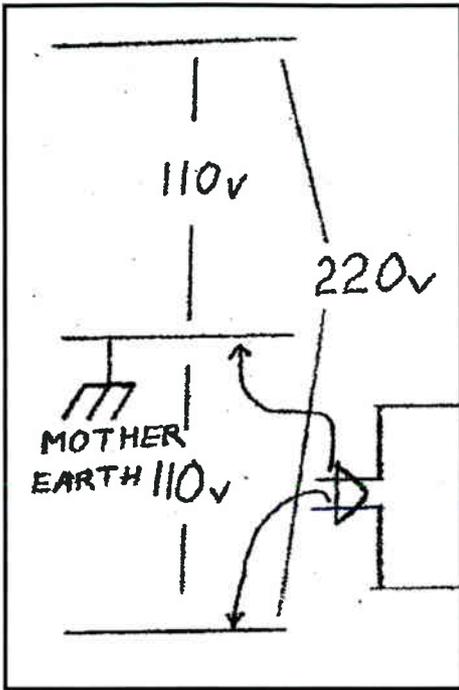
touches the outside metal of the lamp, then there is a good chance that 110 volts will pass from the floor through the person to the lamp. Water fixtures in bathrooms and kitchens make a good ground connection as well as water in a bathtub. So any electrical appliance that is wired or plugged in such way to make the outside cabinet or metal pieces hot with respect to ground are potential electrical hazards. I remember back in the 1980's a girl was electrocuted in Indianapolis when she was in the bathroom and touched a metal lamp and the faucet at the same time. Such a tragic ending to a young life. TV's with metal cabinets were a shock hazard and I would warn people who had one and were using it in a basement or a house with a concrete floor.

the house with a middle leg or common ground that is literally connected to mother earth. So there are 110 volts between one leg, hot sides, and ground and 110 volts between the other leg and mother earth. See the included diagram. This is where basements and concrete floors can become a real electrical hazard. If a metal lamp is wired where the hot side of the AC 110 volt line is connected to the metal lamp, then there is the potential for 110 volts to be between the outside metal of the lamp and the floor which is connected to mother earth. This means if someone is in his or her bare feet and

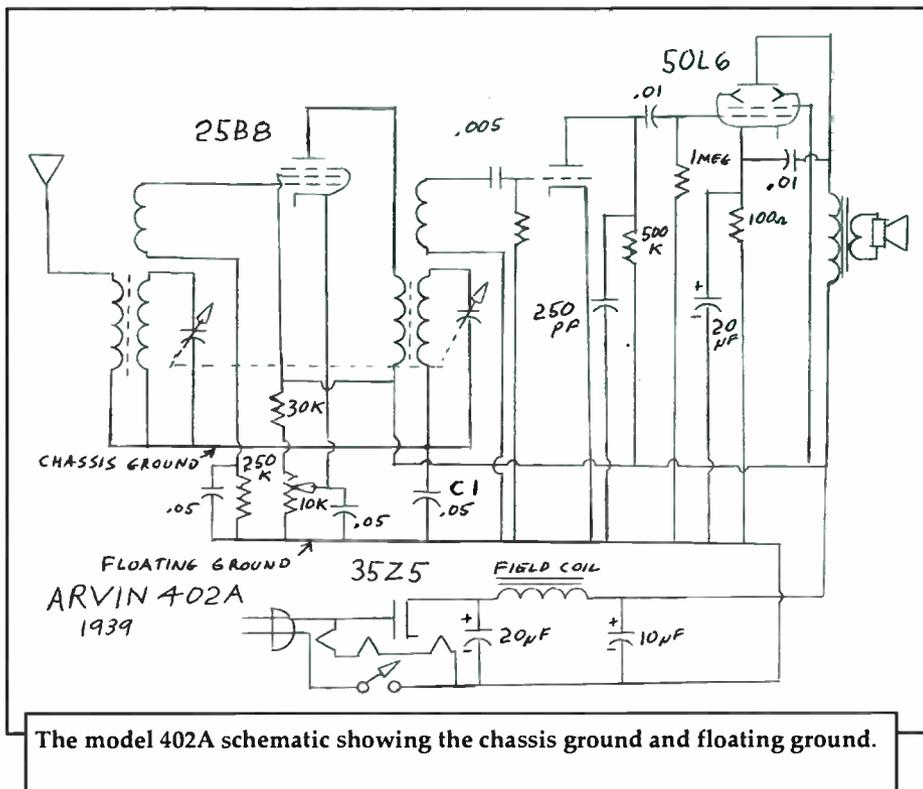
The model 402A schematic showing the chassis ground and floating ground.

is the hot side. Then the radio companies used a floating ground in their radios, which prevented the AC line from being directly connected to the metal cabinet. Some of you are probably thinking, wait a minute, the tuning capacitor or variable capacitor is mounted directly to the metal chassis, so how is it connected to ground or the negative side of the power supply? If you look carefully in the schematic you will see a .05 mfd capacitor going from the floating ground to the metal chassis. Reactance wise, it will look like a short to radio frequencies, but an open circuit to the 60 Hz line voltage/current. With the polarized plug and the floating ground, these radios were relatively safe. Not so with the TV's where I could measure 110 volts between the cabinet of a 1959 Muntz TV and ground. Reversing the plug cured the problem and I would instruct owners of metal TV's to reverse the plug if they could feel a little tingling, buzz or roughness when they touched the metal cabinet.

So what did I do to resurrect this little Arvin/Kent radio? Obviously I replaced all the capacitors and I made sure the .05 mfd capacitor that goes from the chassis to the floating ground was a high quality capacitor. This radio had been used in a kitchen and had a lot of grease accumulated on the insides of it. The outside of it was rusty with missing paint but not grease coated, but I figure the lady

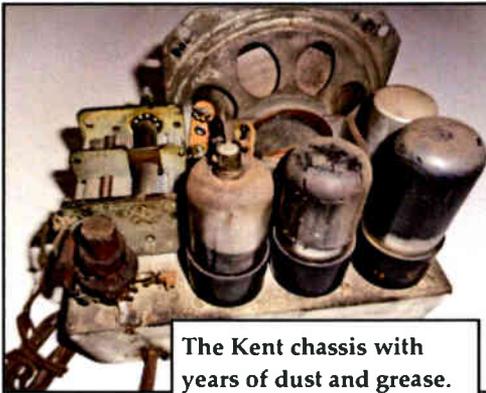
The Kent chassis with years of dust and grease.

The first thing I did was take the chassis out of the cabinet and inspect it. The only capacitor that had been changed was the filter capacitor; all the others were original, including the resistors. The 35L6 took the place of the 50L6, which the radio originally came with and a dropping resistor was added to suck up the extra 15 volts when using the 35L6. More on the tube switch later. The speaker cone was loose and the variable capacitor was really full

of grease and the chassis was coated with grease. 409 cleaned up the chassis nicely and it cleaned up the variable capacitor after I removed it and soaked in 409. I used a toothbrush, an old one, to clean between the plates and all over that variable capacitor. The toothbrush worked great on the chassis too. The variable capacitor was rinsed with plain

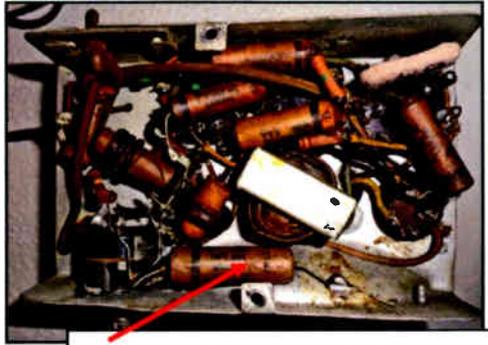
If this .05 mfd capacitor fails as a short, the chassis and floating ground are common—a shock hazard!

new. The tubes checked good and with new capacitors I plugged it in and it didn't work. This is rare but a new .01 mfd ceramic capacitor was shorted. Ceramic capacitors are normally very rugged and reliable, so this surprised me. I checked the other new ceramic capacitors of the same brand and type and they all checked good. So I replaced the bad NOS capacitor and the radio works. The speaker was re-glued and the cone was positioned so the voice coil didn't rub and now it sounds pretty good.

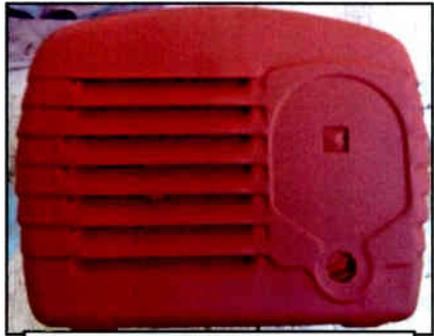
The Kent with primer/filler

I stuffed an old plastic bag inside the cabinet to protect the paper work from paint. Then I set the small cabinet on top of a paint can so I could reach all side. I had a red filling primer. A filler primer is capable of filling in small dents and scratches, which this radio didn't have, just the natural little lines from being pressed out at the factory. I do a real thin coat at first what painters call a tack coat. This allows the next coat to really stick

to the surface and is less prone to running. The primer dries fast so it didn't take long to build up a few

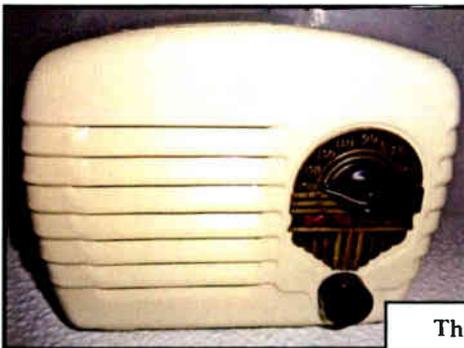
The restored Kent

it original. After using steel wool on the yellowed cigarette stained paint I saw a bright ivory color that I couldn't find at Walmart, so I went to the auto store. There I found a GM color that was almost a perfect match so I bought it, not cheap, but it worked out very well. Using the same technique of starting off with a tack coat made the following coats go on better and I didn't have any runs. Having painted lots of cars helped with this project. The GM paint dried very fast so it didn't take long to apply about 5 coats and so now the cabinet really looks great. My wife had a double-backed tape and that's what I used to put the bezel back on with. I did use the paint stripper on the bezel to bring out the highlights like the numbers and lines, but left the rest of it dark. A red magic marker was used on the KENT letters, to replace the original red that was removed by the paint stripper. The cabinet now looks like new.

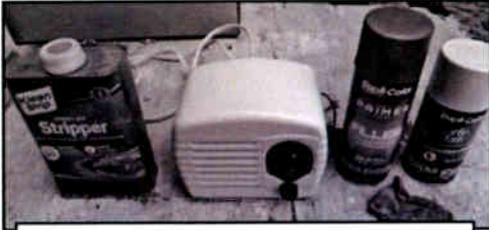
Stripper, primer, and finish for the Kent

scraper. Once the paint was gone, I took sandpaper and sanded all the rusty spots. A Dremmel tool with a wire brush worked great at getting rid of paint that remained in tight spots in the grill area and in creases. Be careful with the rotary wire brushes because at high speeds they like to throw out wire and can be a potential eye hazard, so I recommend wearing safety glasses when using rotary wire brushes. Paint thinner worked great at cleaning up the cabinet and made it ready for primer paint.

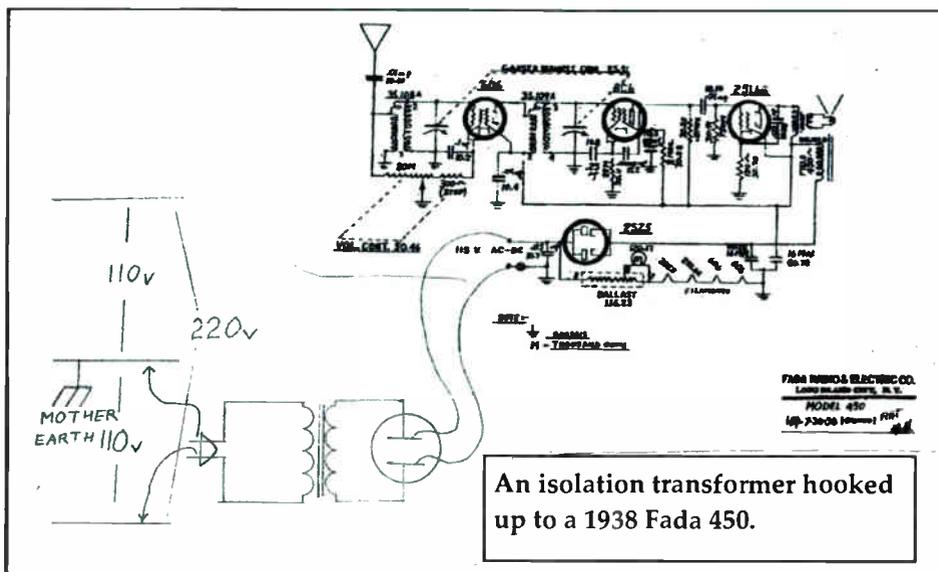
An isolation transformer hooked up to a 1938 Fada 450.

How does an isolation transformer work? The transformer has two windings, a primary that is plugged into the wall outlet and the secondary where the radio is plugged in. There is no physical connection between the primary

and the secondary and so there is no physical connection to the hot side or the neutral/ground side of the power line, hence, isolation. The enclosed diagram shows an isolation transformer hooked up to a 1938 Fada 450, a cute little TRF radio that works surprisingly well. One side of the AC cord goes directly to the metal chassis and the original cord was not polarized. This is not unusual when the cabinet is plastic and the Fada 450 used a Bakelite cabinet, but if you were to hook up test equipment to this cute little radio you would have a 50/50 chance of the chassis being hot. So using an isolation transformer with this radio eliminates a lot of headaches.
