The BULLETIN
A PUBLICATON OF THE INDIANA HISTORICAL RADIO SOCIETY.
CELEBRATING FORTY-SEVEN YEARS OF DOCUMENTING EARLY RADIO

## The Indiana Historical Radio Society Bulletin Winter 2018

#### A Kingston Chairside Model 690-B by Fred Prohl

#### Motorola 63C Clock Radio August, 2018 By Edward Dupart

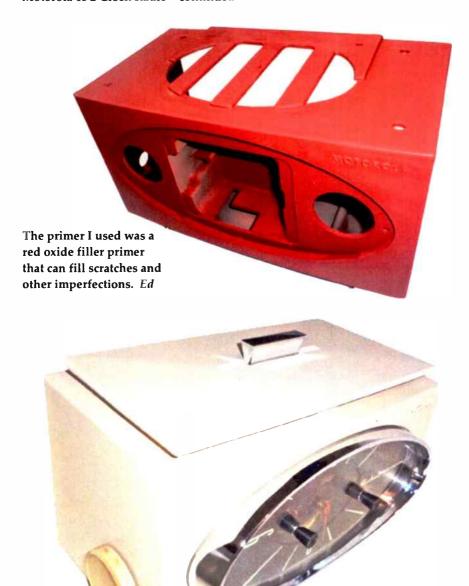
GM touchup lacquer was used for the off white finish. A clear glossy topcoat was required to give a soft luster. Ed

was ready for the off white. I wanted it to be the original color and I had some leftover off white from a previous radio restoration, but it wasn't enough. So off to the auto store I went and bought a can of GM touchup lacquer that was a perfect match. The difference between the two paints was the first can produced a nice shine, but the second can didn't have a shine and required a clear, glossy topcoat. So a clear, glossy lacquer was put on top of the off white and now it shines. It took about three coats of the off white with a little wet sanding in between coats to cover the cabinet completely. Then white polishing compound was used on the clear, glossy lacquer and wow, does it look good now! I can't find the crack on the top without taking a peek at the bottom of the top. The cabinet is ready to be put back together and it does look good.

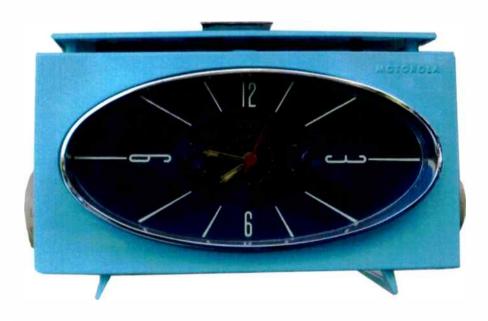
My wife and I thought the original off white was boring, so I found another factory color that we both liked and so now the radio is aqua and now, we really think the radio stands out. The color used was a standard off the shelf Rustoleum aqua lacquer. Ed

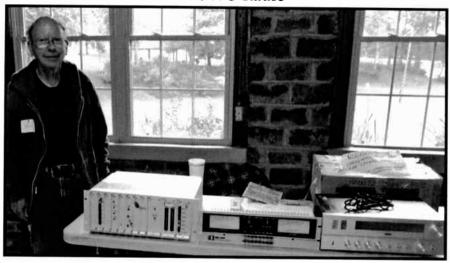
#### AM Stereo Broadcast -- WOWO Radio

IHRS member Bob Streeter, W8ST, displayed equipment used at WOWO AM radio to broadcast AM Stereo in the 1980's and 1990's. Bob was asked to describe the function of each of the three units on display for publication in the IHRS Bulletin. He responded as follows:

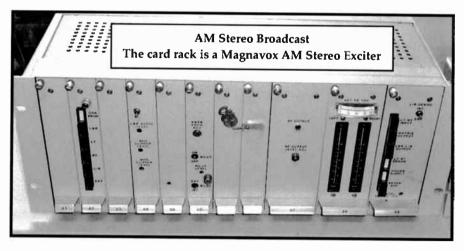
The card rack is actually the only surviving Magnavox AM Stereo Exciter. It was manufactured by Continental Electronics Manufacturing Corporation (Dallas, TX) under contract to Magnavox. The exciter was designed for Magnavox

by Jack Sellmeyer, P.E. (a Magnavox consultant). The card rack system was used for ease of maintenance. This unit provided the FM modulated RF signal (used for the pilot tone or slow speed digital data) and the phase modulated RF carrier applied to the standard AM transmitter. The unit also provided the correct audio signal to the AM transmitter modulation circuits. This particular exciter saw service at WOWO and drove the

50 KW transmitter in AM Stereo continuously at the WOWO transmitters in Roanoke, IN from April 26, 1982 to March 19, 1995 when the Motorola AM stereo system was mandated.

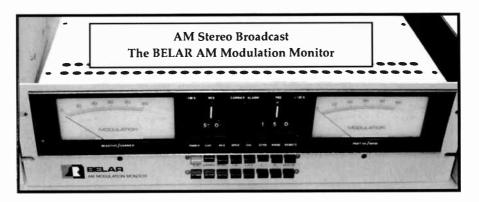
The BELAR AM Modulation Monitor is a modified Belar AM broadcast station modulation monitor. In this case, the standard Belar AM monitor was modified to include a detection system for the Magnavox AM Stereo system. The monitor displays the modulation parameters of the envelope modulation (L+R channel), the angular modulation (L-R Channel), the pilot tone, the left audio, and the

right audio channels. This particular monitor saw service at WOWO during the AM Stereo test program, with supervised performance data provided to the FCC. This monitor ran continuously at the WOWO transmitters in Roanoke, IN from April 26, 1982 to March 19, 1995 when the Motorola AM stereo system was mandated.
