VOL 51
FALL
2022
No.
3

The
Indiana
Historical
Radio Society

Arvin's First Home Radio: The 1935 Arvin Model 41

The Zenith Royal 97 Super Navigator

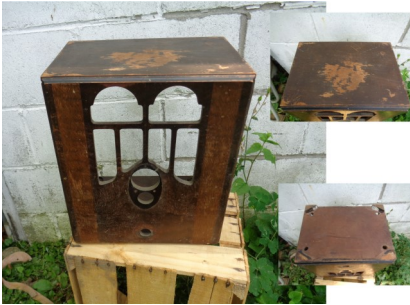
I picked up this little Arvin a couple of years ago and I finally got around to working on it. The cabinet was in pretty good shape; only two small pieces of veneer were missing, some loose places needed re-gluing and the finish was peeling off. The two front feet were missing, but they're simple 3/8" triangular pieces of wood. The chassis was rust free but dirty. All the tubes were in their places. The grill cloth was dirty but in good shape along with the original knobs. When I removed the speaker, I found it to be perfect, free of holes or rips. This was a good radio to restore.

The cabinet had some loose veneer and two small missing pieces, so I did a lot of re-gluing and replaced the missing pieces with two pieces of scrap veneer. I also had to make the two front feet--easy to do with the band saw and scrap wood. The cabinet is now very solid.

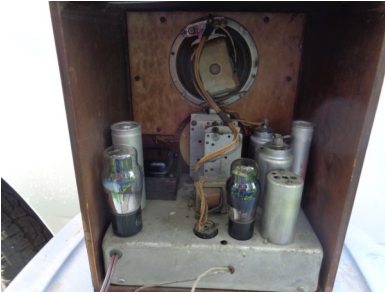
What did I find when I really looked inside? Lots of stink bug carcasses were in front of the chassis. Out came the vacuum cleaner and I sucked them up along with the dirt. All the tubes were removed as well as their shields. That allowed me easier access to vacuum dirt from the chassis top. Both a paintbrush and toothbrush assisted in getting into hard-to-reach areas.

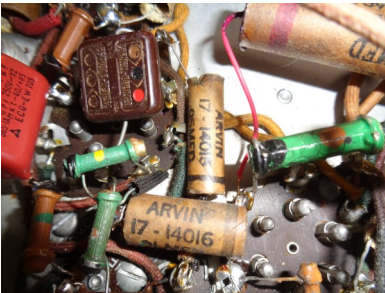
Inspecting the underside revealed that little had been done to the chassis over the decades. All but one of the paper capacitors had an Arvin stamp on them. The two filter capacitors had been replaced and needed to be replaced again. Otherwise, everything looked original and it was very clean. The line cord was totally shot.

I took a gamble and replaced the line cord, filter capacitors and the audio coupling capacitor--they always seem to go bad. A meter was connected to the 80 rectifier to monitor the B+. Upon applying power, the radio came to life. No smoke, no static, just lots of stations coming in. I was happy!

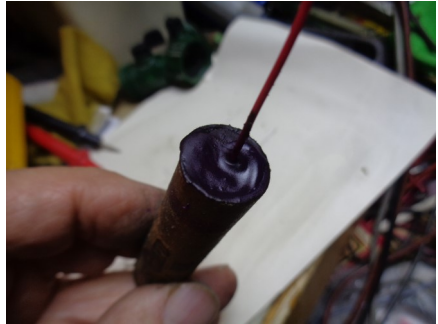
The Arvin capacitors' outer jackets fascinated me, so I decided to pop out their old guts and put new capacitors inside. It's a little extra work, but it maintains the originality of the radio. Some of you are thinking, "Who's going to see the underneath of the chassis?" Answer: people like me. I checked the old caps and they were all very leaky--it made me wonder how this radio worked so well. Oddly, the only capacitor that checked good was a blue Solar capacitor. Usually they are bad, but in any event, it was replaced anyway. The resistors looked fine, none needed replacing.

Upon re-applying power, the radio came to life and sounded great on strong stations, but squealed and howled on weaker stations. It sounded like a bad bypass capacitor. I got out my capacitor substitution box, suspecting one of the new capacitors I put in was bad. When I touched the screen grid terminal of the 6A7, the

squealing quit. I traced the wire and it went to the screen grid of the 6F7. I put the sub box to that point and the squealing quit. What I discovered was a capacitor was never installed there! The factory never put one in. Upon installing a new cap, the radio played fine. It is C13 in the Riders schematic in volume 6-16. I'm guessing whoever bought the radio only played it on strong stations and would never have noticed that problem. If a weak station was tuned in, the squealing would stop when the volume was reduced-- this was a common problem with TRF sets of the 30's, so this may have been considered acceptable back in 1935-36.

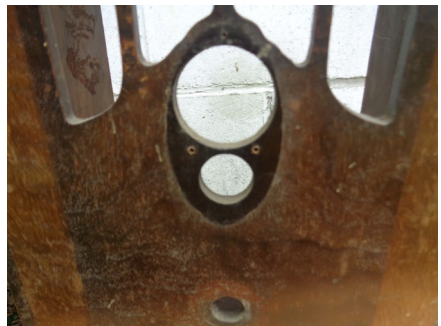
I took pictures of the cabinet so I would have an idea about the color configuration. Removing the bezel revealed that the original color was a very dark brown. The website for Arvin had some excellent pictures and they aided me in my selection of stains and toner lacquers. As I consider this a historic radio for Arvin, my goal was to get the cabinet as close to the original.

I didn't use any strong chemical stripper; instead I used an orbital sander and removed the old finish. When I was done, the cabinet was very smooth and ready for refinishing.

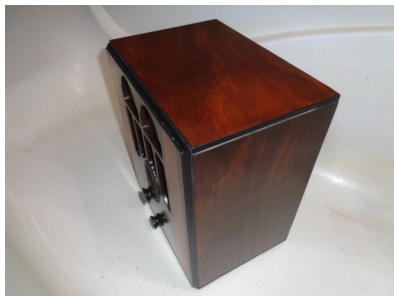
The top appeared to have a slight red cast to it, so I mixed a dark red stain with a dark walnut stain and applied it. A red mahogany toner lacquer was added to the top and that quickly set the stain.

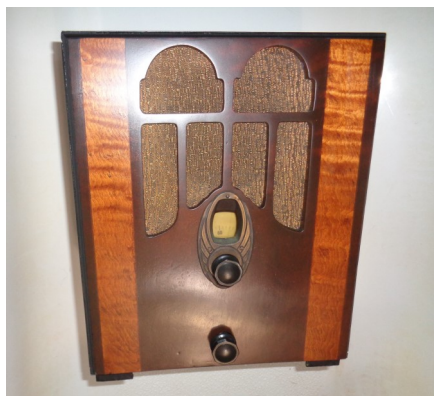
The grill cloth was dirty but the backside looked like new so I simply reversed it. I put it all back together and was rewarded with a great looking and playing radio!

A dark walnut stain was used for the sides and the front. The veneer in-

serts were very light in color, so I used a Gunstock stain for them. I taped off the inserts and sprayed the rest of the front with Van Dyke brown toning lacquer. The entire cabinet was then sprayed with satin lacquer and wet sanded between coats. The top had gloss lacquer applied to it.

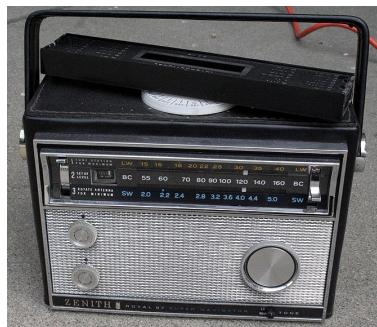
What a neat radio! From what I could find on-line, looked like this design came out in 1965. This set probably was built in 1969 as Joe said there were many date-codes from that year.

Pulled the battery tube and saw that one of the wires was corroded by earlier battery leakage, so I cut all the wires off and attached 5" long pig-tails to which I soldered on a 9V battery clip.

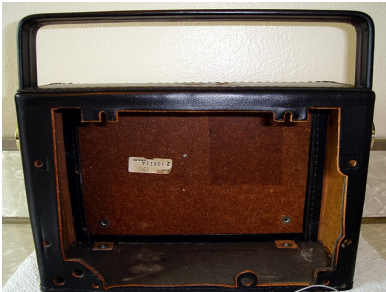
The battery holder had a bit of dried leakage residue and rust inside the tube, so I scrubbed it first with vinegar then dish-soap solution before a final rinse and dry. Was very careful not to damage label.

The clear plastic tuning dial was nearly flawless except for a small, thin outline of where a splash of paint had been. Tried Isopropyl alcohol on one of the mounting tabs to make sure it was safe to use, then carefully wiped off this residue. It left some cloudiness, so I went over entire outer surface with Novus-2 and it appeared better than before.

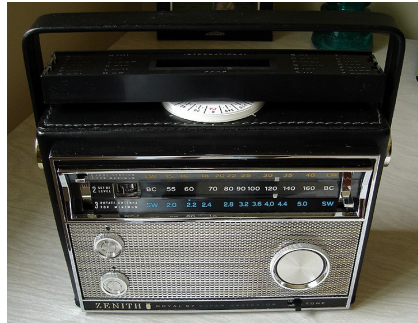
Here is the finished set. The leather hinge back cover is the only cosmetic issue with radio—it has torn even more with my handling, unfortunately. The rest of case is pliable & excellent.

Note the fold-up sights at each end of antenna bar.

Wish I could get a good pic of this "lit up". the dial-light not only brightly illuminates the entire tuning dial but the compass rose as well---sure looks neat!

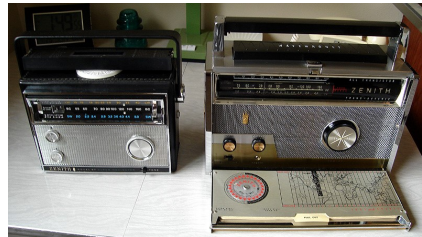
The last pic shows this radio next to 1958 Royal 1000-D for size comparison. As Joe mentioned, this set had components with 1969 date codes and I found a couple parts dated 1968.
