Proceedings of The Radio Club of America, Inc.

JANUARY, 1944

TELEVISION BROADCAST COVERAGE

By Allen B. DuMont and Thomas T. Goldsmith, Jr.

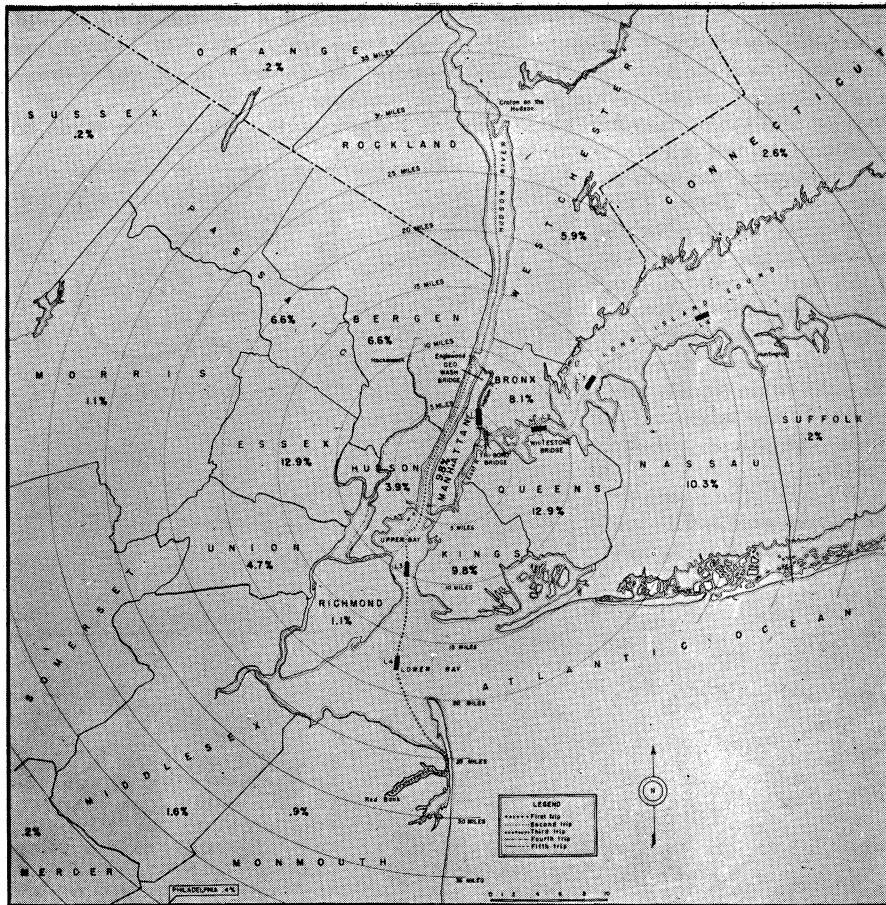
FIG. 6. MAP SHOWING THE DISTRIBUTION OF TELEVISION RECEIVERS IN THE NEW YORK AREA, AND POINTS WHERE RECORDINGS, SHOWN IN FIGS. 22, 25, 26, 27 WERE TAKEN

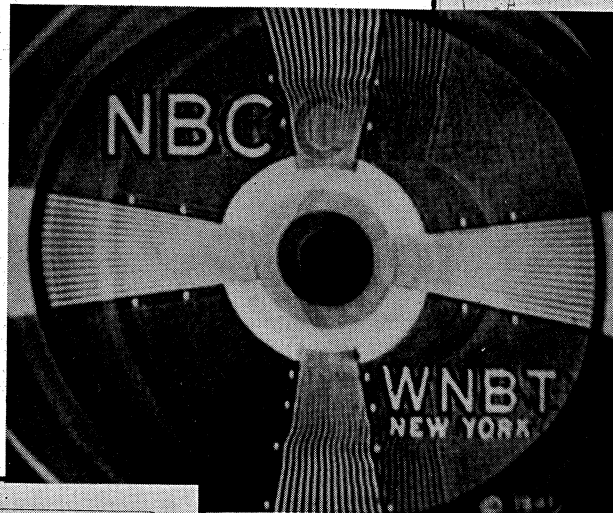
FIG. 10, BELOW. IN THIS CASE THE REFLECTION IS FROM AN OBJECT NEAR THE TRANSMITTER. THIS ALSO CAUSES A FIXED GHOST AT THE RECEIVER. FIG. 12A, RIGHT. ACTUAL PHOTO OF A FIXED GHOST, DISPLACED TO RIGHT OF MAIN PATTERN

duced by directive antennas using reflectors. Fig. 12 is a typical pattern where the receiving antenna is approximately one-eighth of a mile from the mountain, and Fig. 12A where it is located about one-half mile away. It also occurs in Maywood, New Jersey, and other points in a small sector as shown in Fig. 11. This condition is very difficult to correct, as the angle between the direct and secondary image is extremely small, so a directive antenna does not help. Some improvement has been accomplished by using two antennas and feeding the output into a phasing arrangement to cancel out the secondary image.

Type A — Fixed Ghost ★ A fixed ghost appears as another and generally weaker pattern displaced usually to the right of the main pattern. It may be caused either by a reflecting object near the receiver, Fig. 9, or near the transmitter, Fig. 10, or at some intermediate point. In certain cases this reflection only occurs within a narrow arc, Fig. 11. The three figures illustrate only a few of the many position conditions which can produce a rather crisp displaced pattern in addition to the main picture. For such a fixed ghost, a reflecting object near the transmitter can give appreciable energy to the receiver over a path of greater distance than the straight line from the transmitter to the receiver. If the receiver is at rest, or is moving in a direction such that the difference in these two paths is not changing rapidly, then the ghost pattern may remain essentially fixed and be of an unchanged relative intensity with respect to the main pattern.

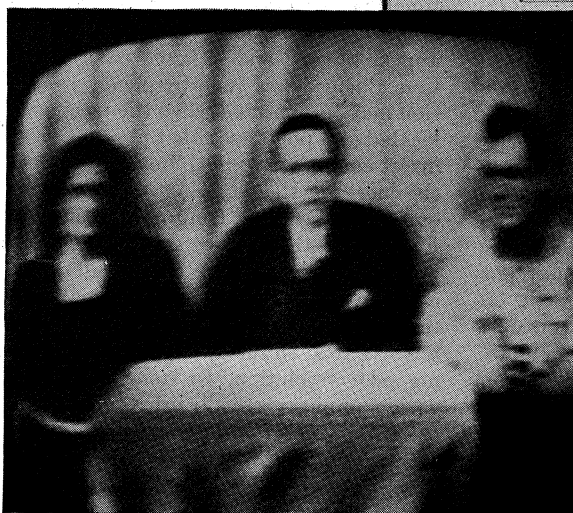
FIG. 13, RIGHT. UNDER CONDITIONS ILLUSTRATED, NO DIRECT SIGNALS CAN BE PICKED UP AT THE RECEIVING ANTENNA. RECEPTION DUE TO REFLECTIONS FROM A NUMBER OF OBJECTS RESULTS IN THE SMEAR GHOST

FIGS. 14, ABOVE AND 15, BELOW. TWO TYPICAL EXAMPLES OF SMEAR GHOST IMAGES DUE TO REFLECTED ENERGY PATHS ARRIVING FROM SEVERAL DIRECTIONS OF COMPARATIVELY SMALL ANGULAR DIFFERENCE. THIS CONDITION IS COMMON WHERE THERE ARE MANY HIGH BUILDINGS

Type B — Smear Ghost ★ In the smear ghost, the receiver screen has no separate and dis-

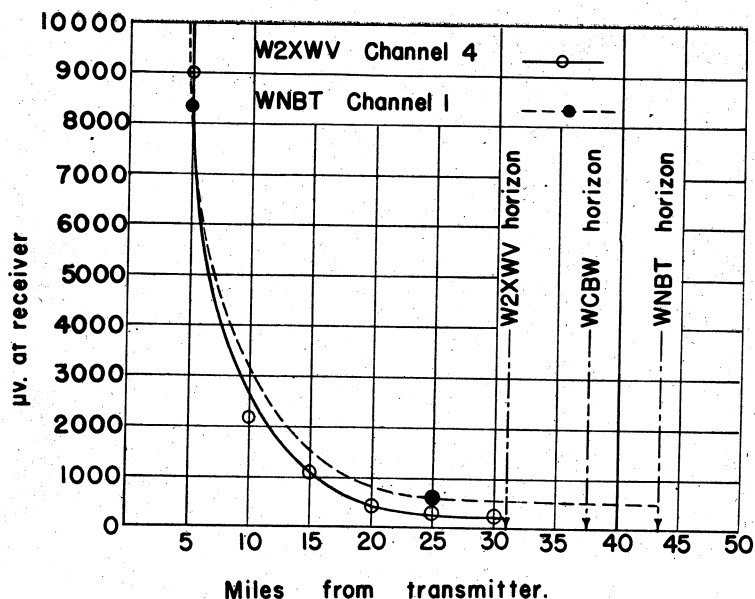
FIG. 28. MEASURED MICROVOLTS AT THE RECEIVER, FROM W2XWV, WCBW, AND WNBT

The field patterns produced by the transmitters on Channels No. 1 and No. 4 have been averaged from the recorded signal strengths. The actual recordings show extreme variations in regions where buildings cause multi-path reception. An average signal drawn through these curves indicates a satisfactory field strength to distances of 35 miles in most directions. Wherever there is a receiving location free of large obstacles and relatively free of local interference, good pictures can be expected. A study of the unobstructed field strength can be obtained best from the recordings taken on the second trip, illustrated in Fig. 6, going from Hell Gate Bridge out in Long Island Sound to Huntington. Measurements were made of the equivalent signal generator microvolts required to give the same recorder deflec-

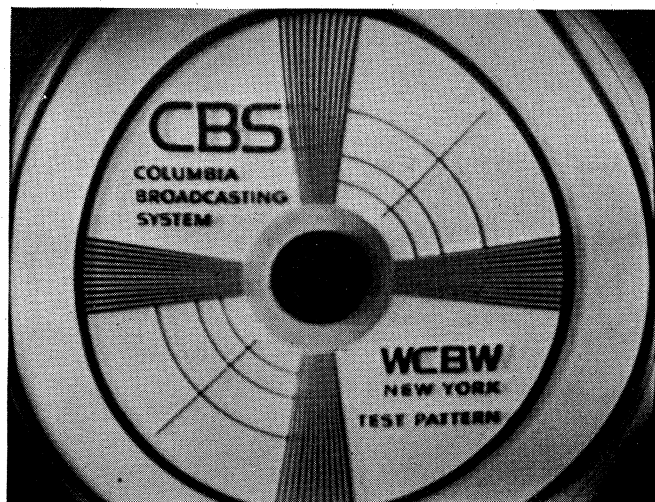
FIG. 30. CHANNEL NO. 2 TEST PATTERN AS RECEIVED ON PREWAR TELEVISION RECEIVER OPERATED AT AVERAGE LOCATION

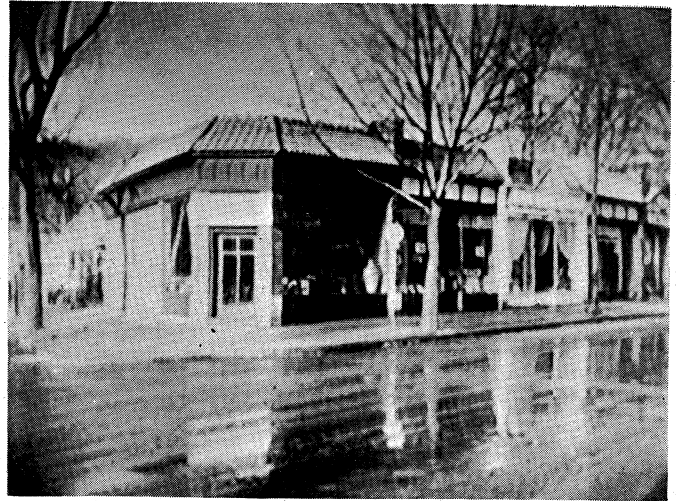
FIGS. 32 AND 33. EXAMPLES OF PICTURE QUALITY AVAILABLE ON RECENT TELEVISION PROGRAM TRANSMISSIONS
