SERVICE ENGINEER

Radio, Television and Audio Servicing

Vol 2. No. 9. February, 1960
 Edited by W. Norman Stevens
 Issued as a special supplement
 with "Radio Retailing"

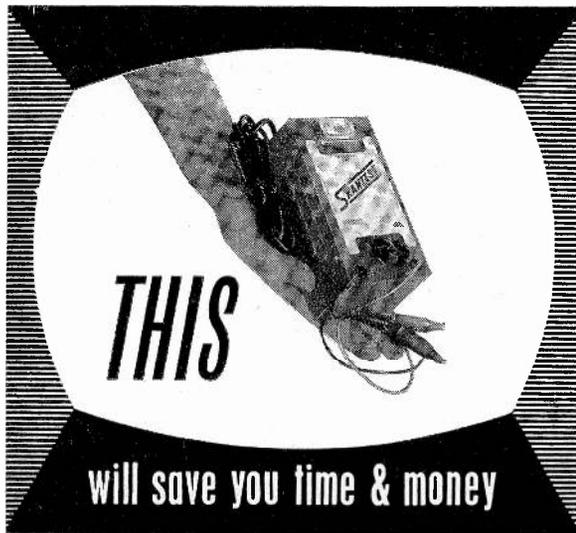
Newly designed—by and for practical TV Engineers—the SKANTEST Time Base Component Shorting Turn Tester consists of a PULSED oscillator circuit with two matching test points. Output is fed to a sensitive indicating neon. The pulse technique used has the effect of showing up intermittent faults, i.e., shorting turns due to pin holes in wire insulation. The test points enable both high and low impedance components to be tested.

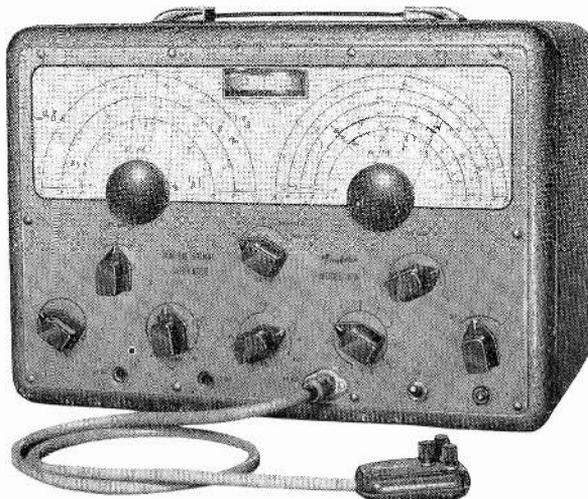
**A.M./F.M. Signal Generator
MODEL 61A**

Approx.: 1v. R.M.S. at 400 c/s.

Dimensions of hammer finish case: 13" x 9" x 8"
