RADIO
Retailing

SERVICE ENGINEER

Radio, Television and Audio Servicing

Servicing the MODERN TAPE RECORDER

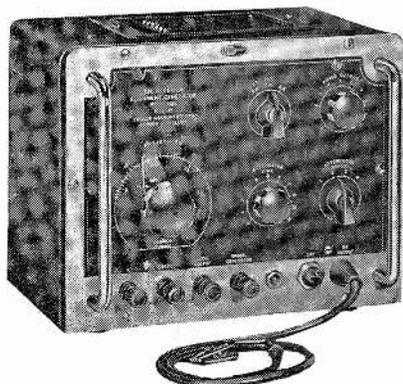
OSCILLOSCOPE MODEL 1091

The robust, portable model 1091 serves most oscilloscope procedures including measurement of voltage and time, waveform comparison, frequency determination, location of distortion and, operating in conjunction with a frequency-swept oscillator, alignment of radio and TV receivers.
