Admiral TV

SCHEMATIC DIAGRAMS

1947-1953

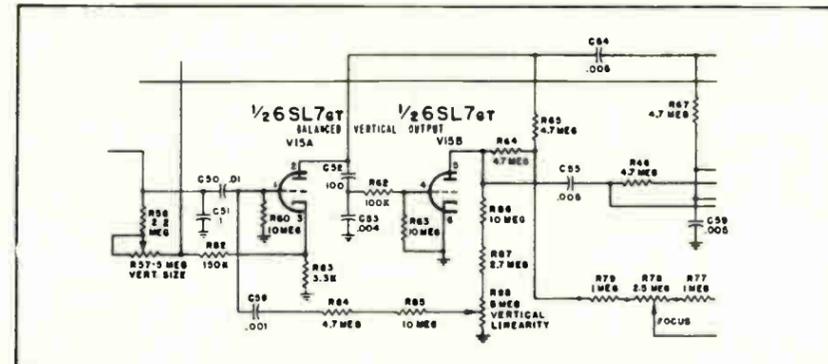
Vertical Output Circuit with Linearity Control

Sets having vertical linearity control can be identified as having nine rear panel controls. The vertical linearity control is located completely to the left. This control is pre-set at the factory and will seldom require readjustment, unless it has been accidentally disturbed or because of replacement or aging of tubes.

Checking of the vertical linearity control should be made preferably using a television test pattern. Examine the central circles of the circular test pattern image and if the pattern appears "egg shaped" in a VERTICAL direction, the "VERT. LIN." control should be adjusted until the circles in the test pattern image become circular again.

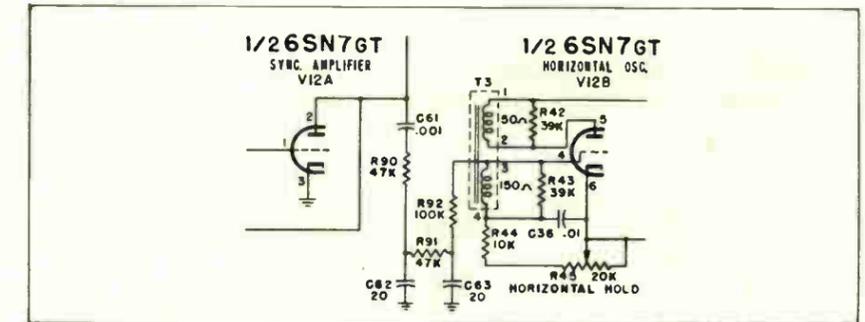
Horizontal Sync Filter Circuit in Later Sets

Vertical lines in the picture appear jagged or broken if high frequency noise signals reach the Horizontal Oscillator. This interference appears in areas having low signal strength and a high noise level. This condition can be corrected by insertion of a noise filter between the Sync Amplifier and Horizontal Oscillator. Production has been changed to include such a filter in later sets.

If this interference condition is encountered in a chassis, a horizontal sync filter can be installed after removing capacitor C35. All parts, with the exception of C61, must be mounted on a tie-strip. The tie-strip can best be mounted under the chassis between vertical oscillator transformer T7 and third IF amplifier V7. See Figure 56, Bottom View of Chassis, for physical placement. C61 should be connected between terminal 2 of V12 and the tie-strip. Dress the leads from C61 to avoid shorts.

NOTE: When the above circuit modification is incorporated, adjustment of the Horizontal Hold control is critical. This adjustment must be carefully made and checked on all channels currently in use. However, once set, readjustment is seldom necessary.

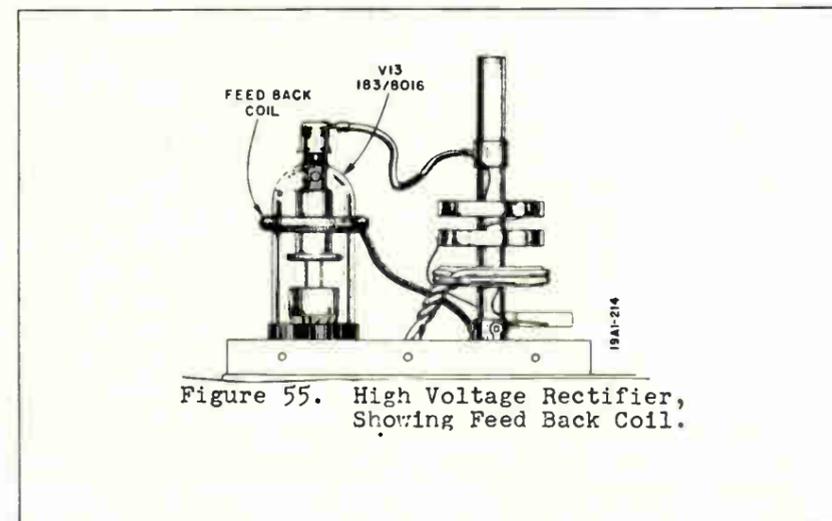
Figure 55. High Voltage Rectifier, Showing Feed Back Coil.

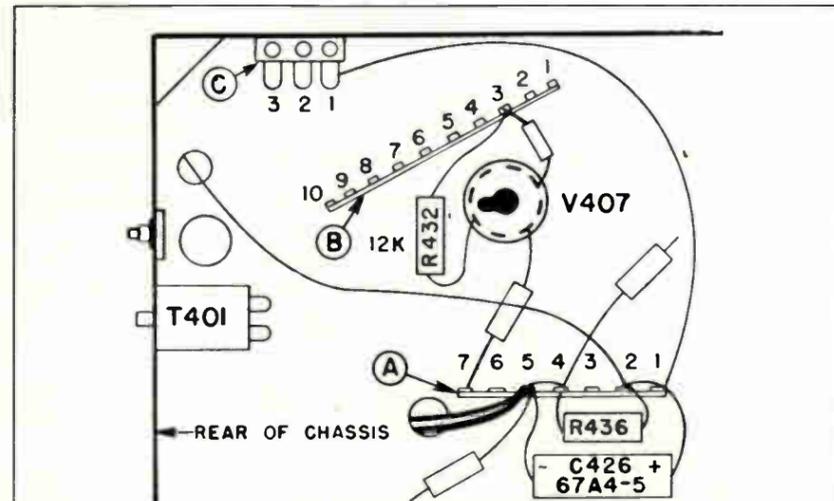
Figure 1-3. Original Circuit, Before Fusing.

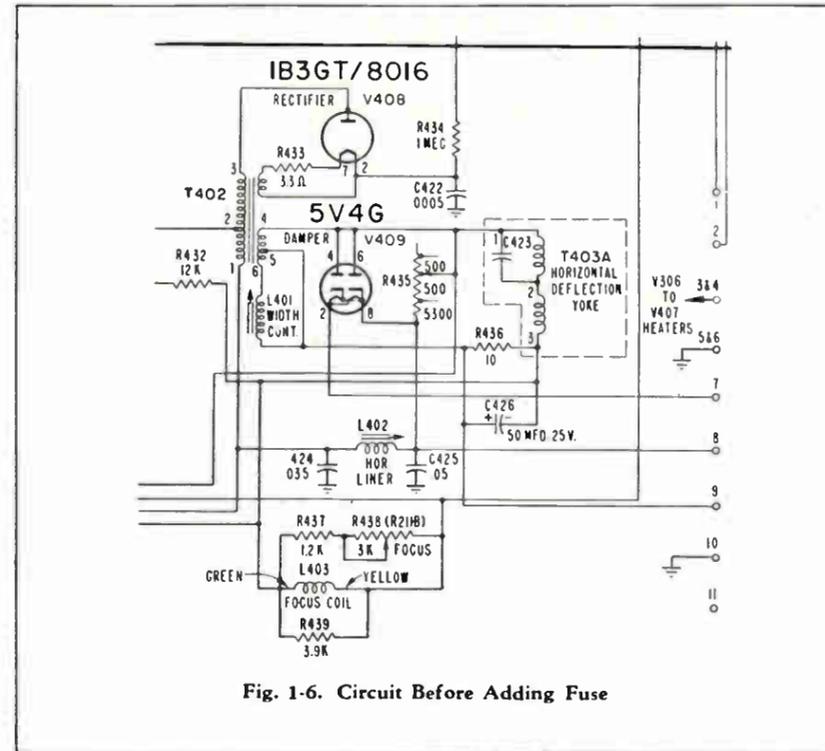
Fig. 1-6. Circuit Before Adding Fuse

In early production models, 6BG6G horizontal output tube (407) failure sometimes results in damage to circuit components (such as horizontal output transformer T402). This original circuit is shown in figure 1-6. The new circuit (see Figure 1-20) results in improved horizontal centering as well as fuse protection.

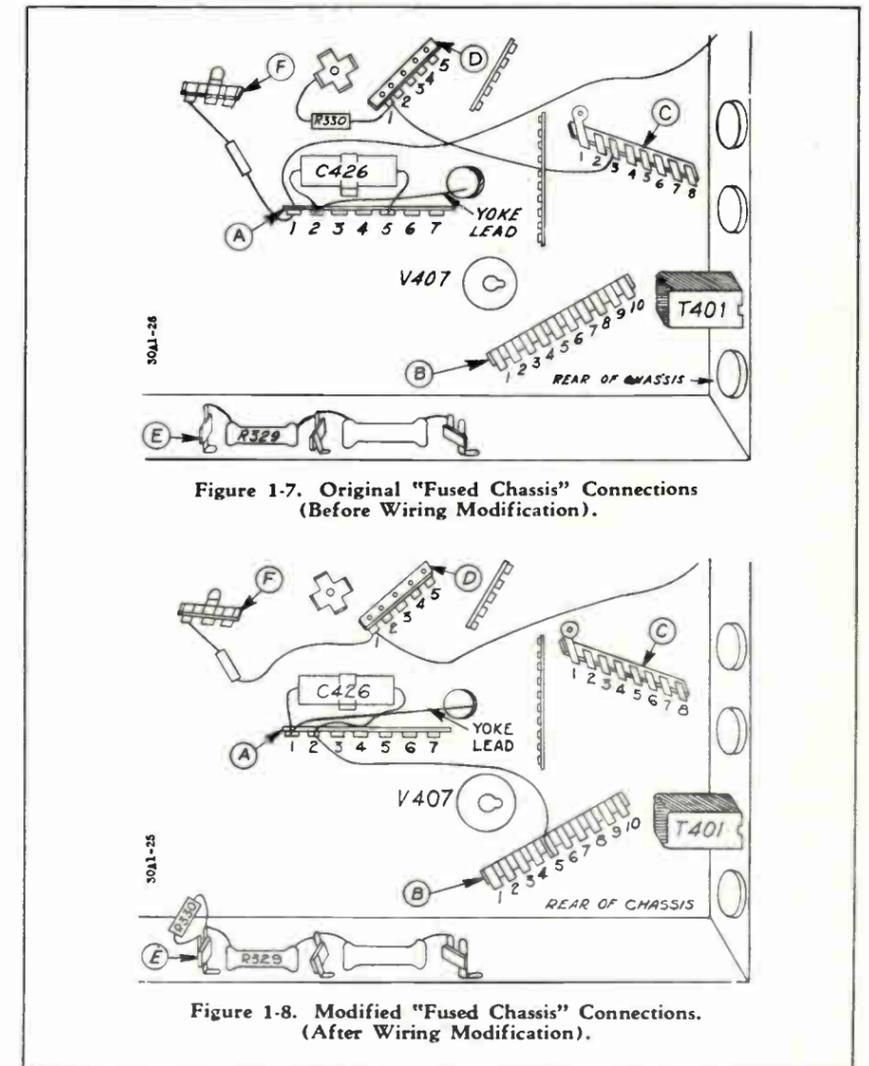
Figure 1-7. Original "Fused Chassis" Connections (Before Wiring Modification).

If a fuse burns out in a chassis wired as shown in figure 1-7, excessive voltage appears across condenser C426. Subsequent failure of C426 may result in damage to other circuit components. Therefore, chassis wired as shown in figure 1-7 must be modified when brought in to the shop. The modified chassis connections are shown in figure 1-8. The necessary modification is chassis wiring can best be accomplished as follows:

duction, some chassis will not appear exactly the same as shown in figure 1-7. The additional terminal on tie-strip "F" was used for the tuner plate decoupling filter in place of terminal 1 of tie-strip "A". Since such a chassis connection leaves terminal 1 of tie-strip "A" open, steps "a" through "d" of the above modification procedure do not apply. A chassis having the four-terminal tie-strip at "F" must be modified by following steps "e" through "h" only.

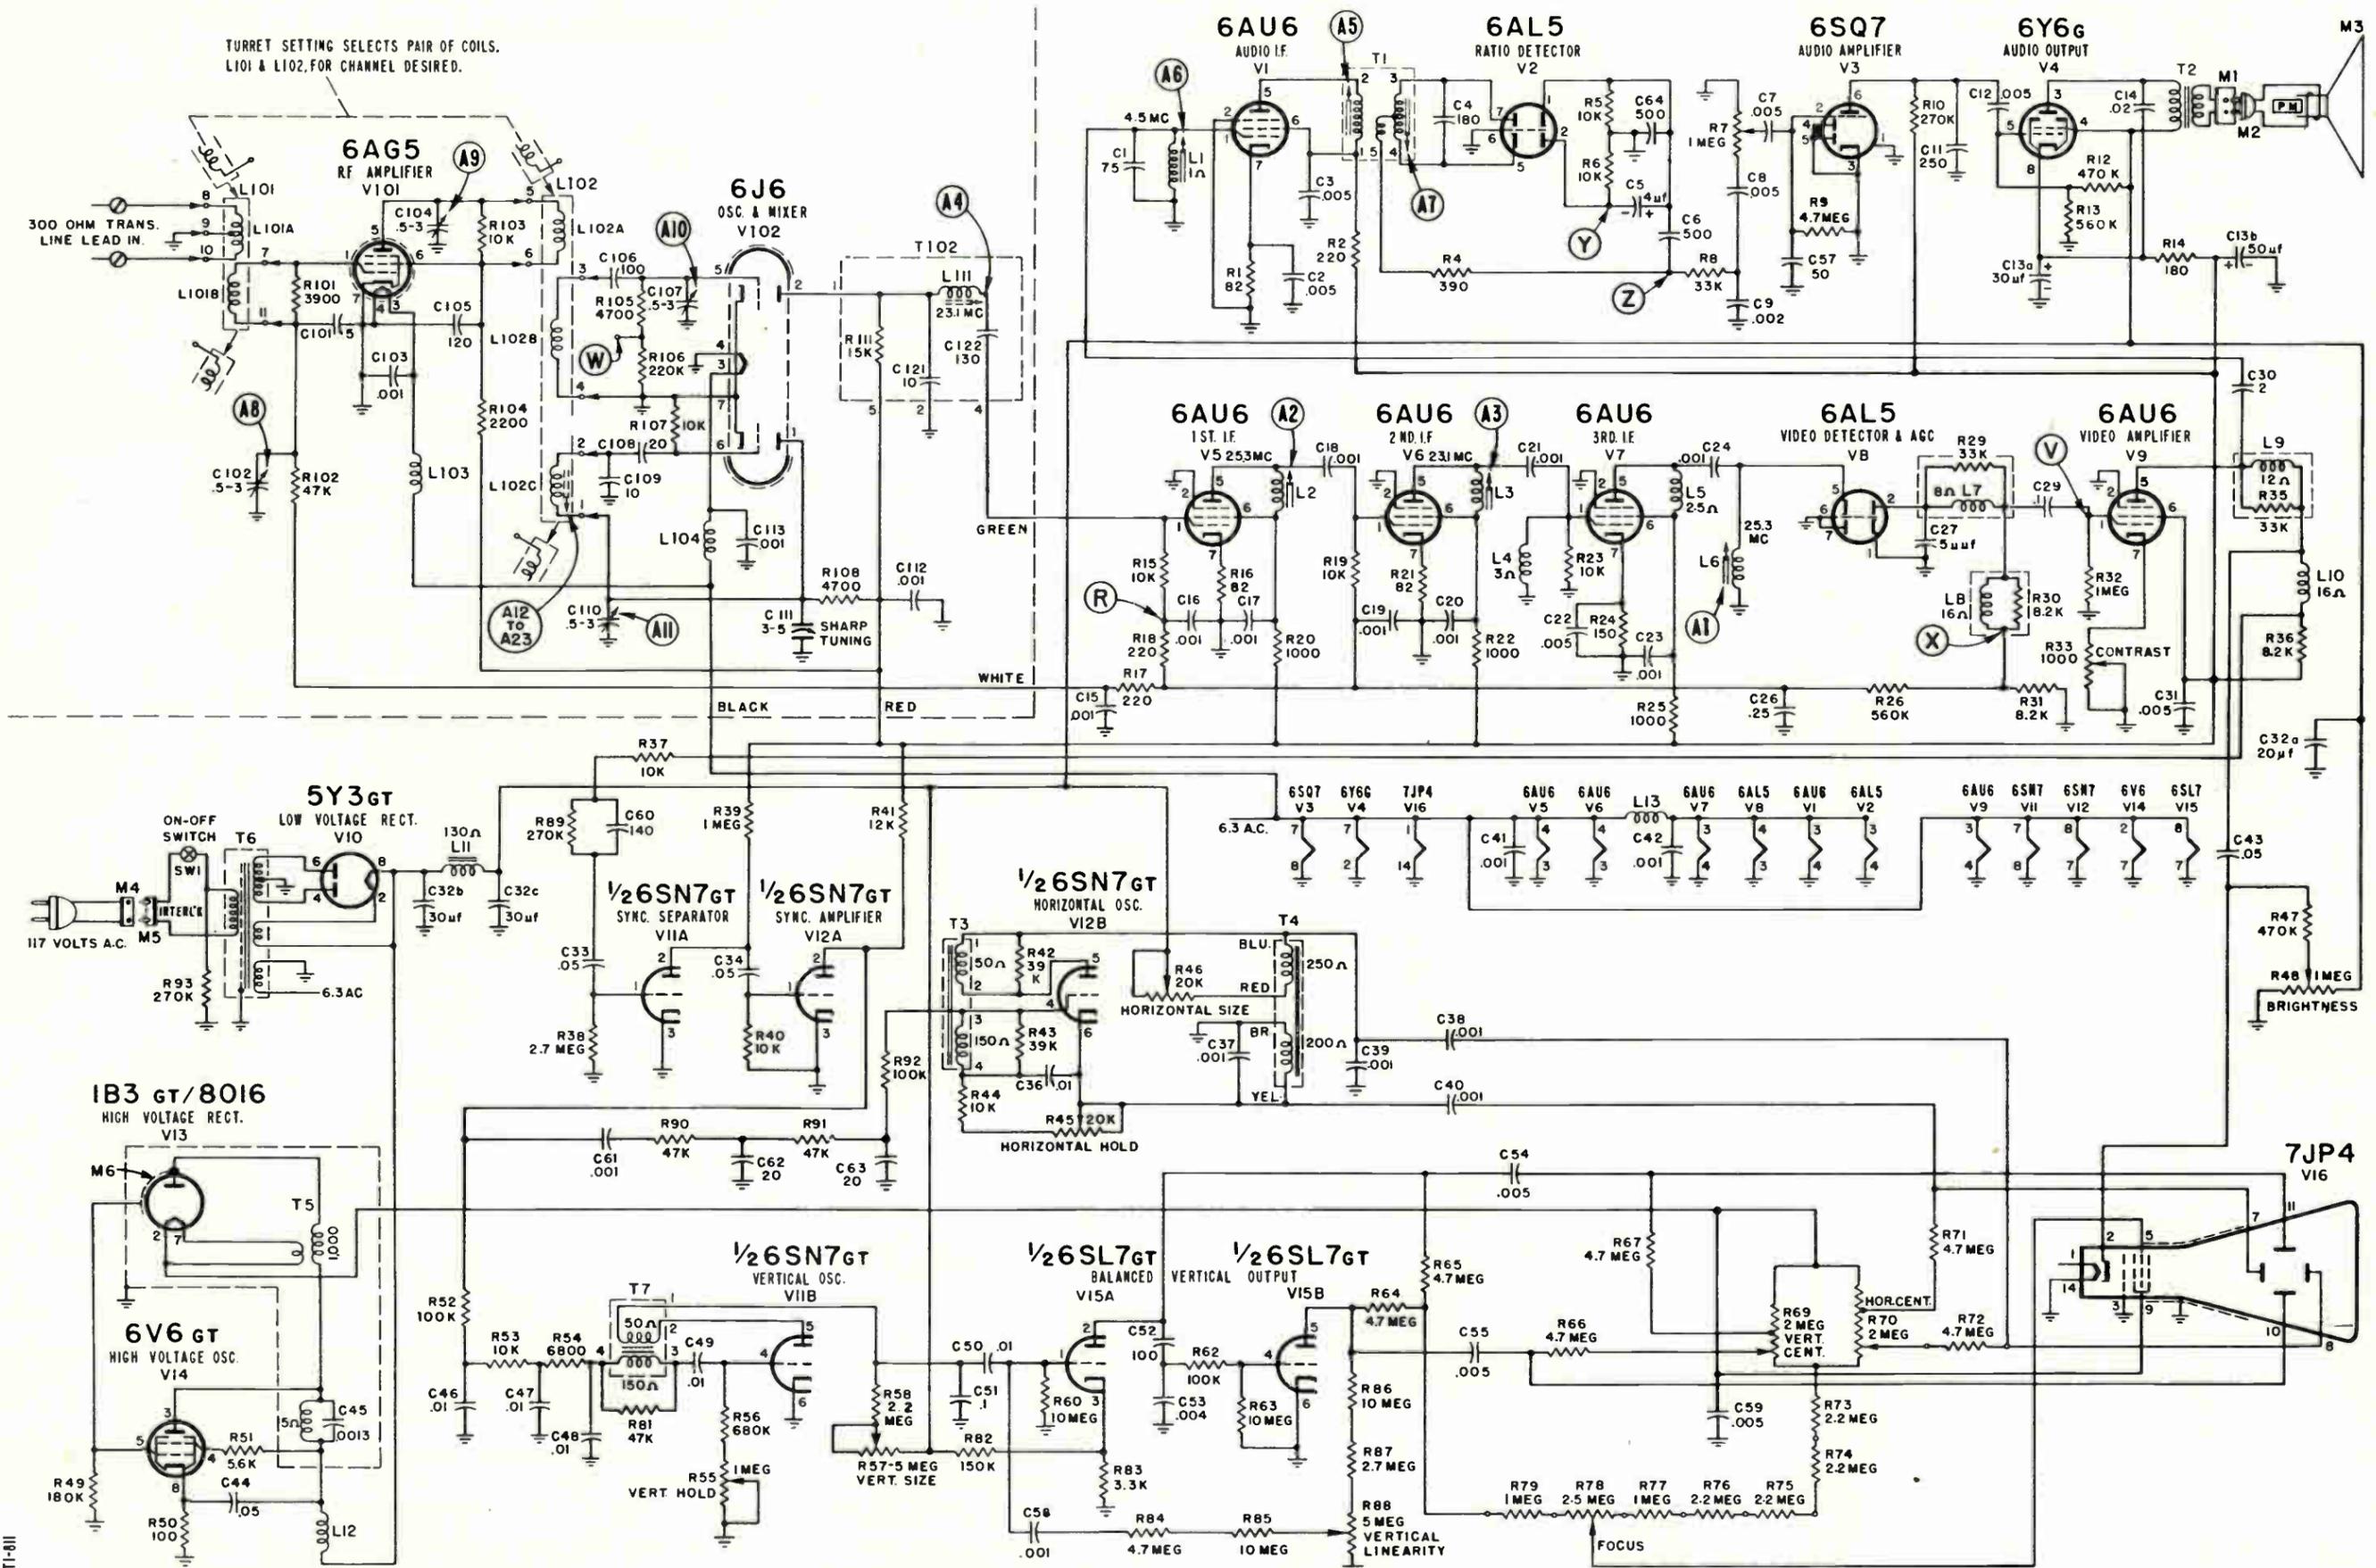
SCHEMATIC DIAGRAM FOR 17T1 CHASSIS

The 17T1 television chassis uses an intercarrier sound system and a 7 inch picture tube using electrostatic deflection. The circuits used in the 17T1 chassis are similar (in most cases identical) to the circuits used in the latest production 19A1 chassis. All circuit differences are outlined in the discussion under the heading "Circuit Differences" below.

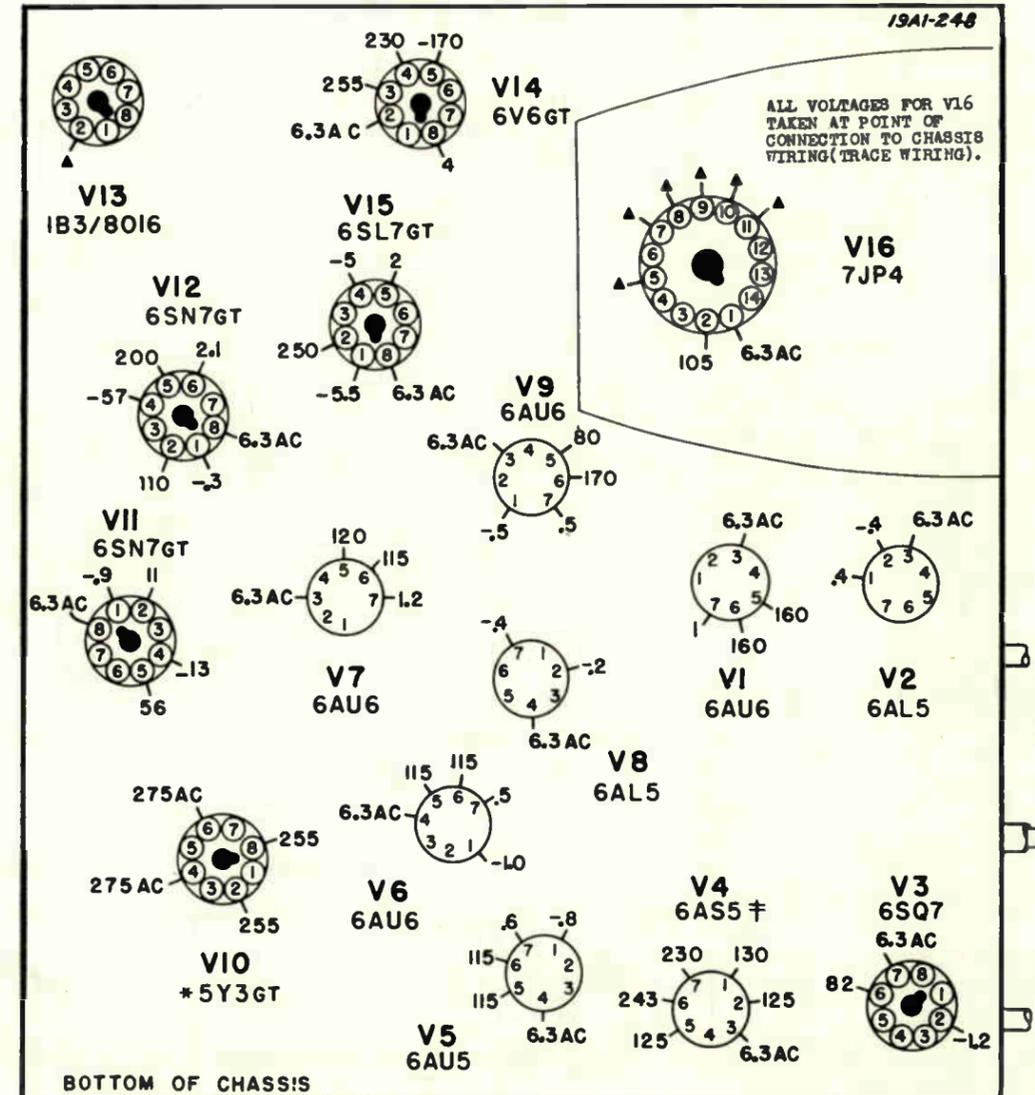
* 5Y3GT ALSO USED: SEE PRODUCTION CHANGES, PAGE 17.

Figure 58. Chassis Voltage Diagram.

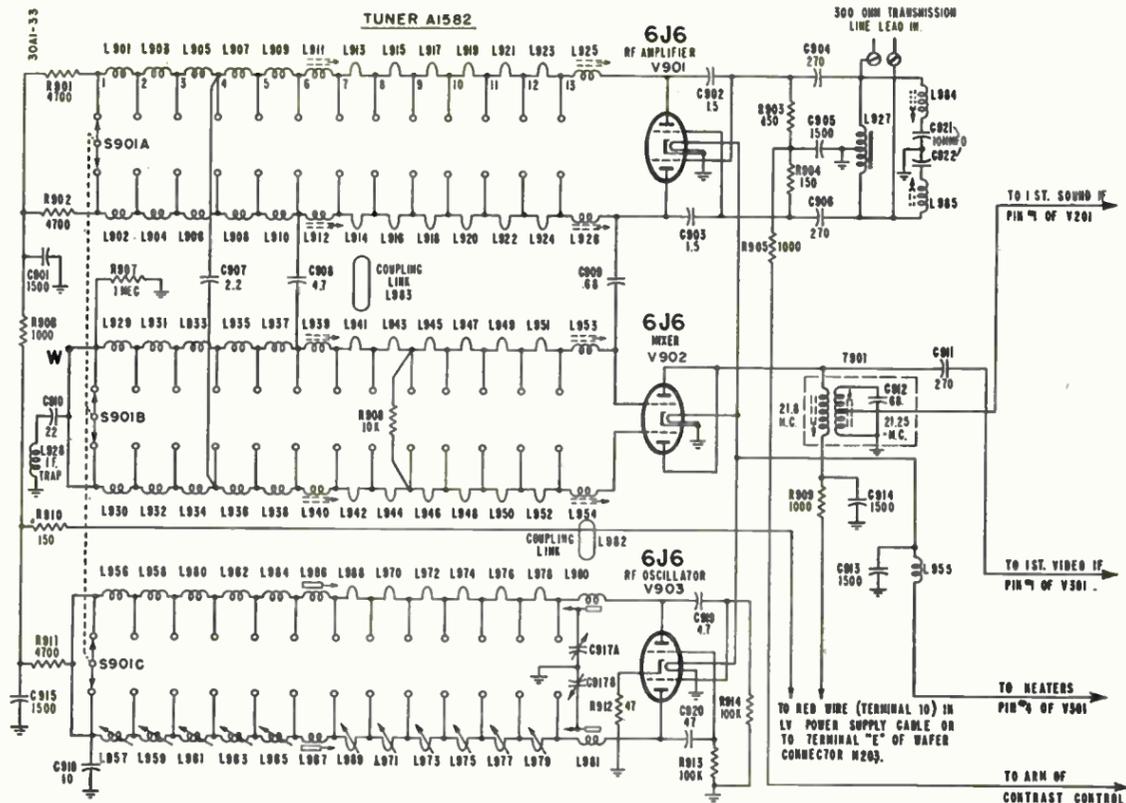
Figure 1-18. Schematic, TV Tuner A1582.

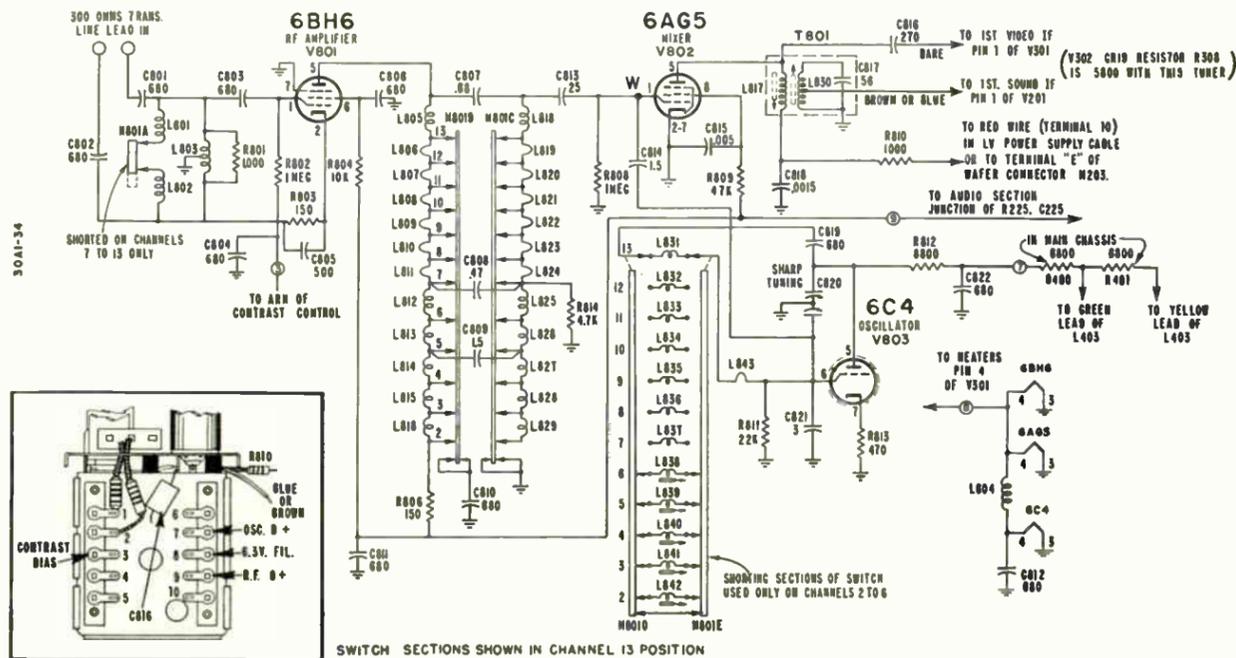
Schematic, TV Tuner 94C9-2.

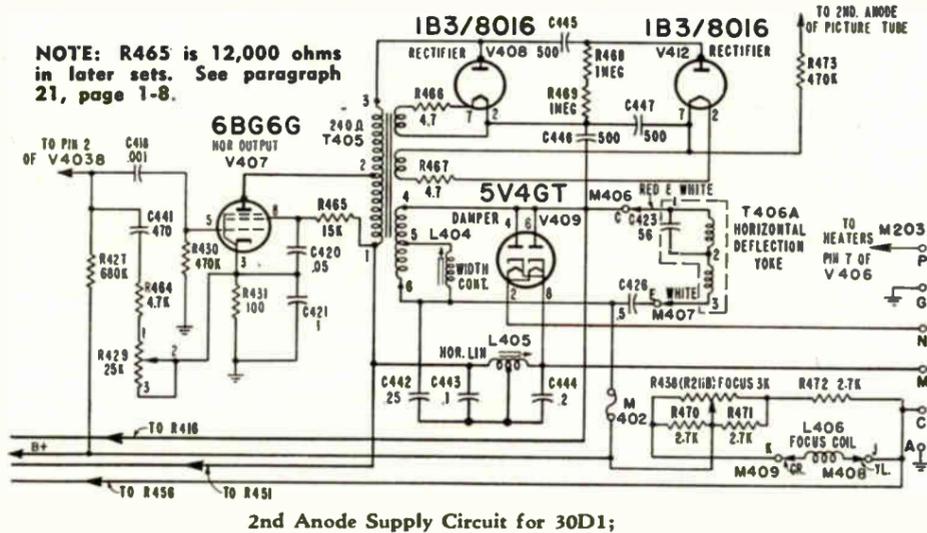
2nd Anode Supply Circuit for 30D1;

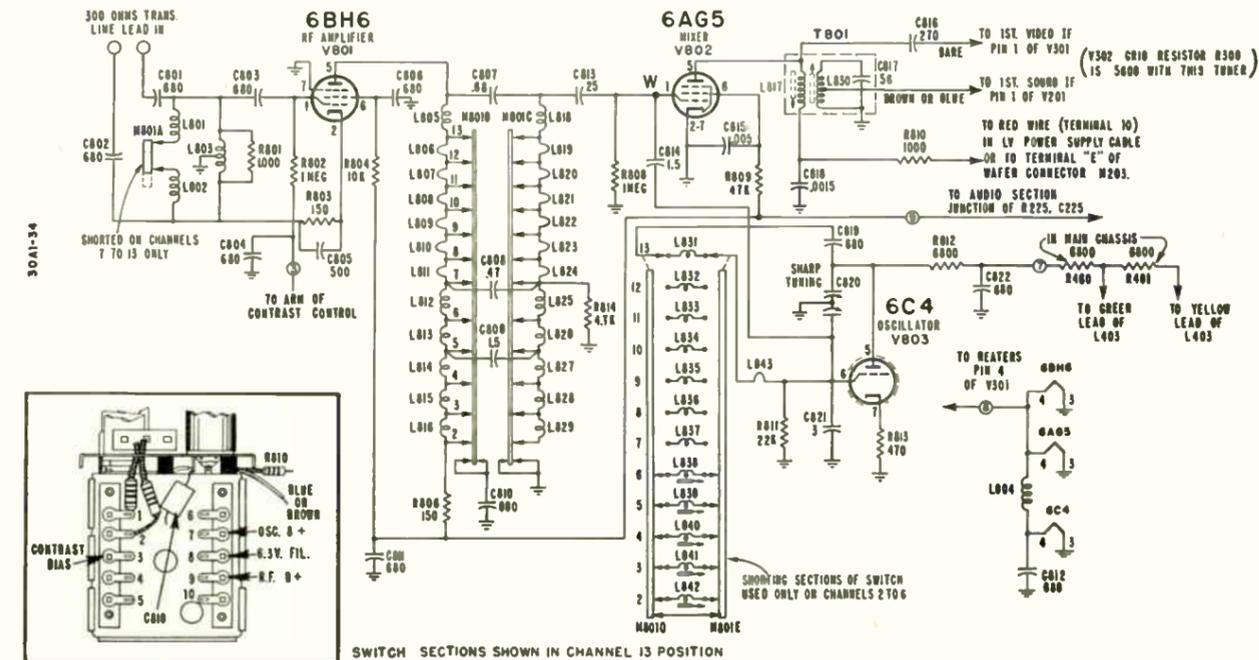
Schematic, TV Tuner 94C9-2.

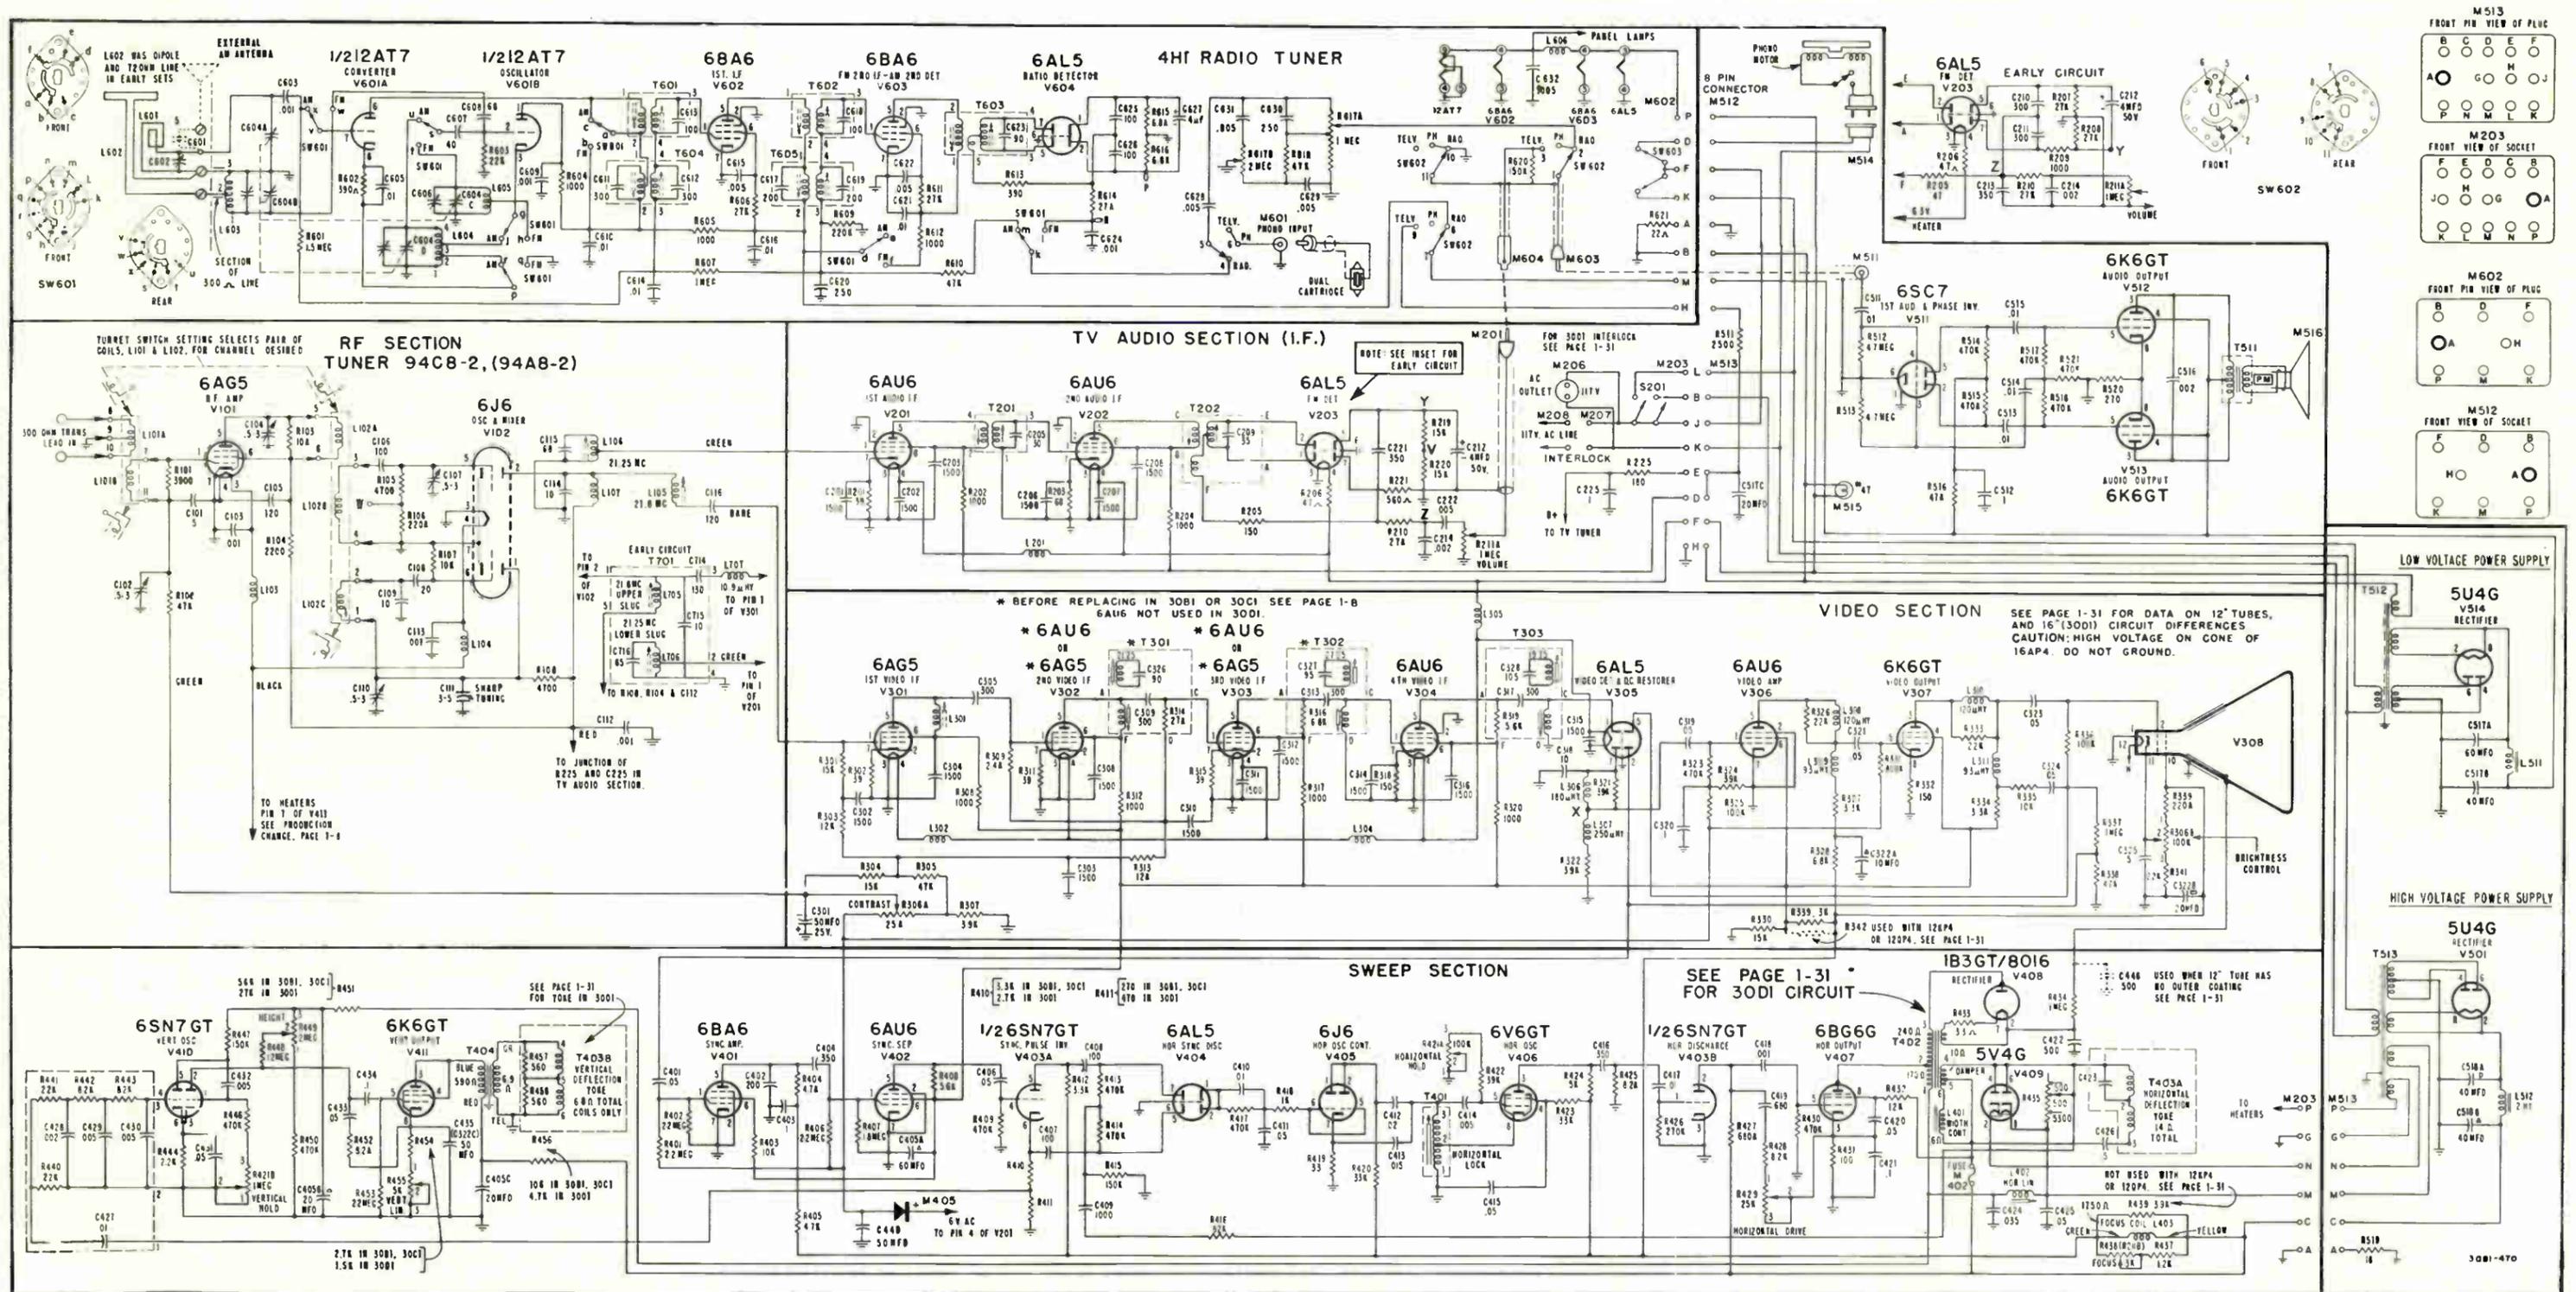
Figure 1-21. Schematic Diagram for 4H1 Radio Tuner Chassis, and 30B1, 30C1, or 30D1 Television Chassis. (For all "4H" Radio-Phono-Television combinations with 10", 12" and 16" picture tubes.)

Circuit differences for 30D1 chassis (16" picture tube) are shown
Circuit changes necessary for different 12" picture tubes

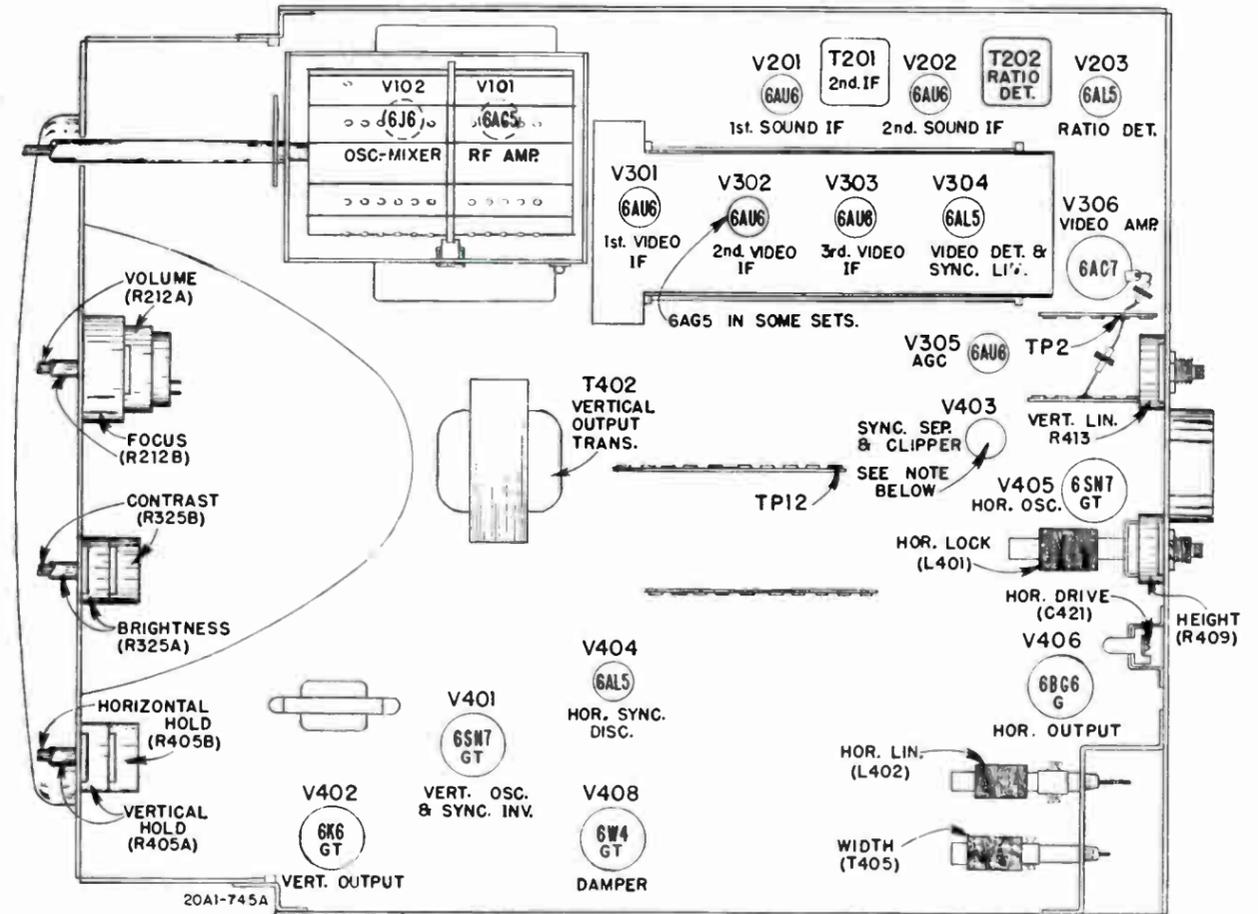
NOTE: V403 is 6AU6 in early sets, 12AU7 in later sets. See figures 85 and 87.
Figure 81. Television Chassis, Bottom View Showing Tube Locations.

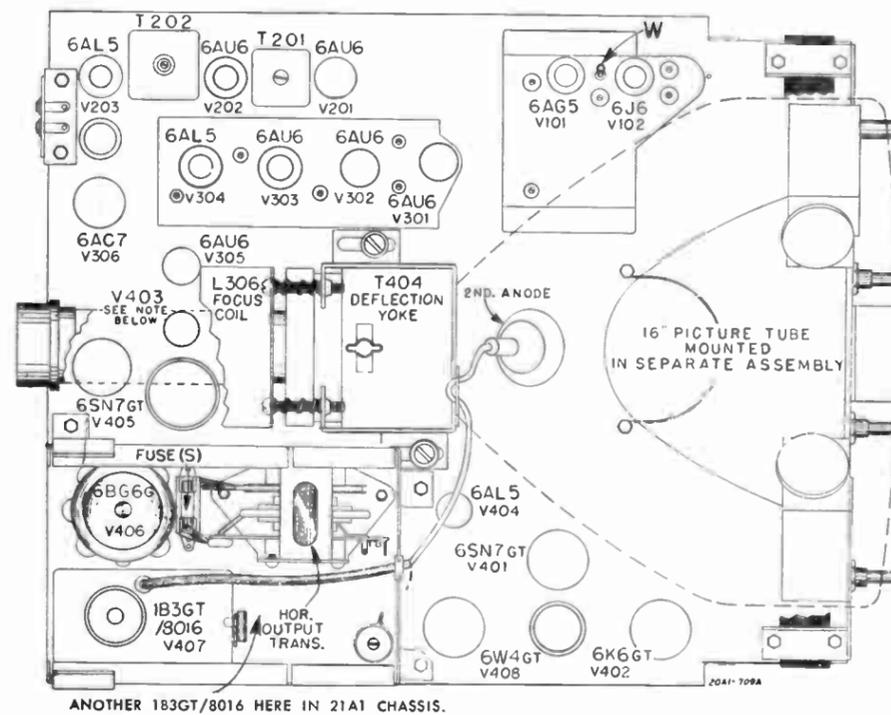
NOTE: V403 is 6AU6 in early sets, 12AU7 in later sets. See figures 85 and 87.
Figure 82. Television Chassis, Top View Showing Tube Locations.

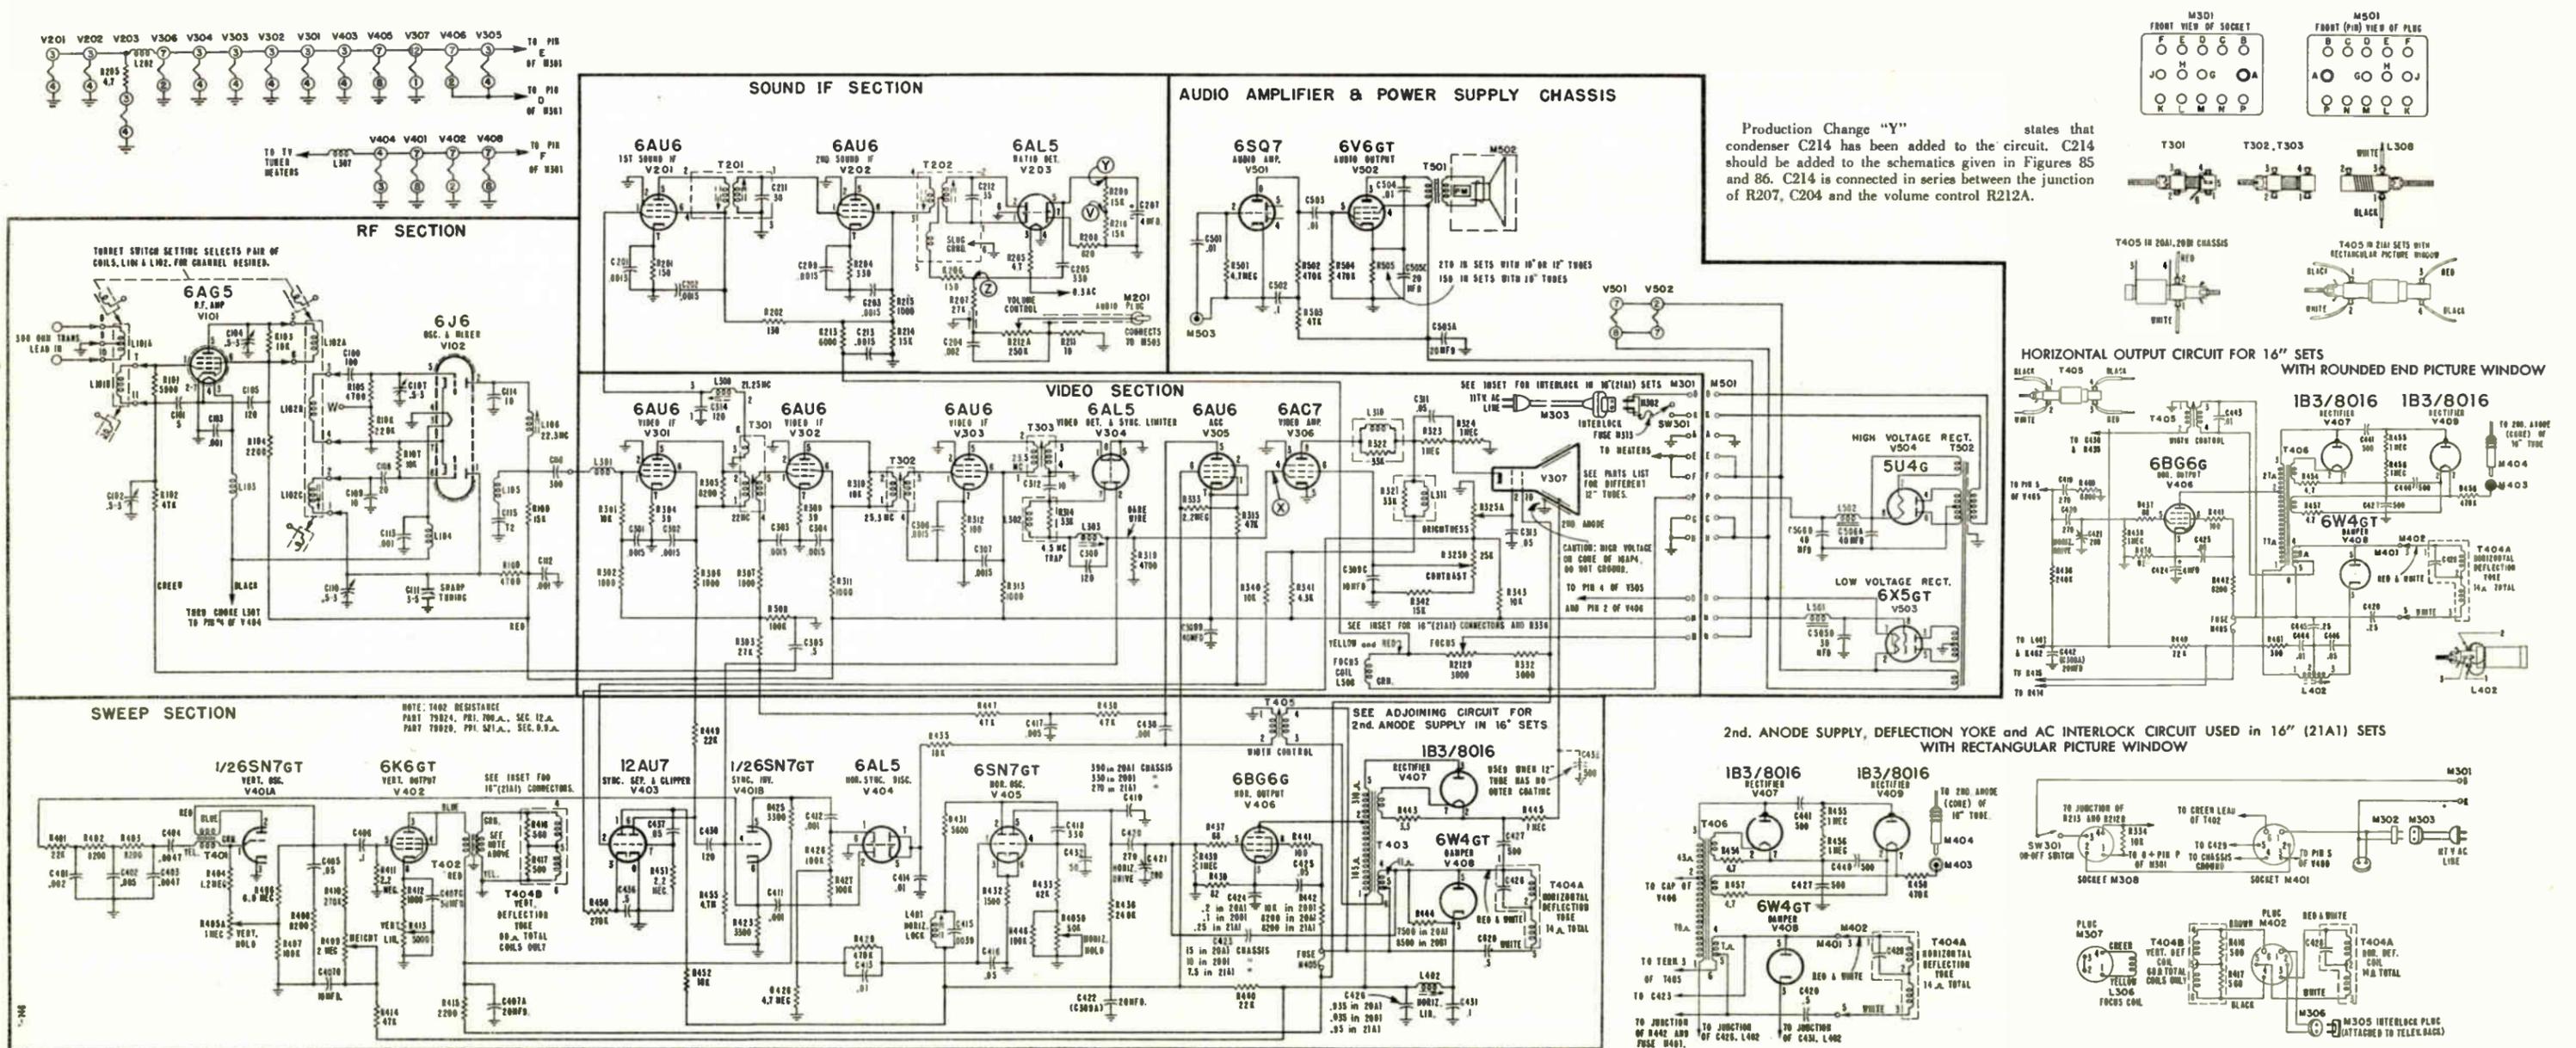
(a) Indicates voltage for sets with 6AU6 sync separator circuit.
 (b) Indicates voltage for sets with 12AU7 sync separator and clipper circuit.
 (c) Indicates voltages for 21A1 chassis.
 NC Indicates no connection to tube element.

Figure 85. Schematic for 20A1, 20B1, 21A1 Television Chassis with 12AU7 Sync Separator and Clipper. (For sets with 6AU6 Sync Separator, refer to Figure 87 or 88.) Chassis having 12AU7 Sync Separator and Clipper are rubber-stamped with run number "16" or higher at rear of television chassis.

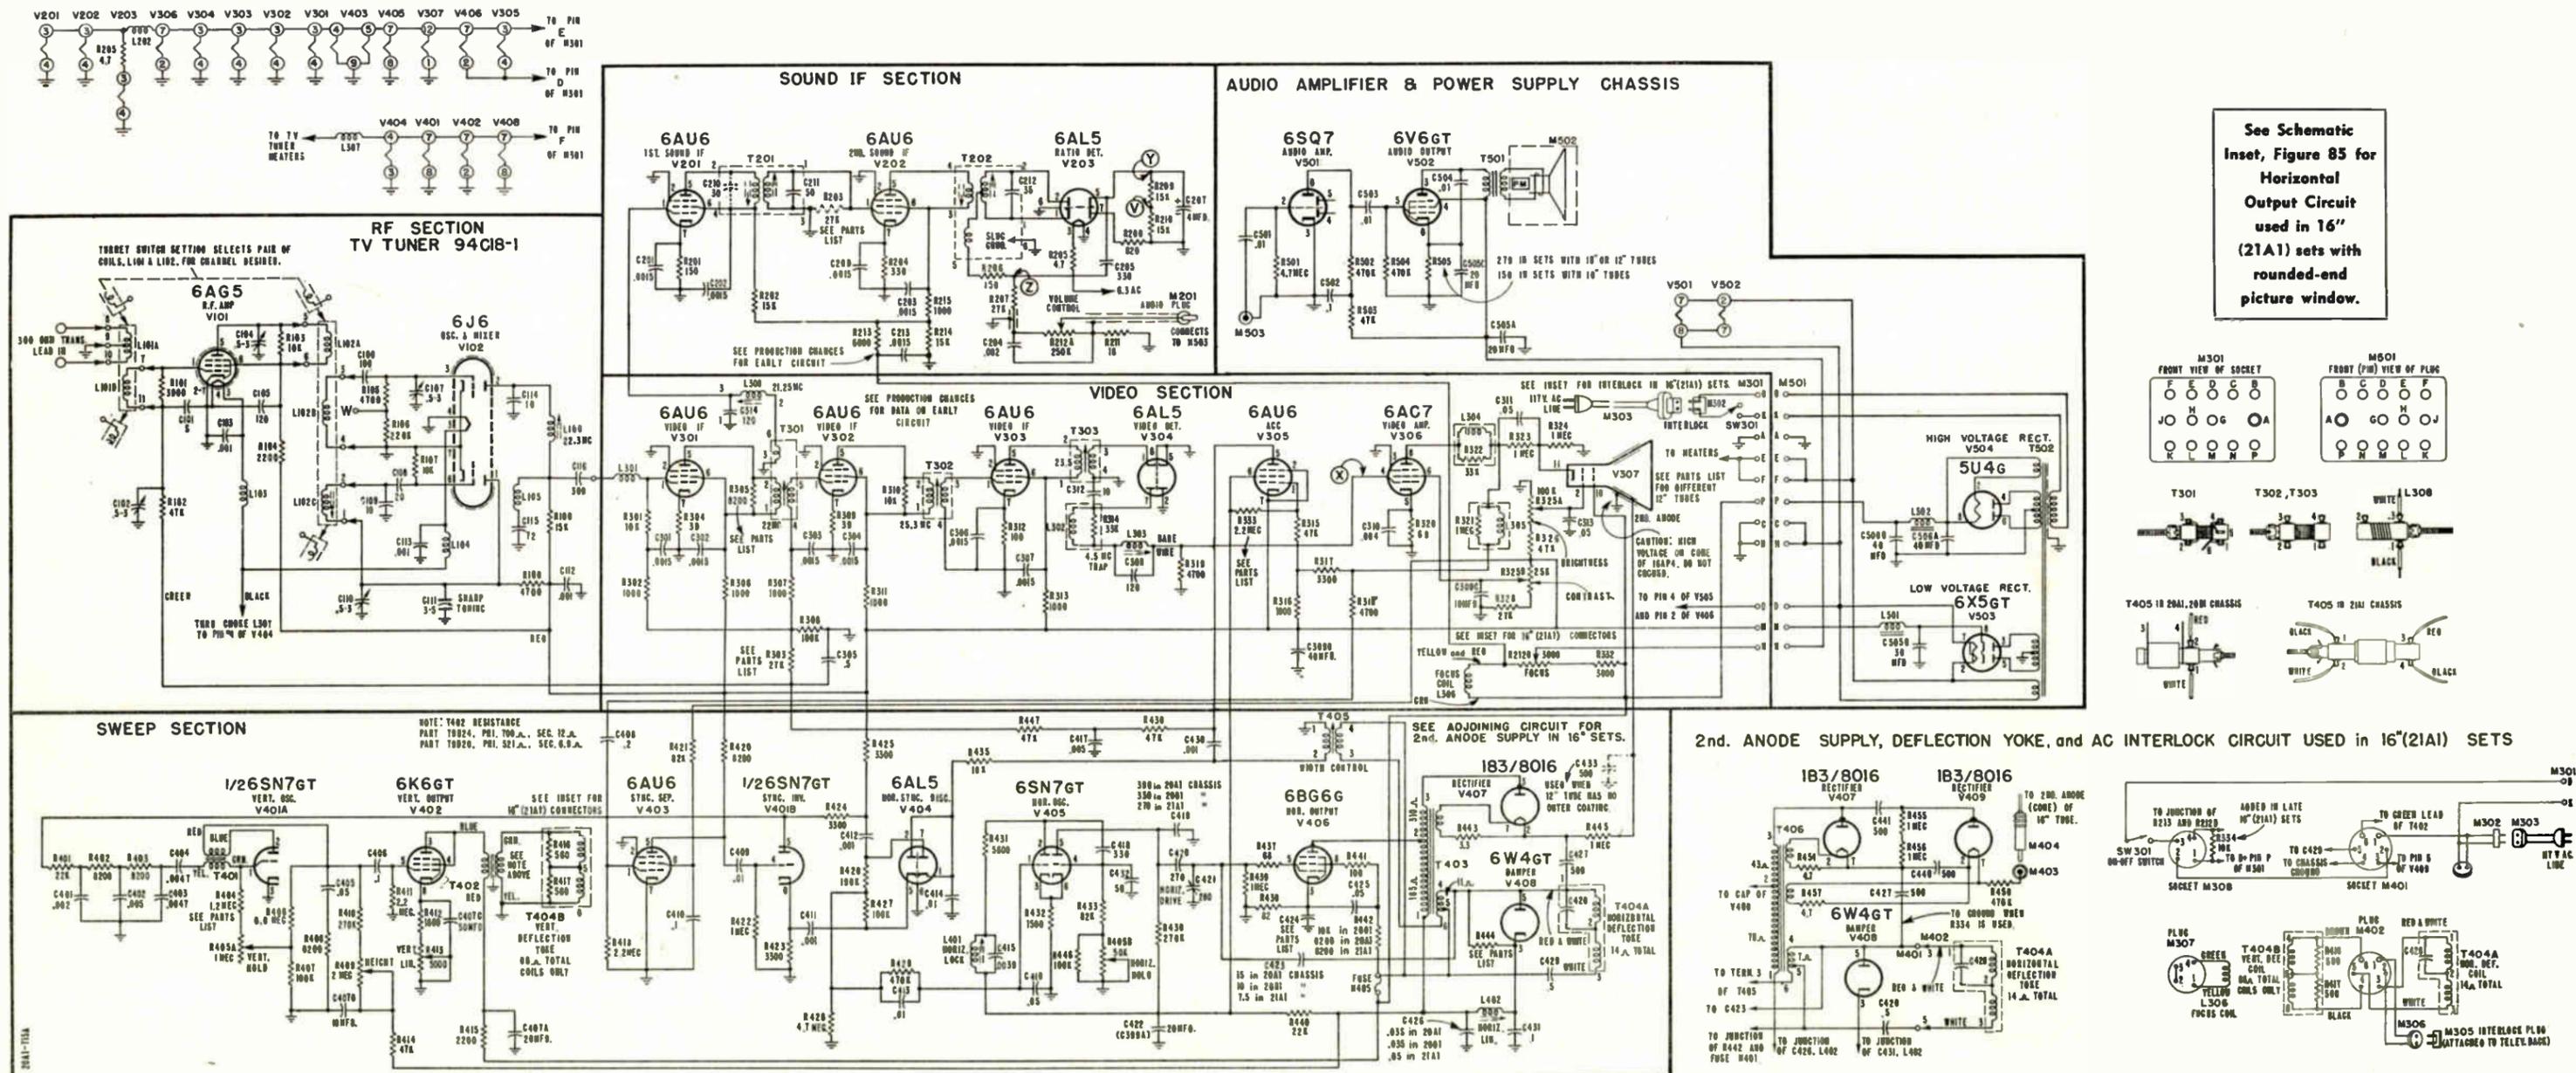
(a) Indicates voltage for sets with 6AU6 sync separator circuit.
 (b) Indicates voltage for sets with 12AU7 sync separator and clipper circuit.
 (c) Indicates voltages for 21A1 chassis.
 NC Indicates no connection to tube element.

Figure 87. Schematic for 20A1, 20B1, 21A1 Television Chassis with 6AU6 Sync Separator. (For sets with 12AU7 Sync Separator, refer to Figure 85.)
 Chassis having 6AU6 Sync Separator are rubber-stamped with run number "15" or lower at rear of television chassis.
