Admiral TV

SCHEMATIC DIAGRAMS

1947-1953

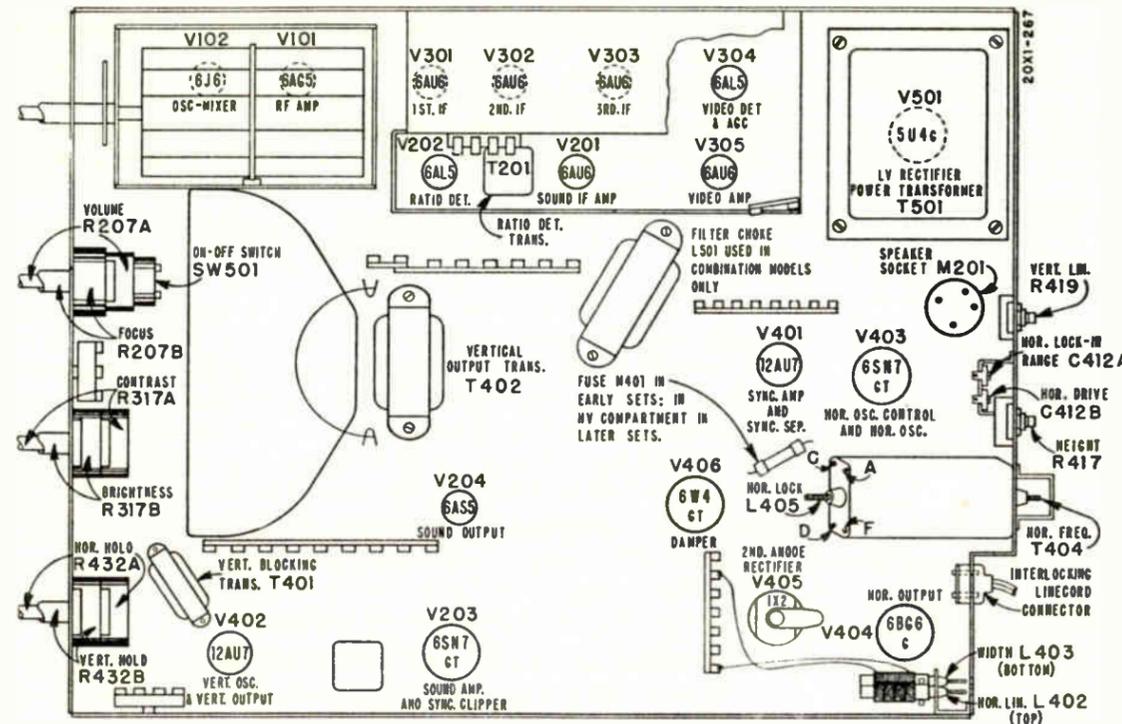
Figure 75. Bottom View of Television Chassis Showing Tube Locations.

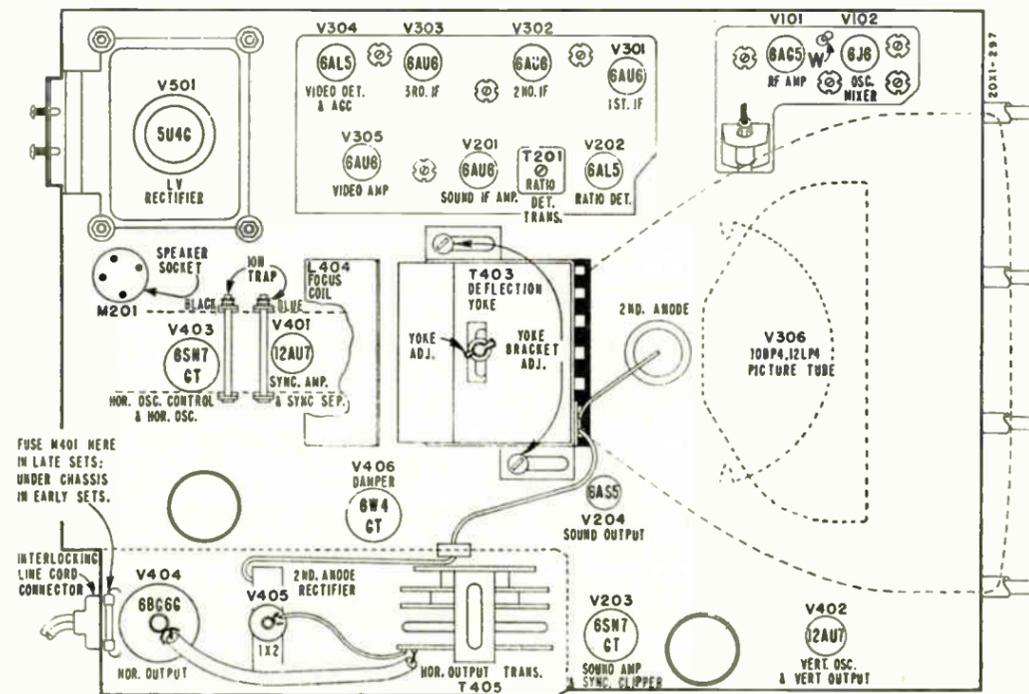
Figure 76. Top View of Television Chassis Showing Tube Locations.

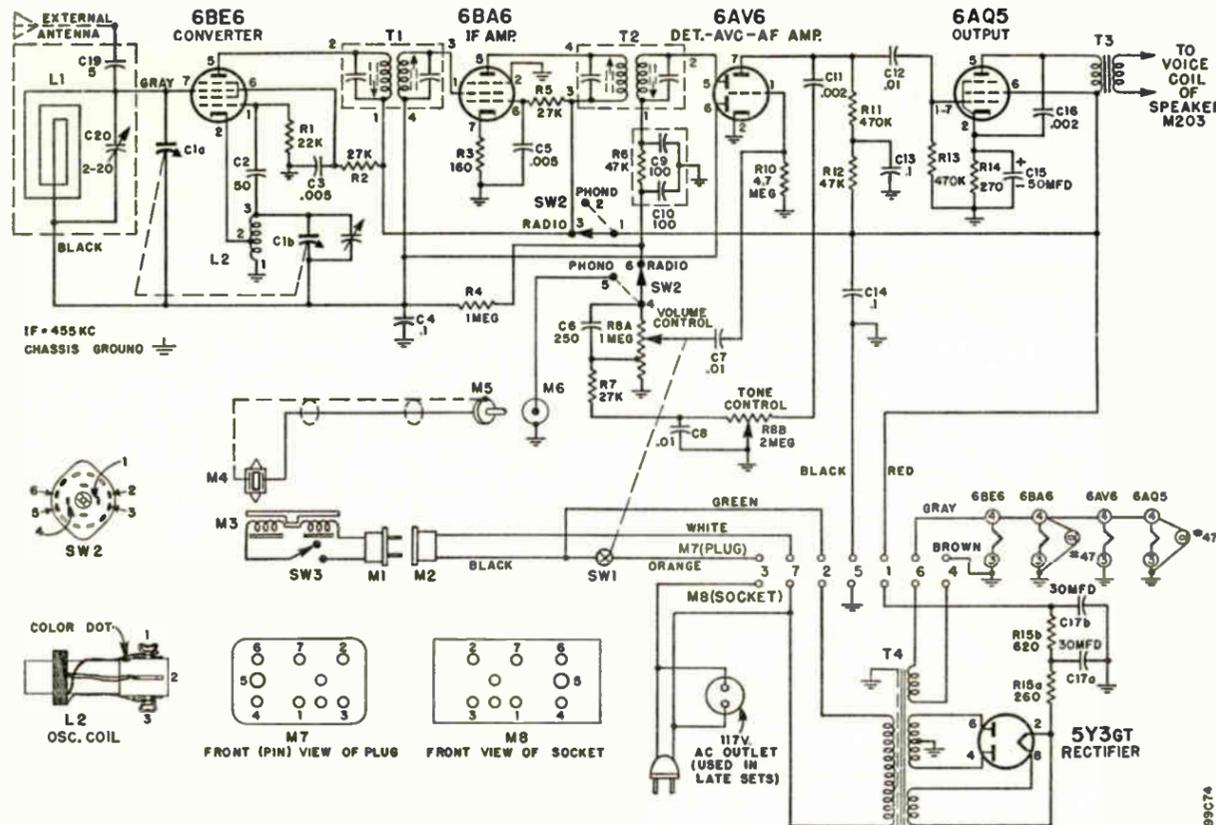
Figure 37. Schematic of 4L1 Radio.

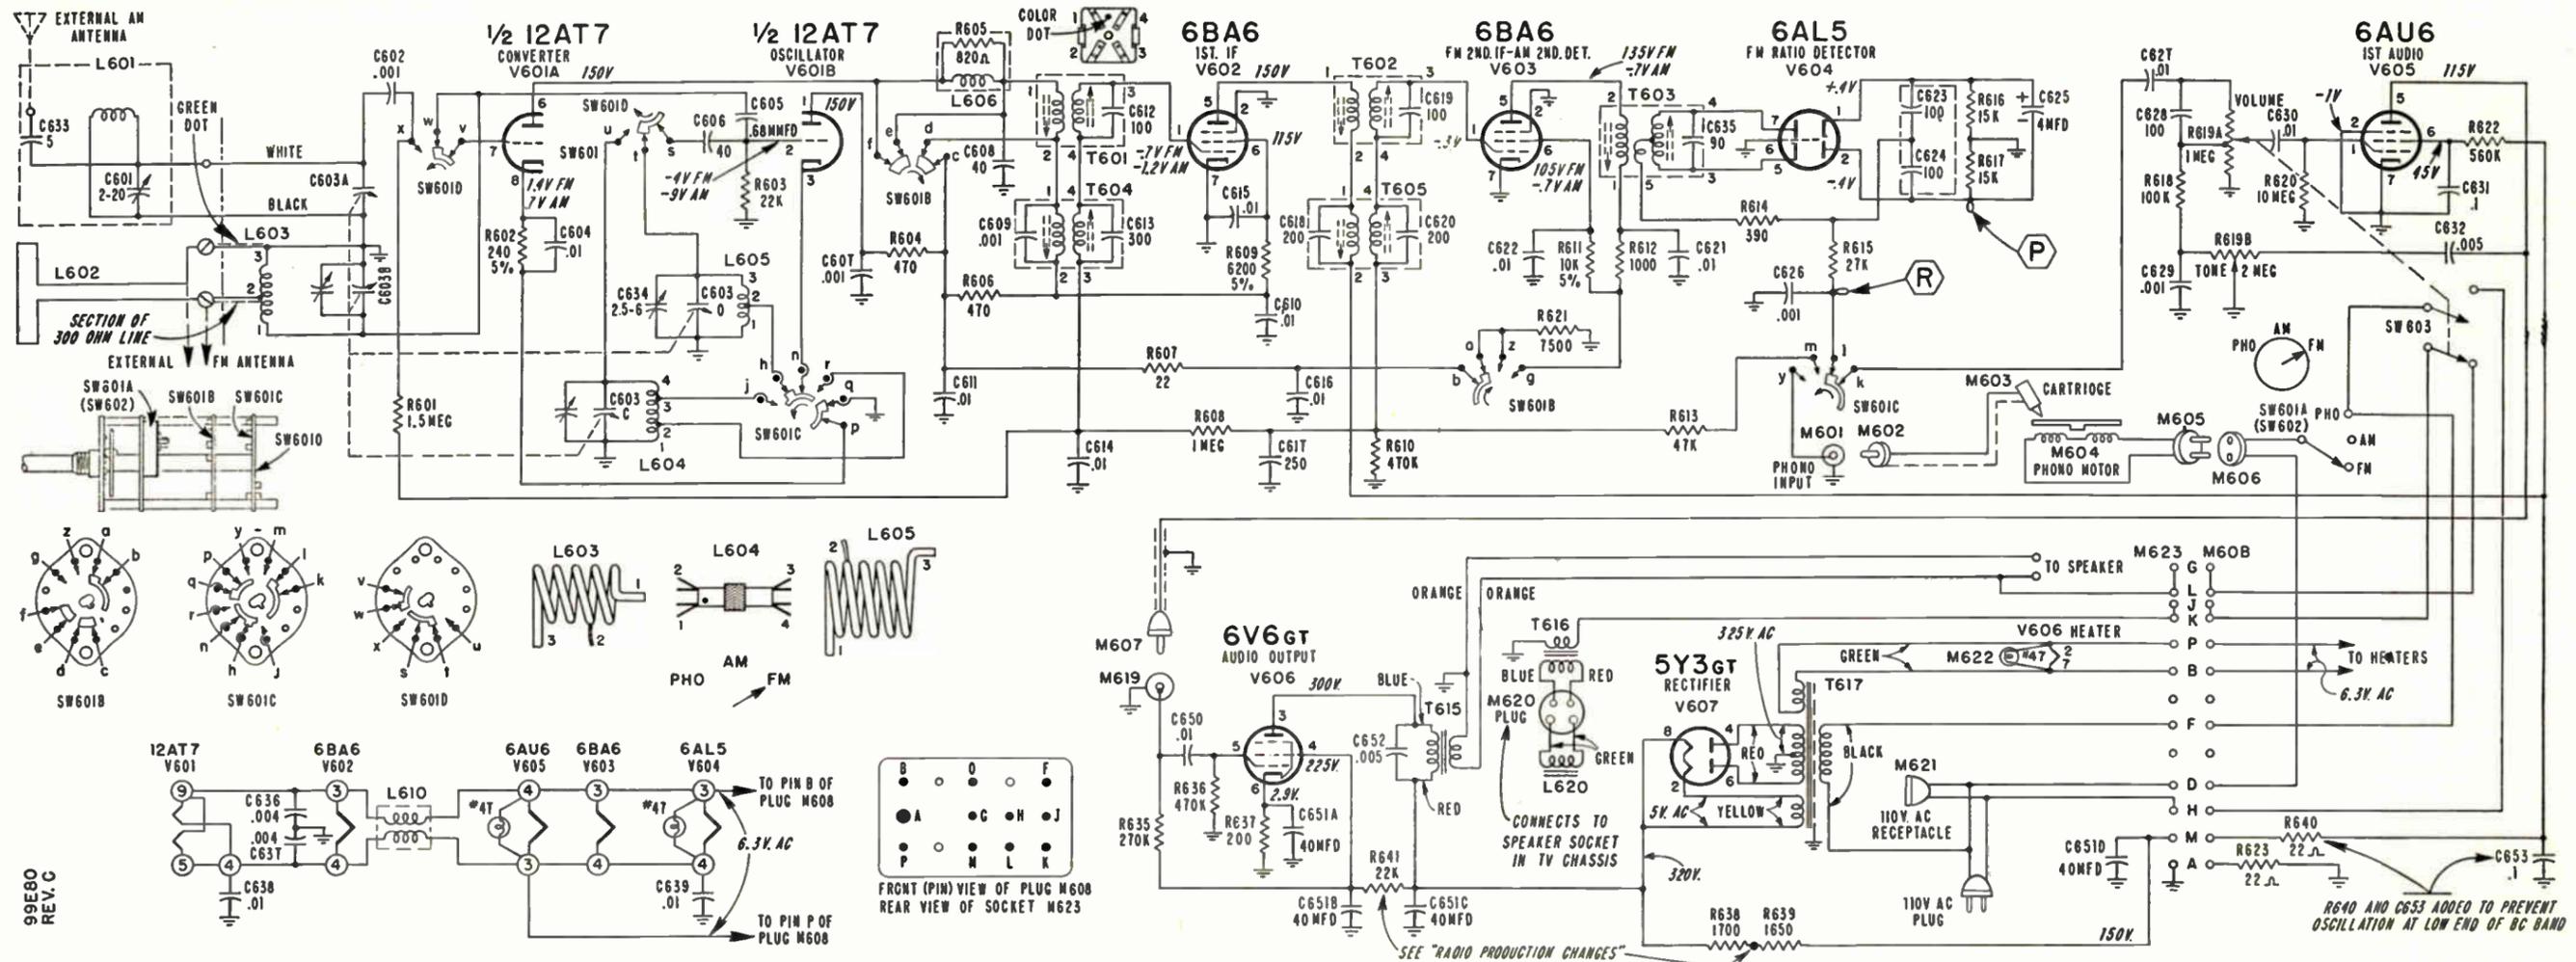
Figure 84. Schematic For 5B2 Radio and 2PA1 Power Supply Chassis.

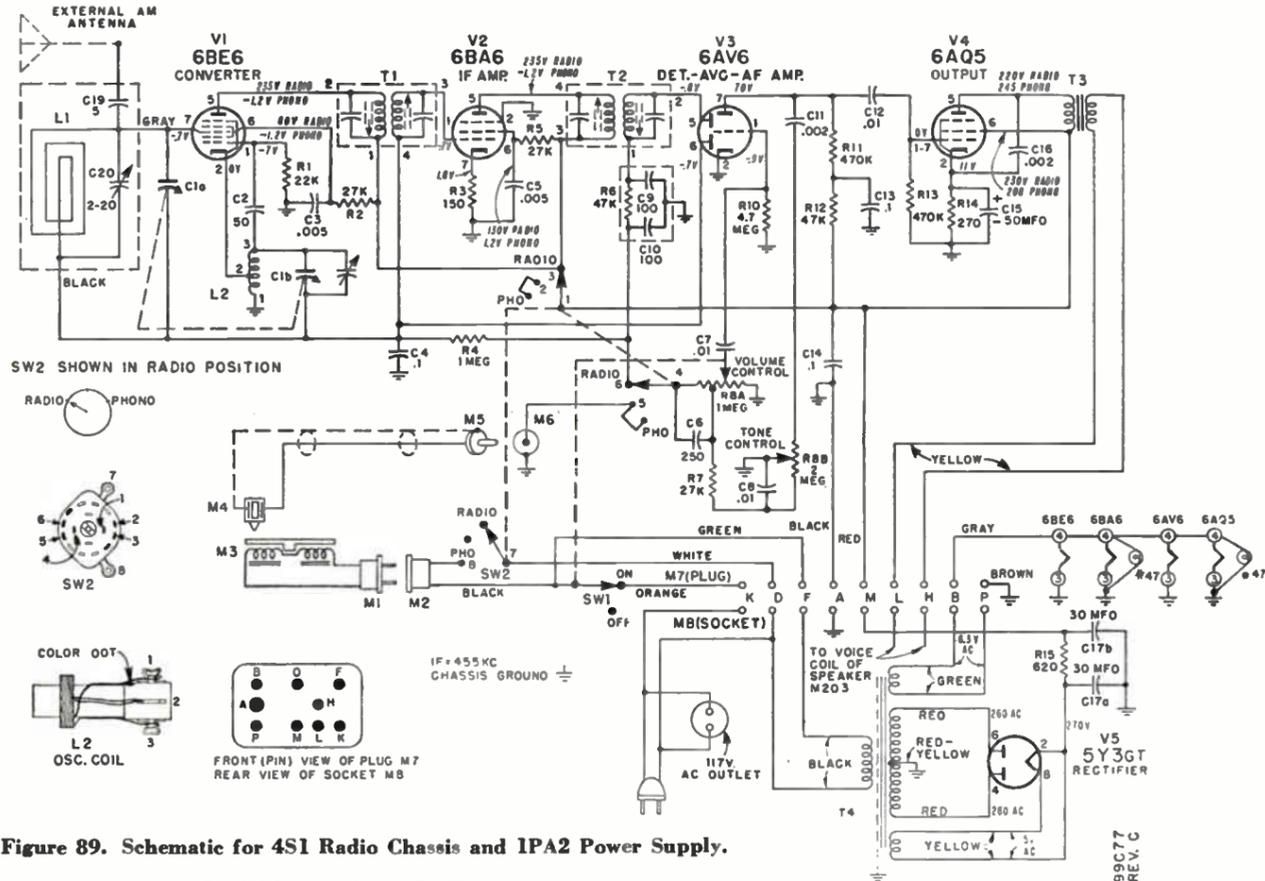
Figure 89. Schematic for 4S1 Radio Chassis and IPA2 Power Supply.

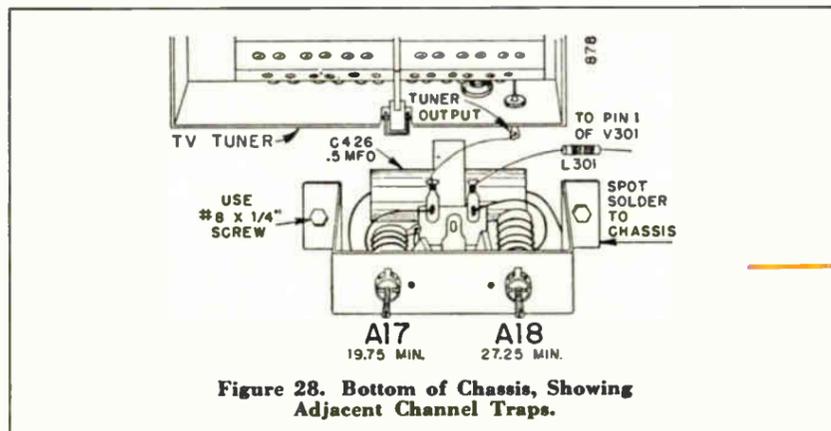
Figure 28. Bottom of Chassis, Showing Adjacent Channel Traps.

The traps will cause the 25.75 MC marker to move slightly. This will not make any noticeable difference in the picture, but slight adjustment (not more than one turn in either direction) of slug A7 (25.3 MC coil) will bring it to its proper location.

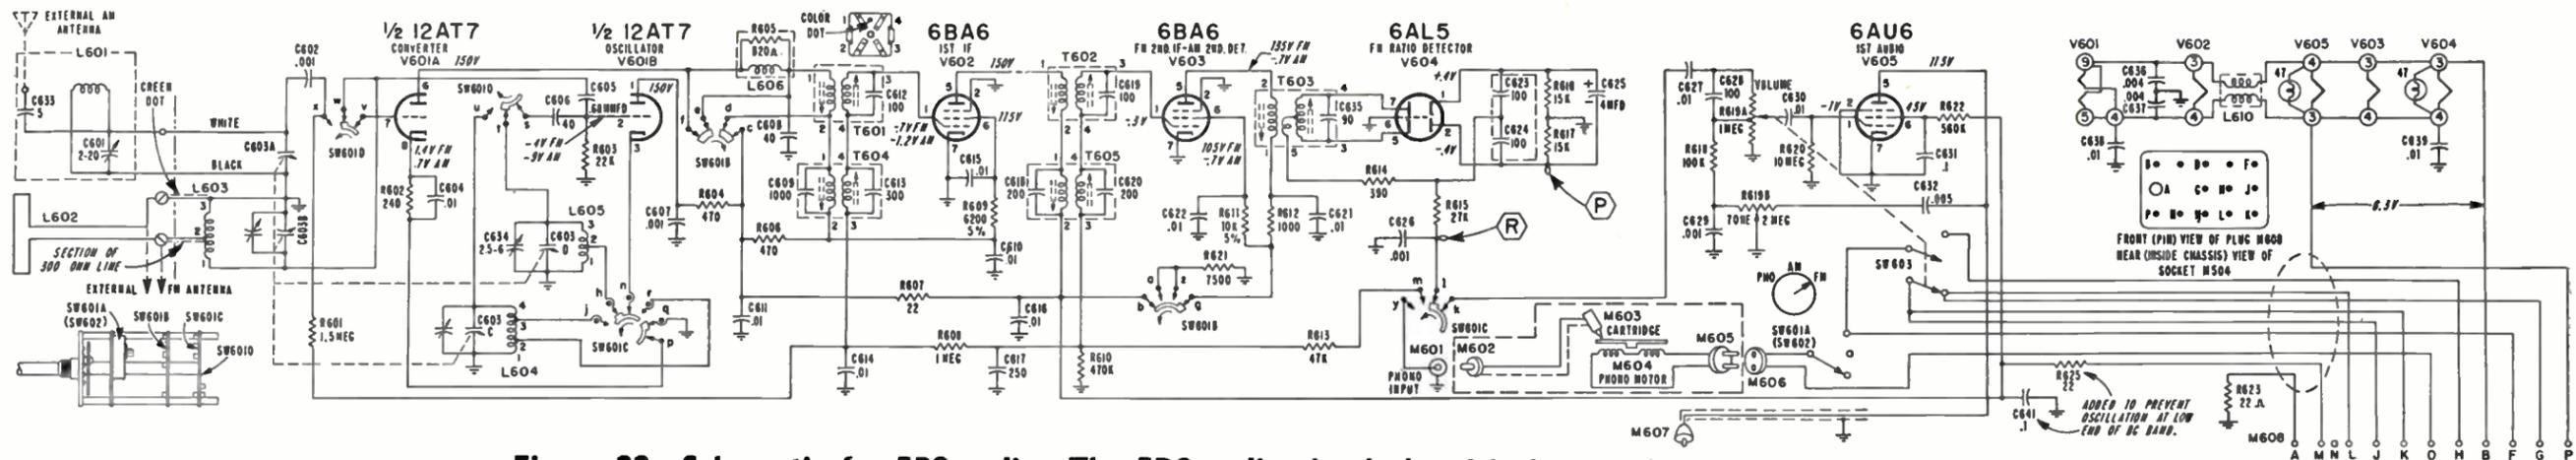
Figure 33. Schematic for 5B2 radio. The 5D2 radio circuit (used in late sets)

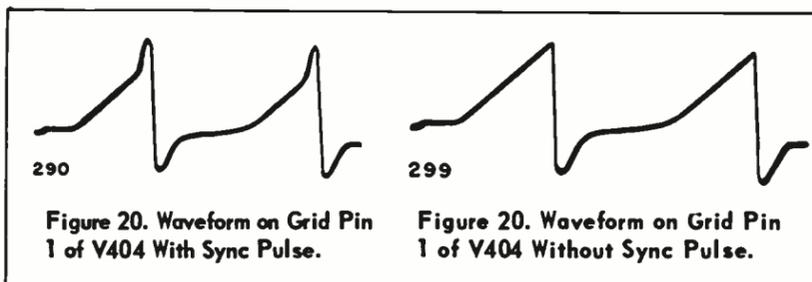
Figure 20. Waveform on Grid Pin 1 of V404 With Sync Pulse.

- a. Check tube V404 (6SN7GT) by substitution.
- b. Check C418 by substituting identical condenser (180 mmfd, 5% - .0003 temperature coefficient) part number 65B6-59.
- c. Check C415 for either open or short.
- d. Check condenser C417 for short.
- e. Check resistance of R427. It should be 100,000 ohms.
- f. Lead dress is critical in the horizontal oscillator circuit. Check to see that lead dress has not been disturbed while servicing.

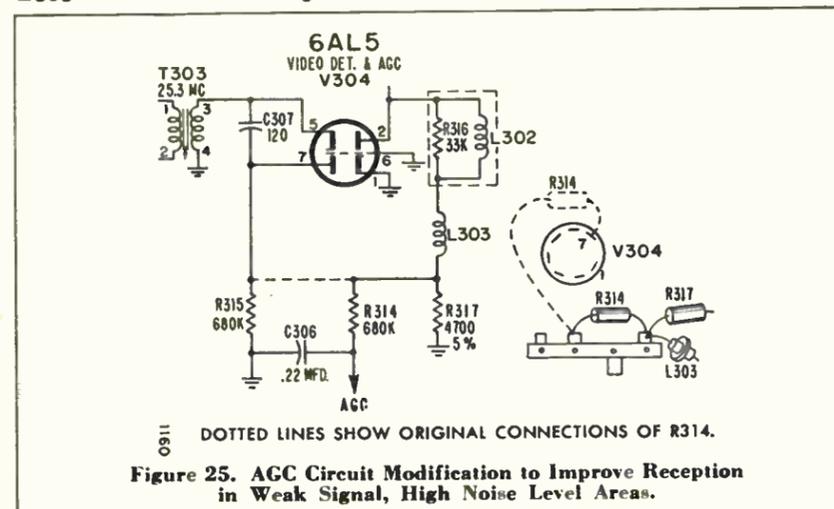
Figure 25. AGC Circuit Modification to Improve Reception in Weak Signal, High Noise Level Areas.

To make this change, disconnect the end of resistor R314 (680,000) from pin 7 of V304 and connect it to the terminal strip (junction of R317 and L303 as shown in the figure below.

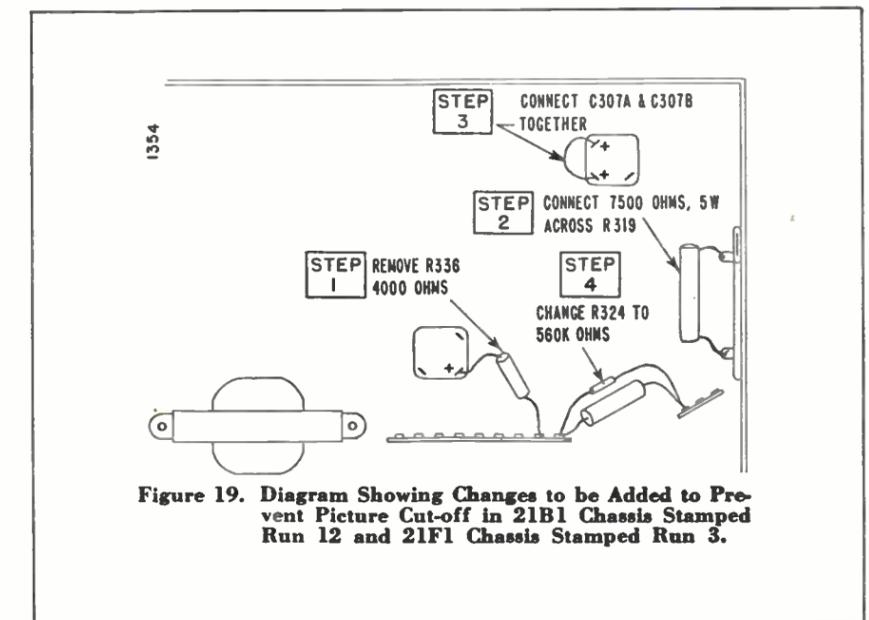
Figure 19. Diagram Showing Changes to be Added to Prevent Picture Cut-off in 21B1 Chassis Stamped Run 12 and 21F1 Chassis Stamped Run 3.

1. Remove resistor R336 (4,000 ohms).
2. Connect a 7,500 ohm, 5 watt resistor R338 (part number 61A1-18) across R319.
3. Connect together the positive terminals of filter condensers C307A and C307B.
4. Change resistor R324 from 180,000 ohms to 560,000 ohms, $\frac{1}{2}$ watt (part number 60B8-564).
5. Erase the old run number from the chassis and mark in the next higher run number.

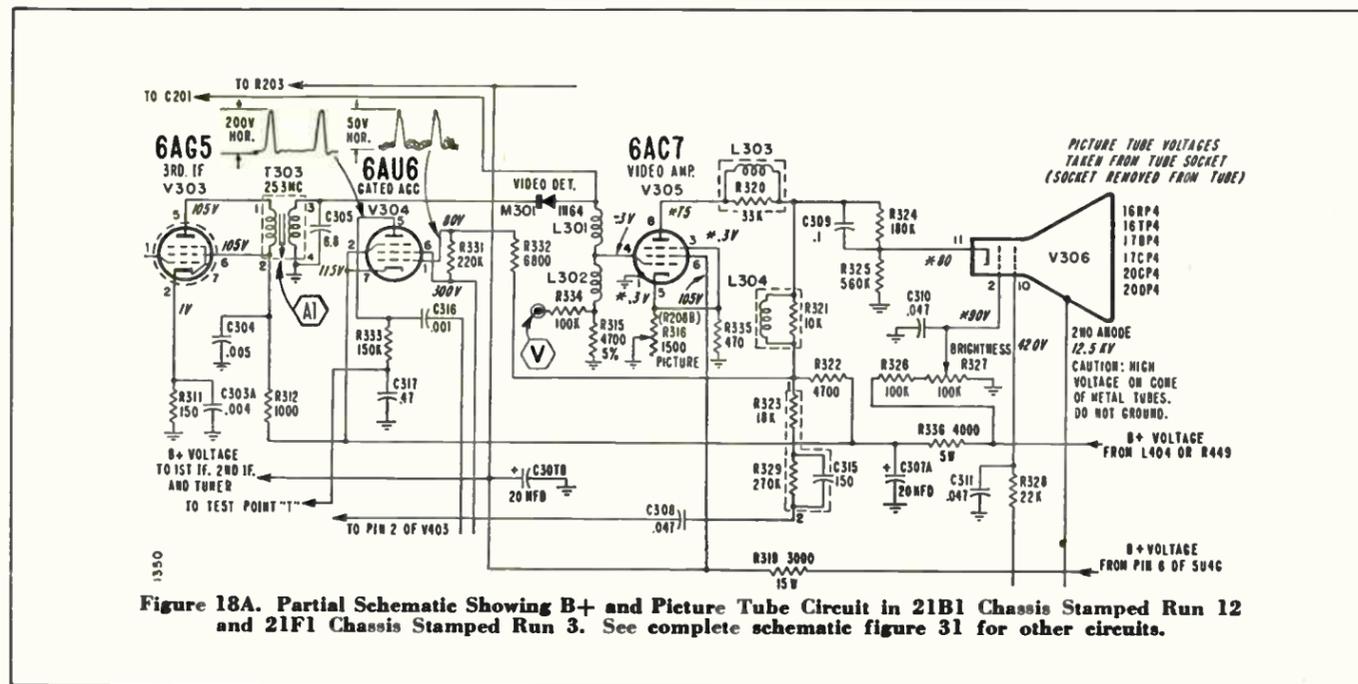
Figure 18A. Partial Schematic Showing B+ and Picture Tube Circuit in 21B1 Chassis Stamped Run 12 and 21F1 Chassis Stamped Run 3. See complete schematic figure 31 for other circuits.

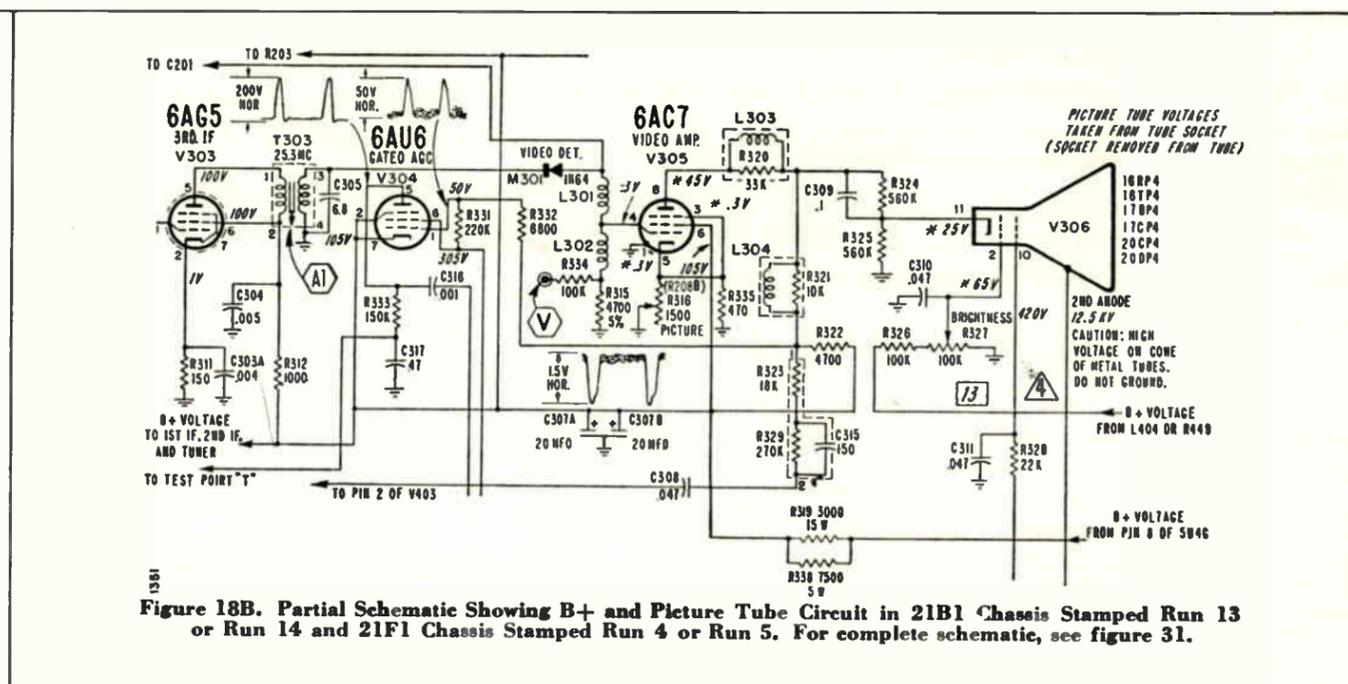
Figure 18B. Partial Schematic Showing B+ and Picture Tube Circuit in 21B1 Chassis Stamped Run 13 or Run 14 and 21F1 Chassis Stamped Run 4 or Run 5. For complete schematic, see figure 31.

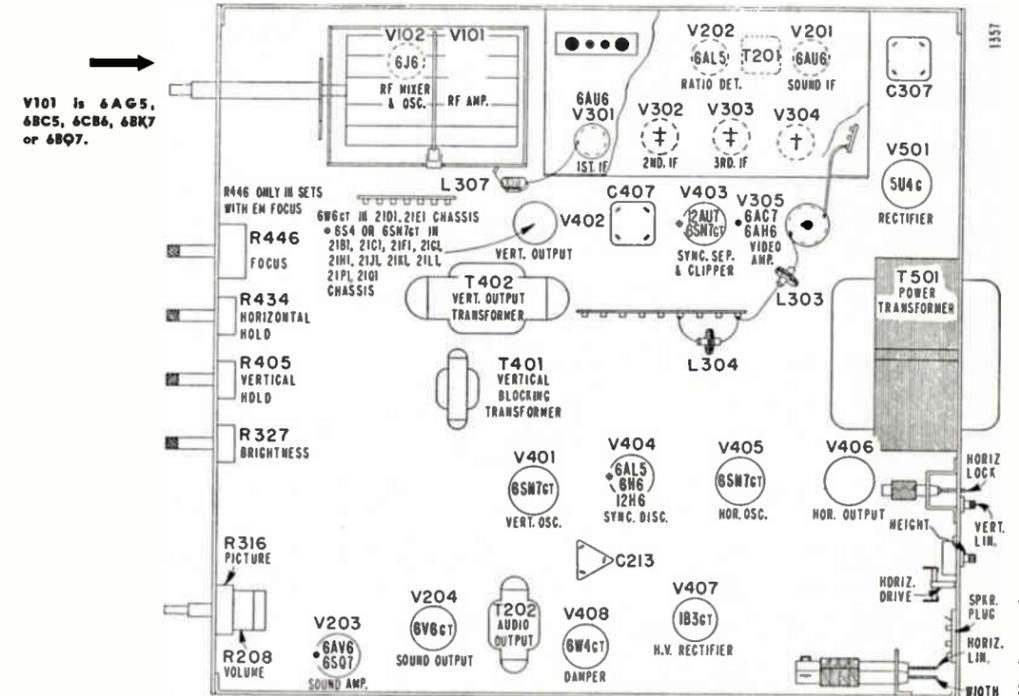
Figure 24. Bottom View of Chassis.

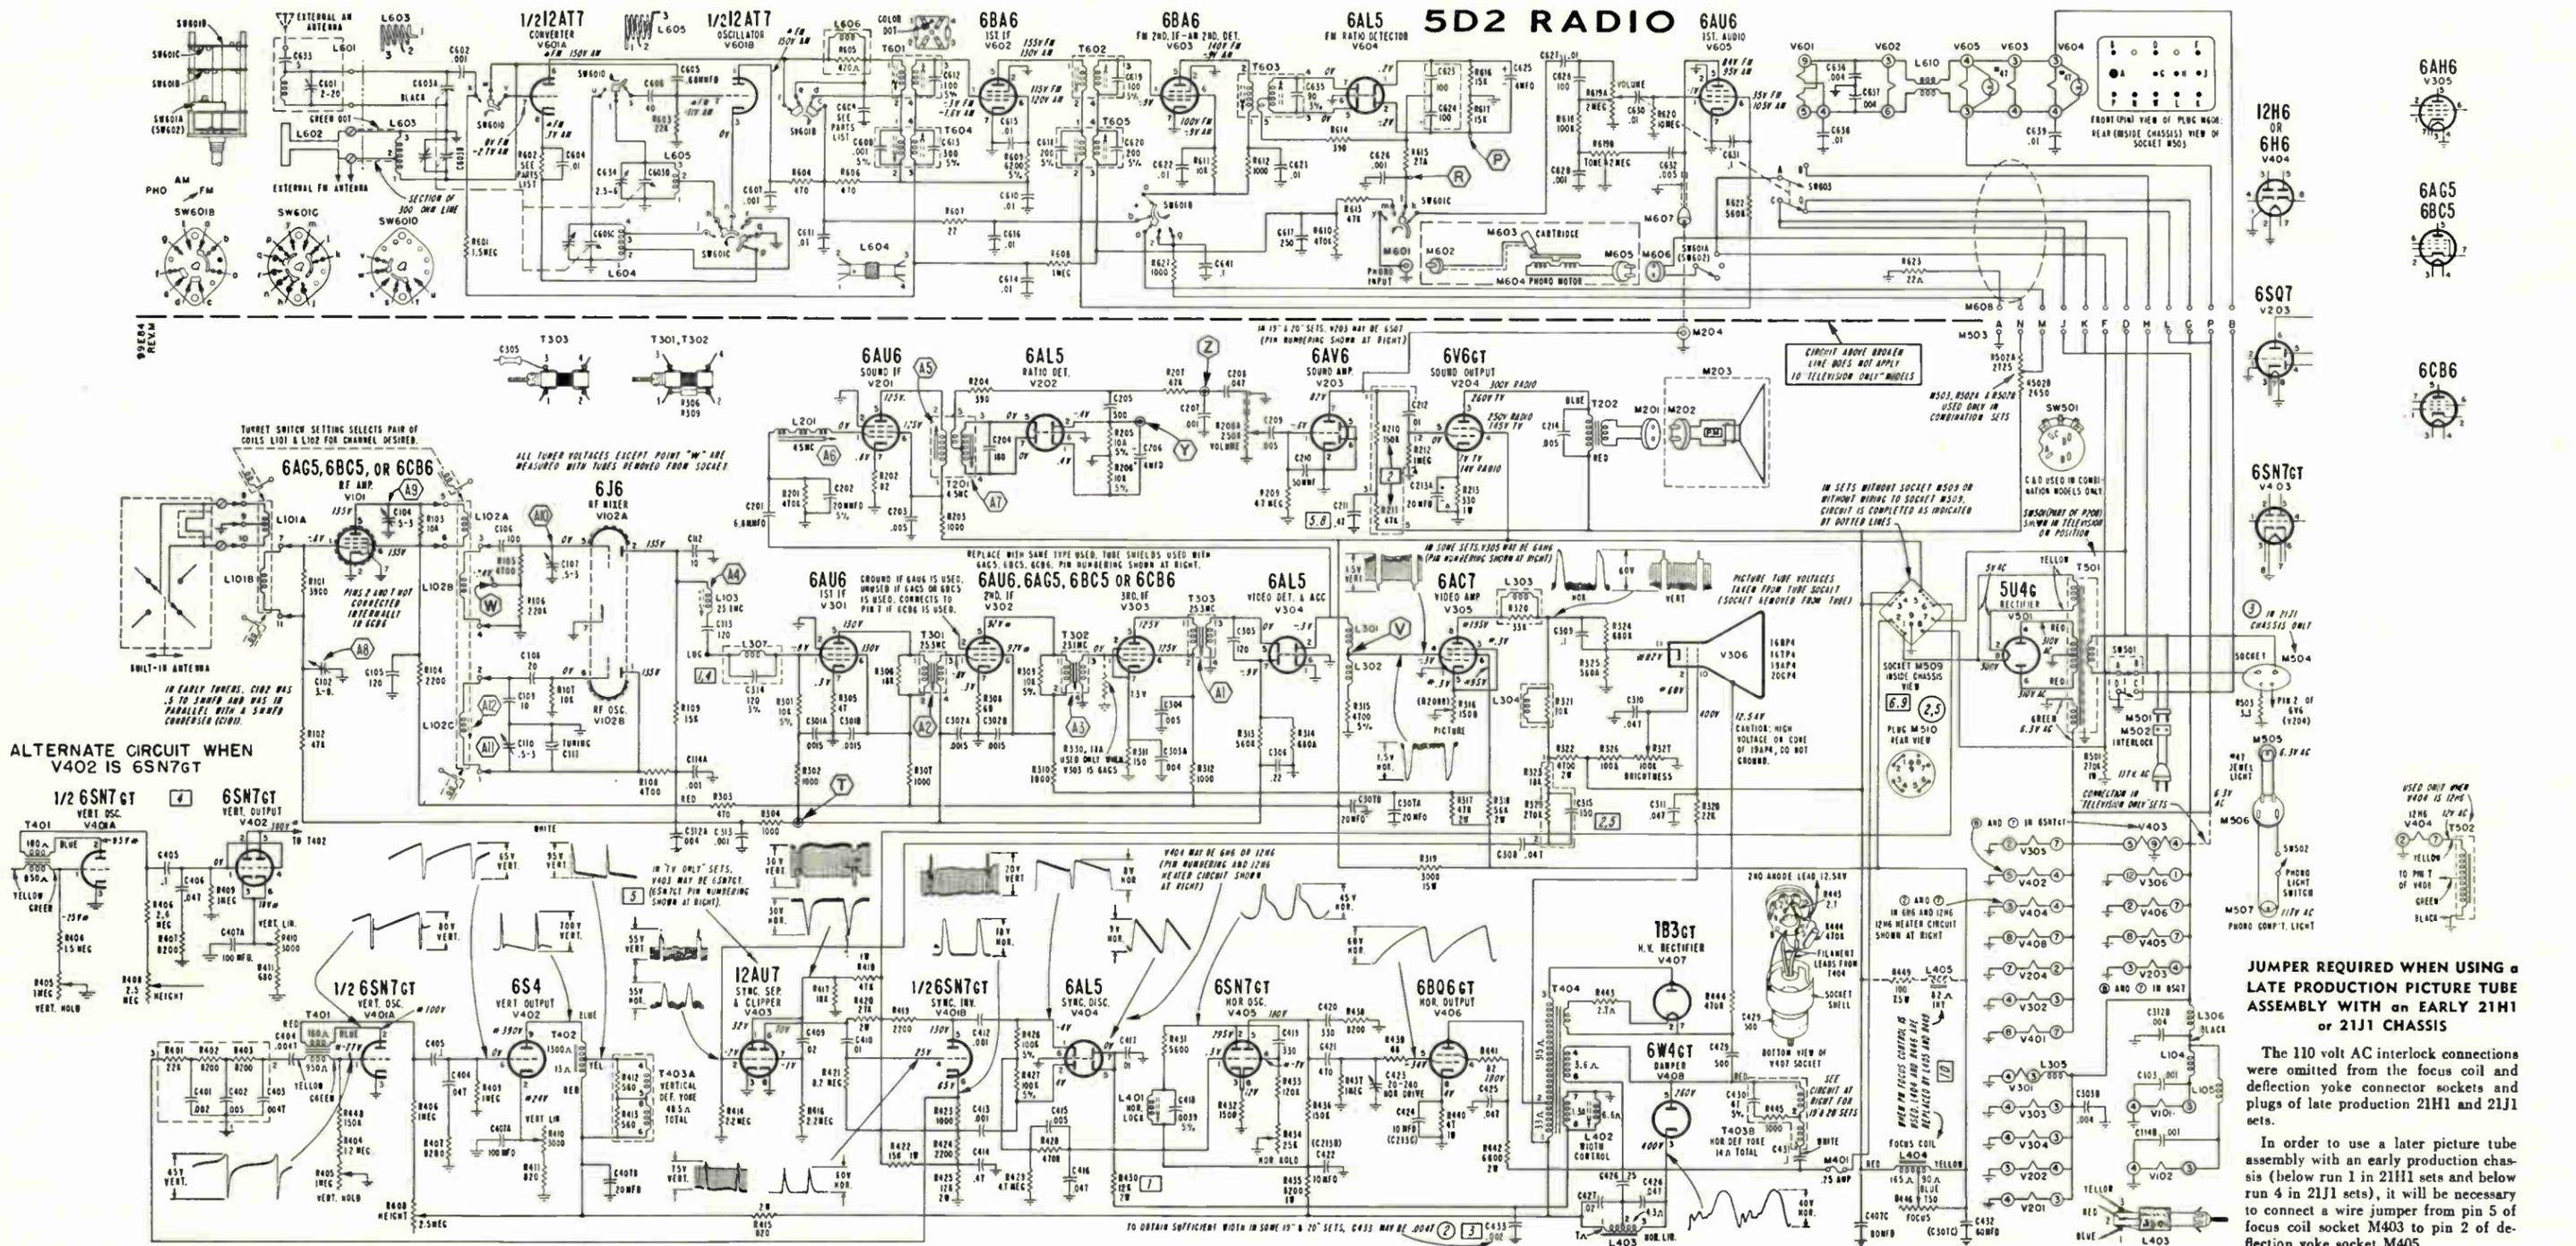
Figure 26. Schematic for 21B1 Chassis (run 10 or earlier), 21C1, 21H1, 21J1 Chassis; 5D2 (AM-FM radio) circuit also shown. See figure 30 for 3C1 (AM radio chassis). For 21B1 chassis with gated AGC, see figure 31.

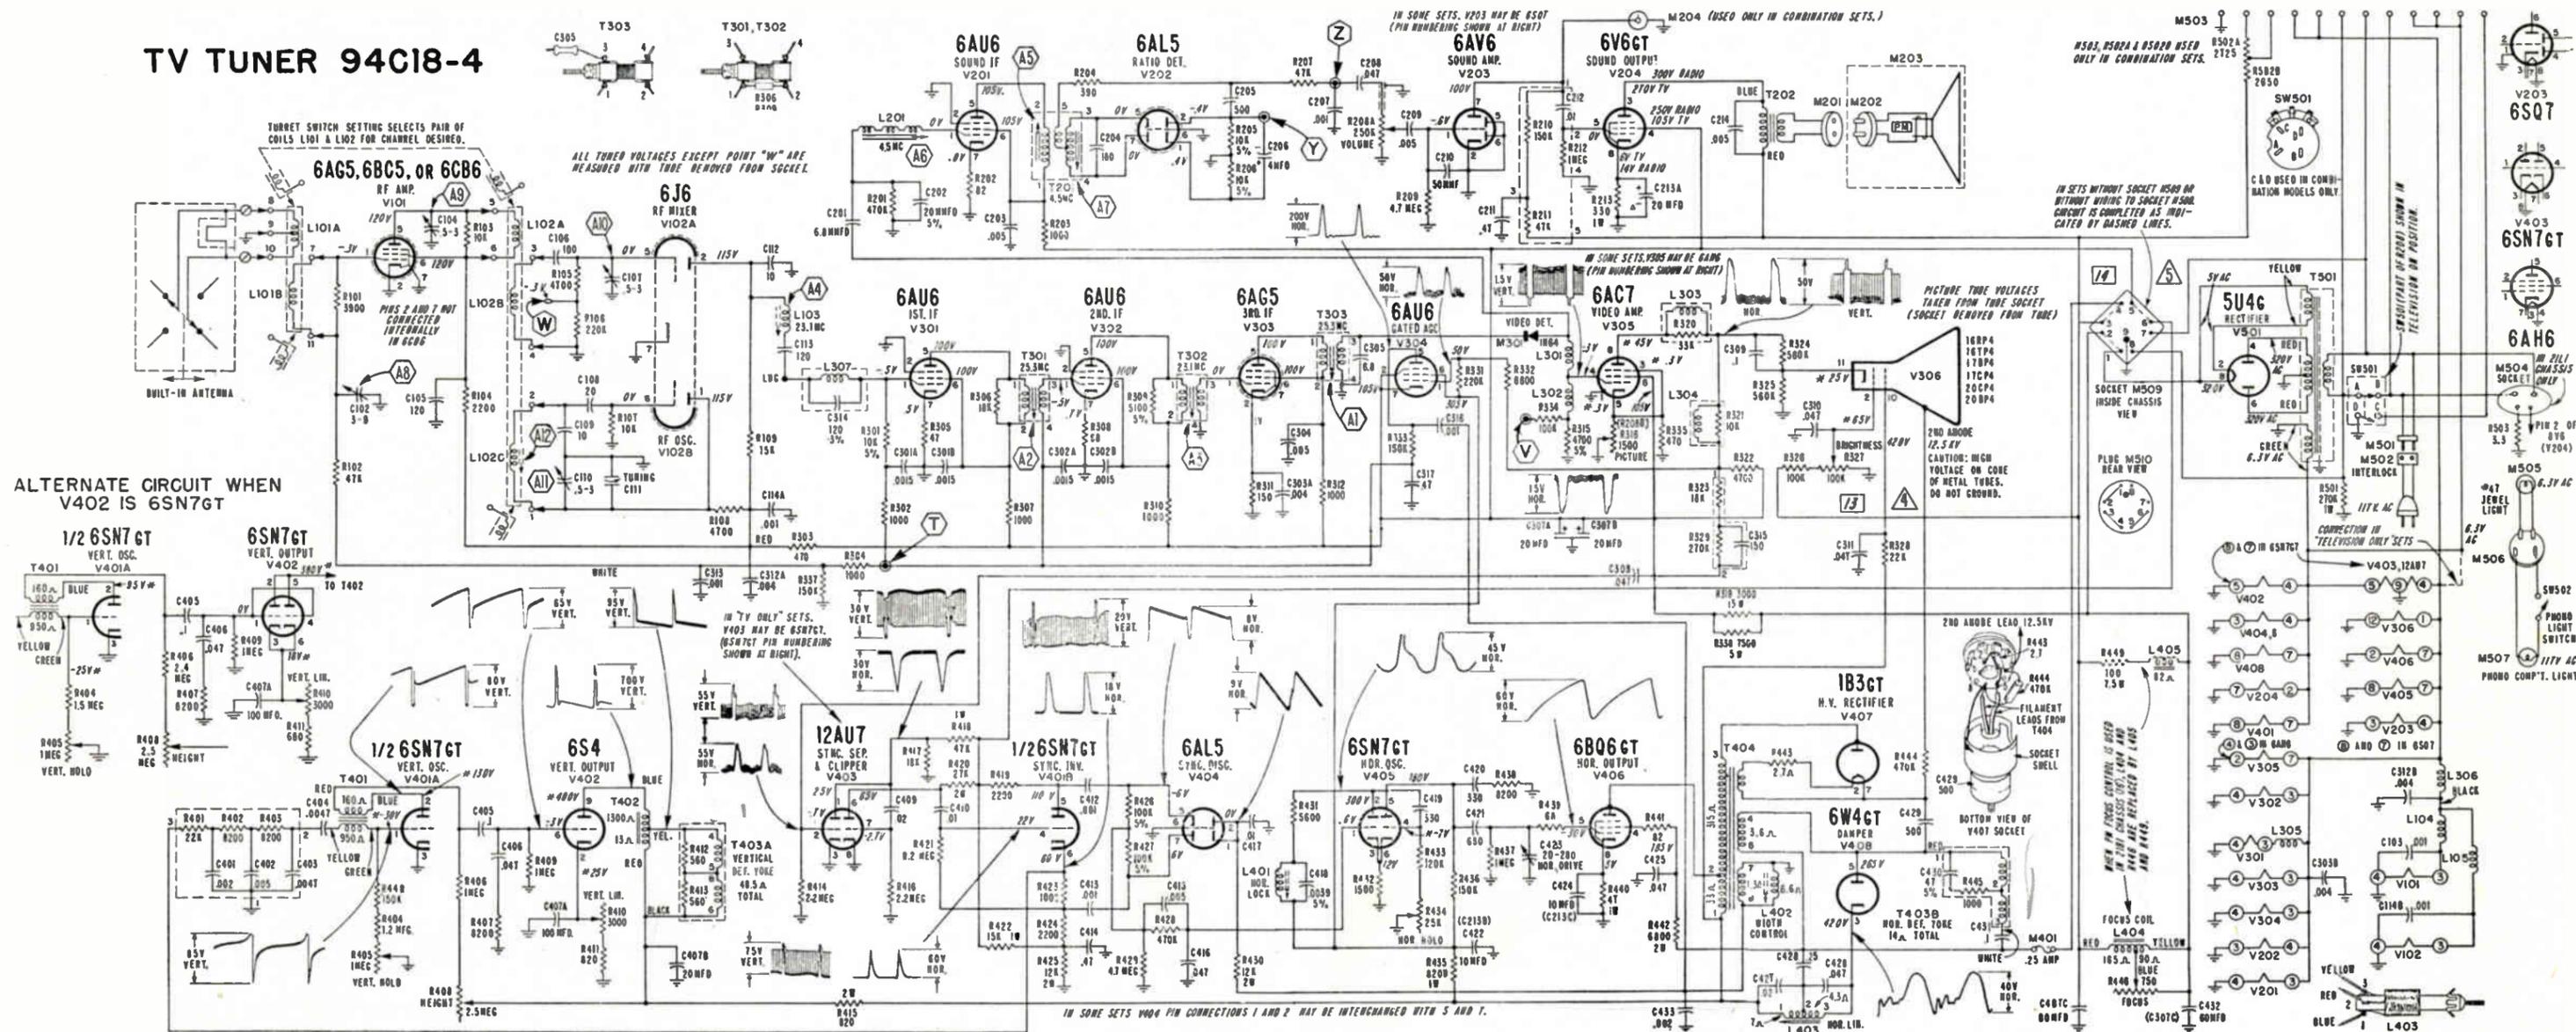
Figure 31. Schematic for 21B1 Chassis Stamped Run 13 or Run 14 and 21F1 Chassis Stamped Run 4 or Run 5. Use this schematic and partial schematic, figure 18A for 21B1 chassis stamped Run 12 and 21F1 chassis stamped Run 3.

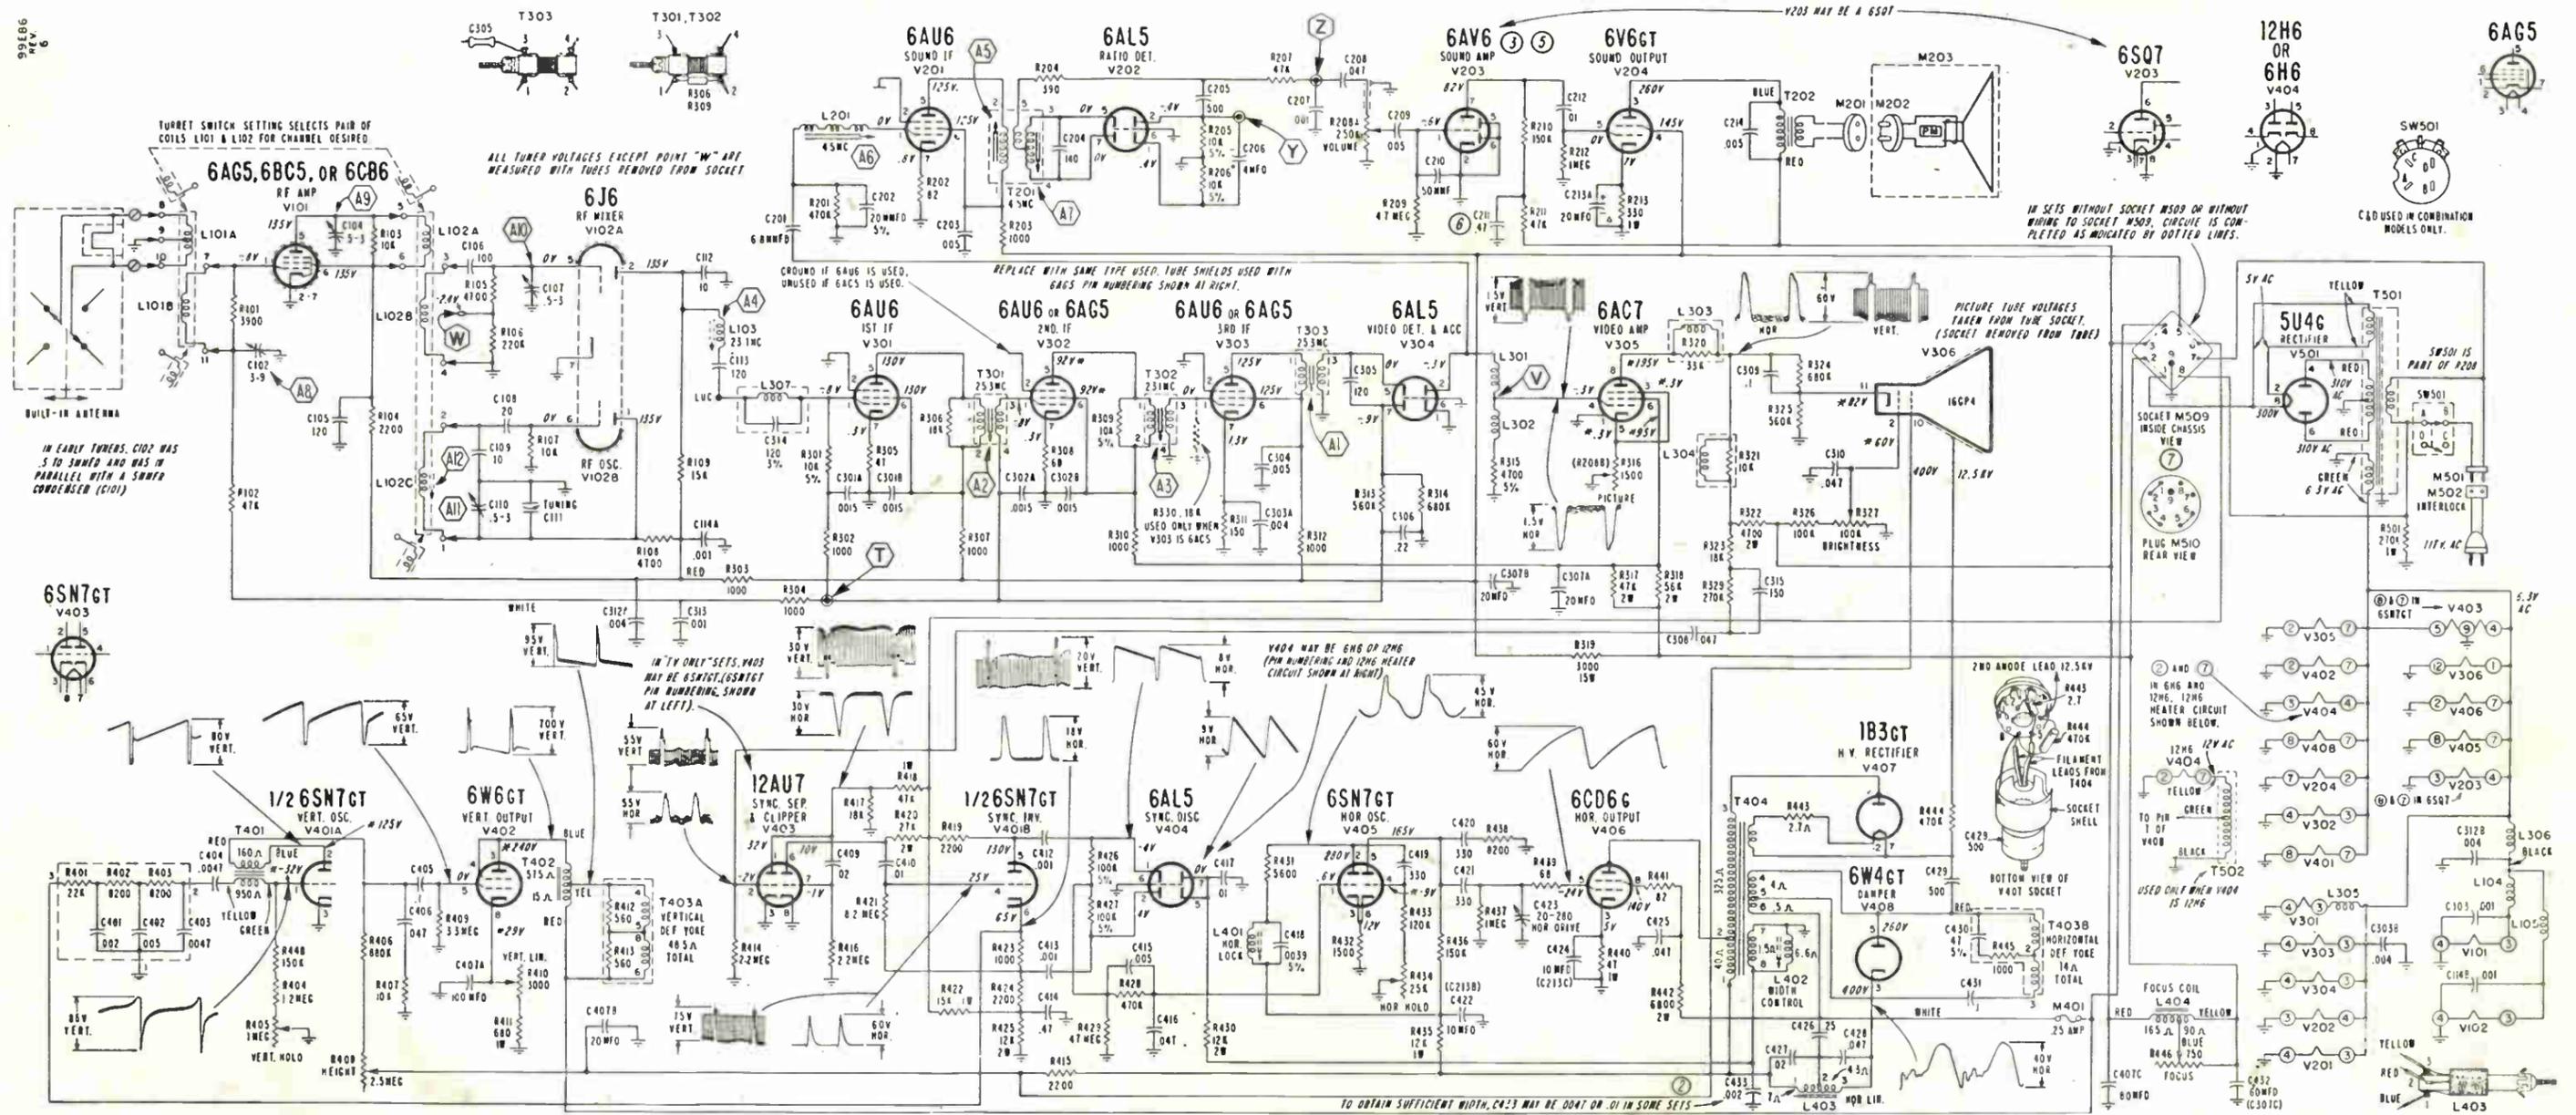
Figure 27. Schematic for 21D1, 21E1 Chassis (16" round tube). See figure 26 for 5D2 (AM-FM radio) chassis used with 21E1 chassis.
