Admiral TV

SCHEMATIC DIAGRAMS

1947-1953

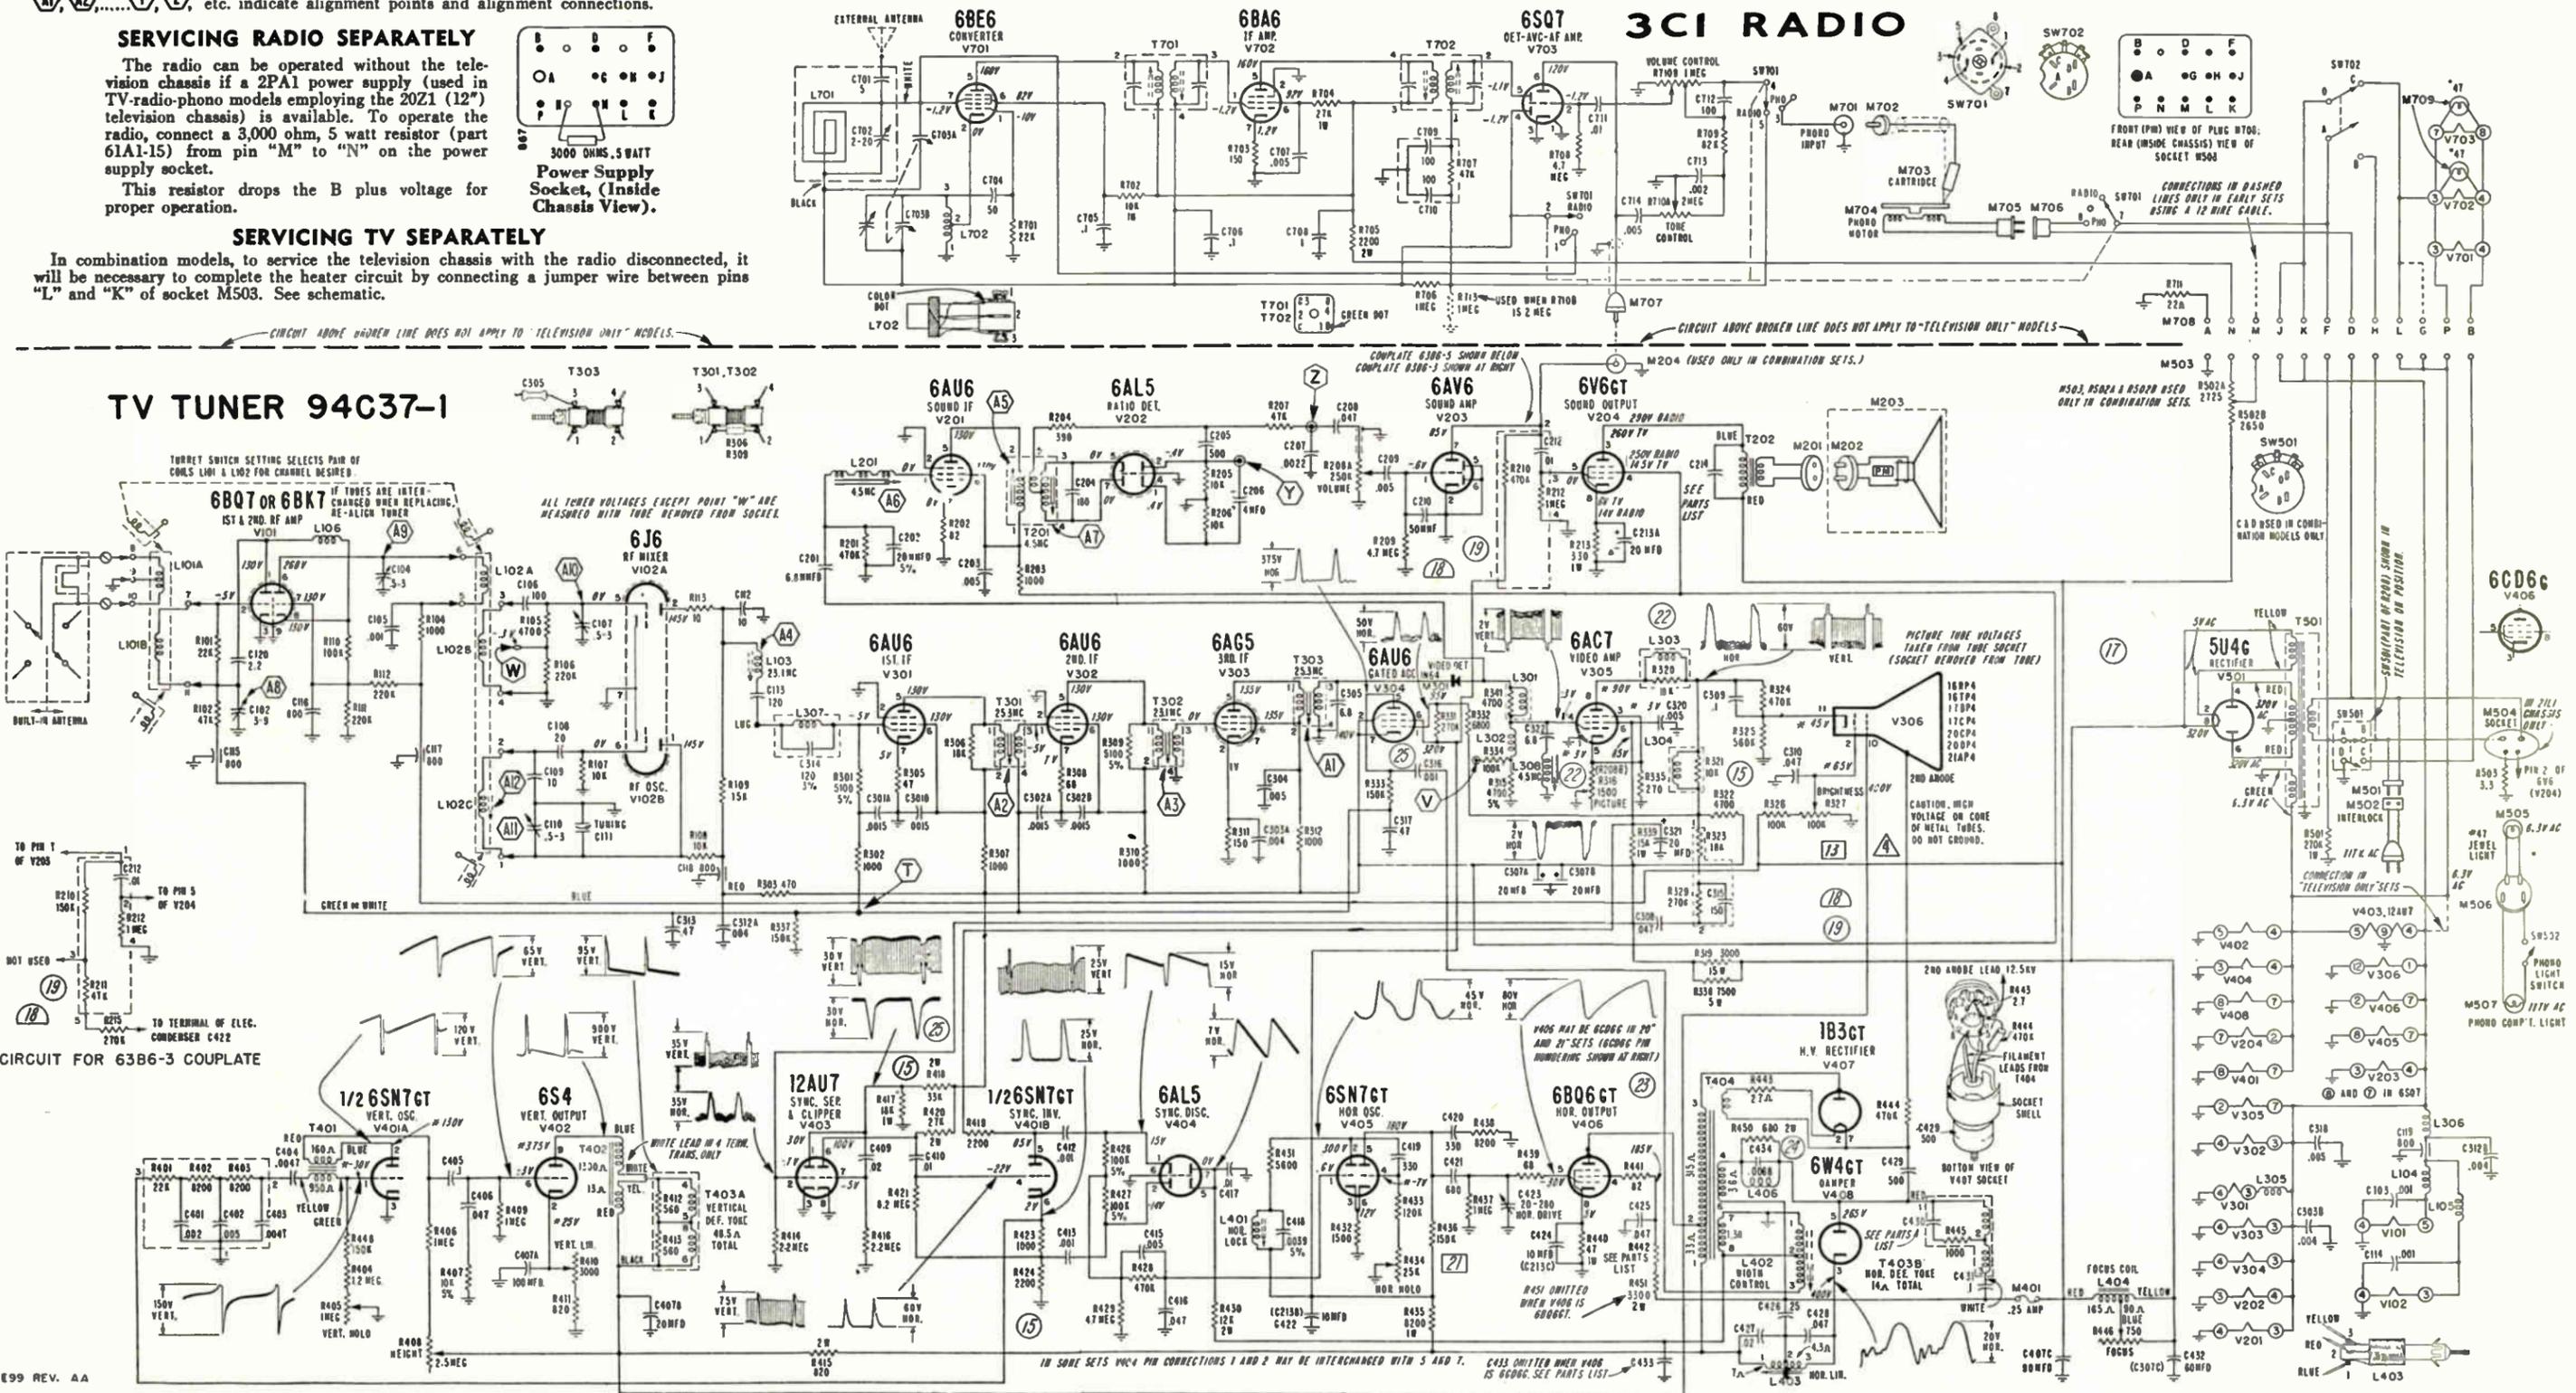
Figure 52. Schematic for 21W1, 21Y1, 21Z1 and 21Z1A Television and Radio Chassis.

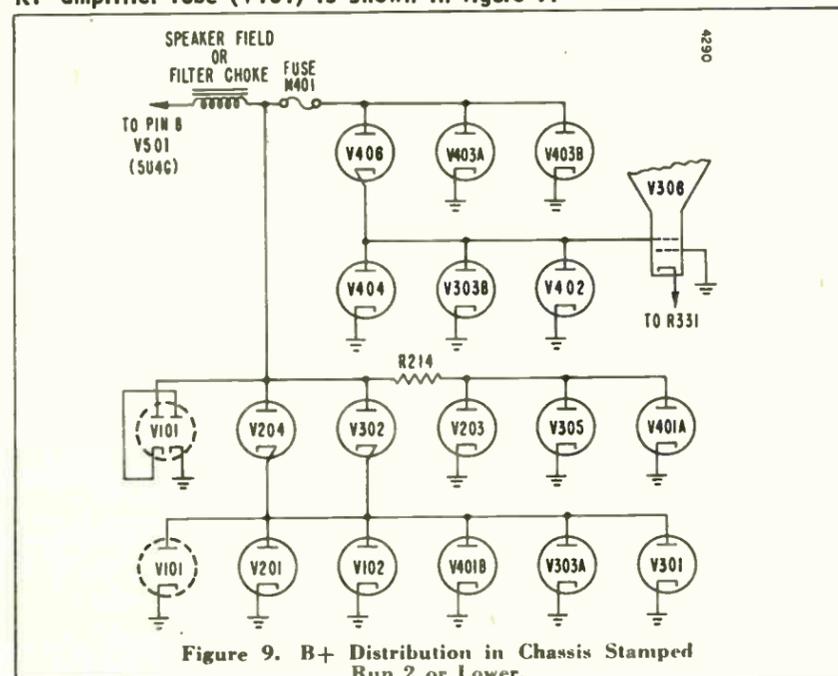
Figure 9. B+ Distribution in Chassis Stamped Run 2 or Lower.

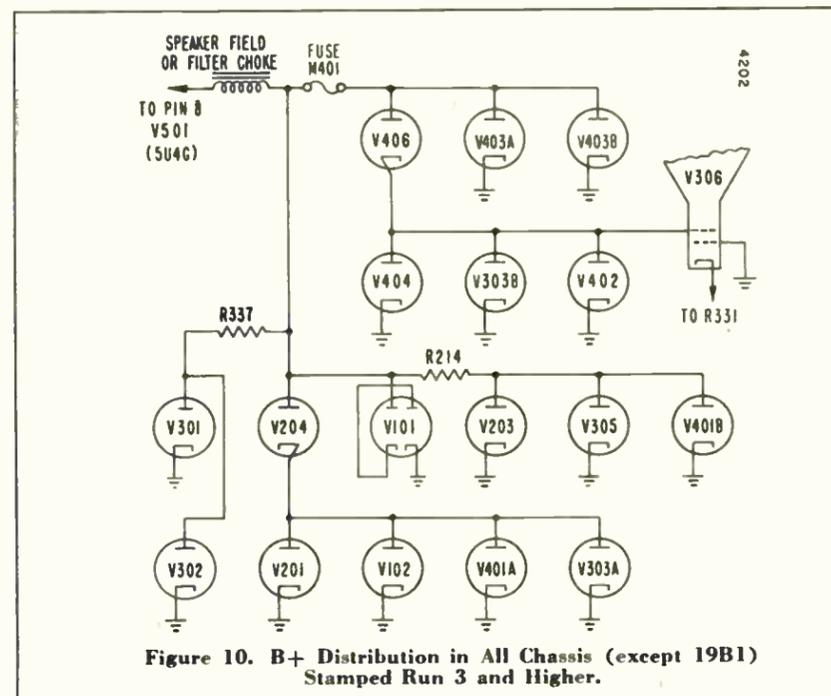
Figure 10. B+ Distribution in All Chassis (except 19B1) Stamped Run 3 and Higher.

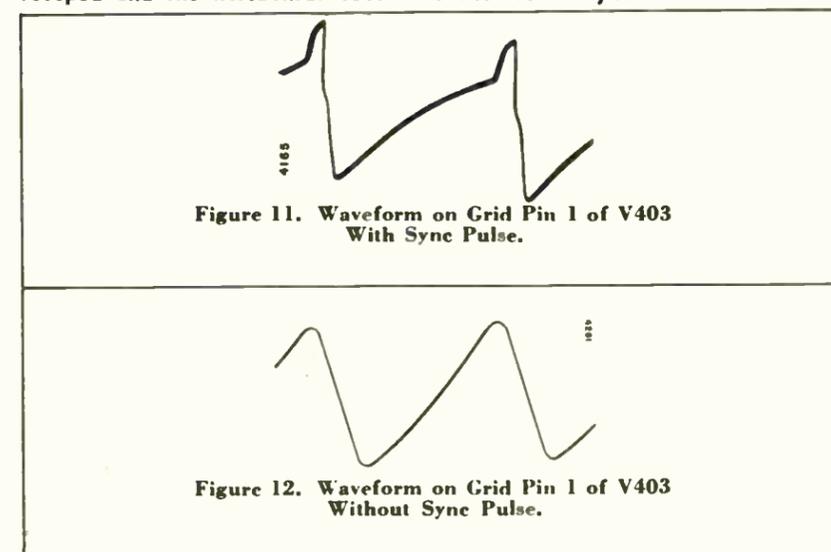
Figure 11. Waveform on Grid Pin 1 of V403 With Sync Pulse.

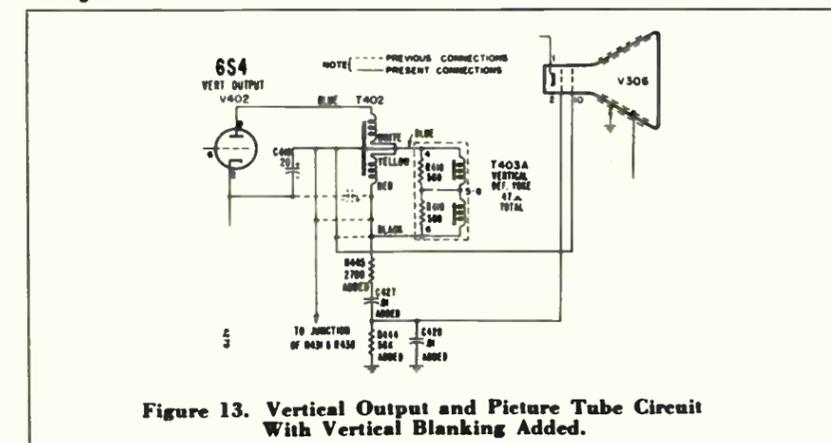
Figure 13. Vertical Output and Picture Tube Circuit With Vertical Blanking Added.

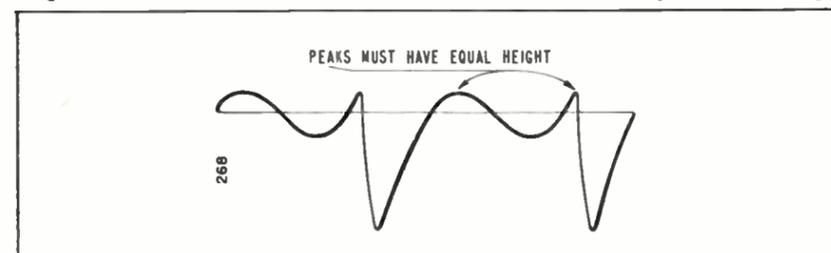
Figure 7. Horizontal Oscillator Waveform.
