SERVICE

AUGUST
1942

SOLVING PROBLEMS OF REPLACEMENT

TRICKS OF THE TRADE

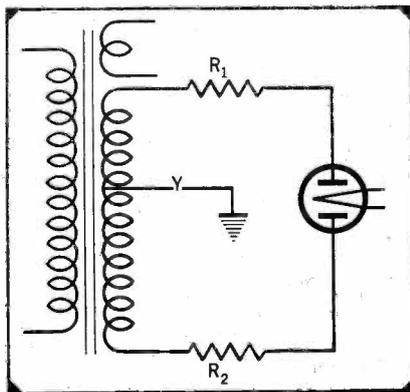
Fig. 2. In replacing power transformers, resistors in the plate leads or a single resistor, placed at "Y", can be used.

wound on the outside of the coil and so have better cooling than the secondary (high voltage) winding. A full wave rectifier requires a resistor in each plate lead as shown in Fig. 2 or a single resistor in the center-tap lead inserted at "Y" in the diagram.

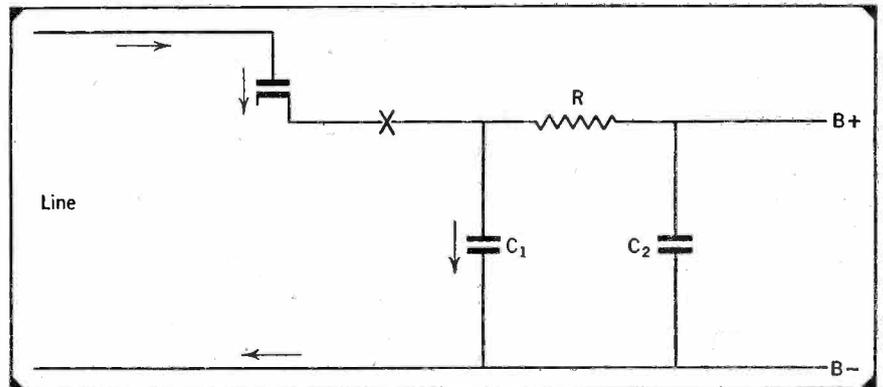
Fig. 1. A diagrammatic explanation of a typical surge resistance circuit.

When the value of C_1 in Fig. 1 exceeds 30 mfd. or so, the charging current becomes excessive and a protective resistor, sometimes called a surge resistor, must be inserted at "X" to limit the peak rectifier current. High capacities in a-c/d-c sets are necessary because it increases the d-c output; no filter chokes are used and, also, because of rather low load resistance. Note the typical resistance-capacity filter in Fig. 1. Many sets have the protection of a surge resistance but, sometimes, the value is insufficient to afford full protection. Because of competition, engineers were forced to squeeze out every milliwatt. Insertion of a resistor where

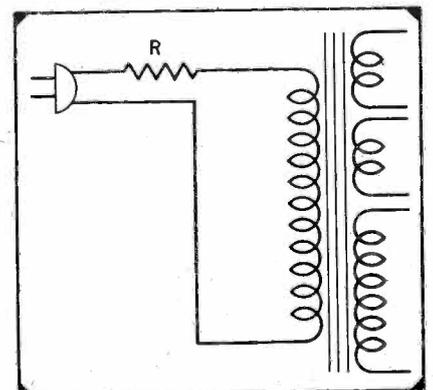
Fig. 3. The use of a primary resistor can be helpful in maintaining correct "B" voltage.

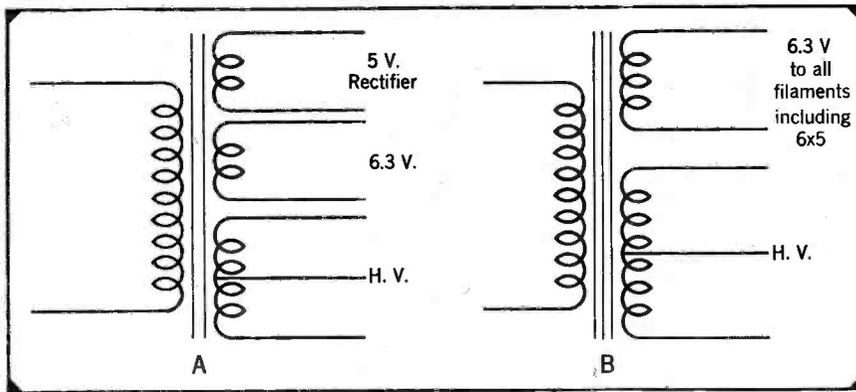
Fig. 4. How to substitute two-filament winding transformers with a single filament winding transformer.

Power transformers having two filament windings with one serving for the rectifier may be replaced with a transformer having a single filament winding provided the rectifier tube is of the indirectly heated type and built for the voltage and current to be handled. The 6X5 is the most common of this group. In Fig. 4, this point is illustrated.

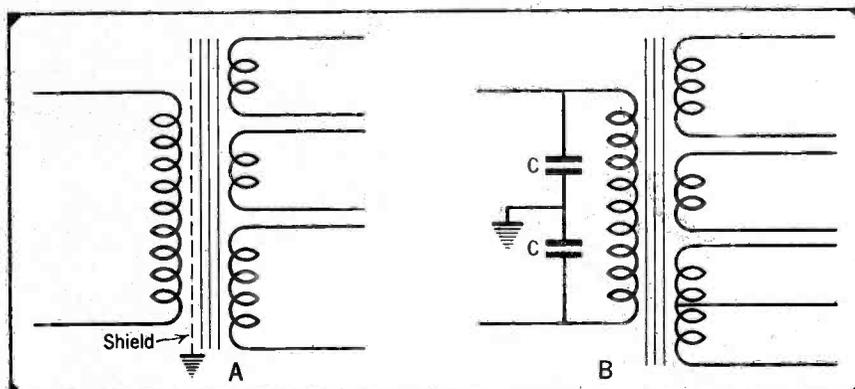
Fig. 5. Eliminating tunable hum with by-pass condensers, when replacing electrostatically shielded transformer.

Where a transformer is replacing one that originally had an electrostatic shield, it is important to connect condensers across the line and to the chassis, as shown in Fig. 5. These condensers run from .01 to .1 mfd. and their function is to eliminate tunable hum that rides in on station carriers. A good ground is also of material aid in reducing tunable hum.

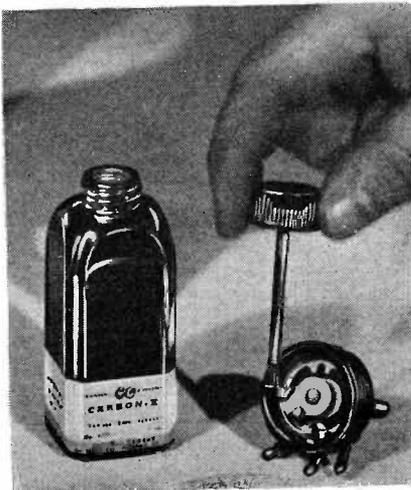
Fig. 1. "Carbon-X," a special liquid for "touching up" the resistance elements of moving carbon-type volume or tone controls, at worn, noisy spots.

Noisy carbon controls can be "touched up" by applying carbon to the worn, noisy spots. For this purpose, "Carbon X," a special compound made by the General Cement Manufacturing Company, is useful and easily applied. It comes in convenient small bottles as illustrated in Fig. 1. Some Service Men fill in these worn spots with carbon from an ordinary soft lead pencil,

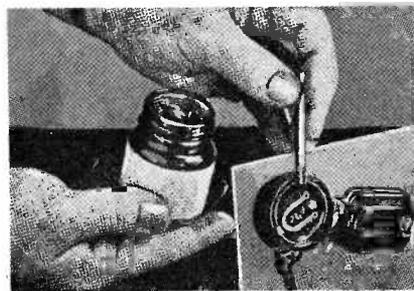
Fig. 2 (above). The method of applying "Grafoline" cleaner and lubricant to noisy wire-wound control.

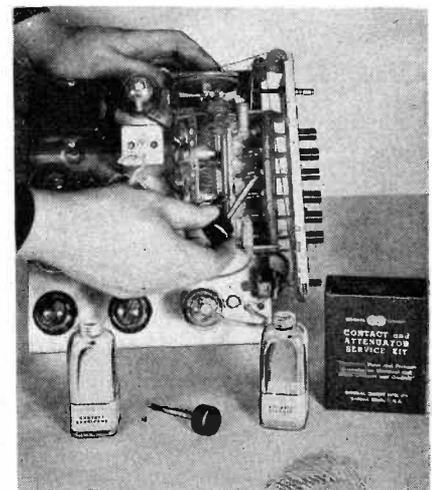
Fig. 3. Applying a contact cleaner and a contact lubricant to the band switches of an all-wave receiver. This simple operation eliminates noisy scratches.

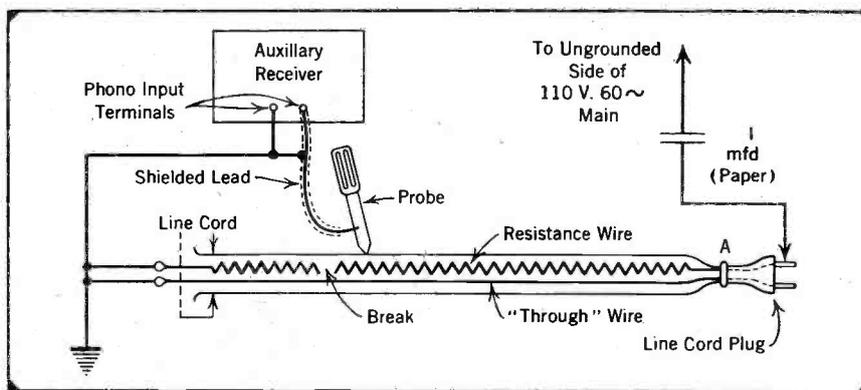
Fig. 4. Circuit for locating break in line-cord resistance.

older a-c/d-c sets, the repair of these essential components may frequently be necessary if the set is to be put back into service quickly. The job is often a very simple one, three-quarters done if the break can be located easily and accurately.

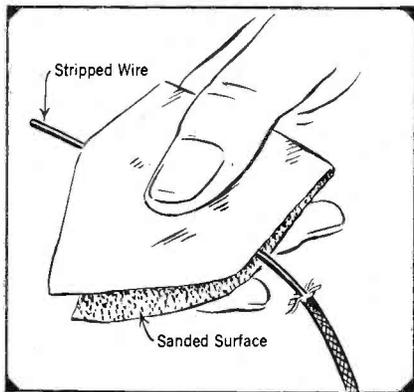
Fig. 5. Sandpaper slip for cleaning insulation off fine wire.

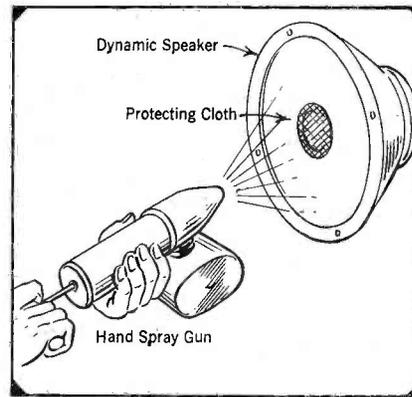
Fig. 7. Applying a coat of thinned lacquer with a hand spray gun for stiffening "softened" speaker cones.

Service shops report that reduction of volume, "thin" reproduction, and rattling due to "soft" speaker cones are again becoming very widespread—mostly among receivers of recent issue. To remedy "soft" cones, spray several times with thinned, clear lacquer, using a spray gun. A hand sprayer is satisfactory. This can be done without removing the cone from the speaker, by covering the center opening of dynamics with a cloth pad, as shown in Fig. 7; the results are better, however, if the cone is first removed and both sides are sprayed evenly. Do not use more lacquer than the cone material readily absorbs, and wipe off any excess before it sets. Allow at least 10 hours drying time before attempting to center the cone or use the speaker. This treatment is also effective on old types of dynamics constructed of doped cloth, such as the early Victors and Philcos, which have softened due to vibration and humidity. When this defect appears, the simple lacquer treatment makes cone replacement unnecessary.

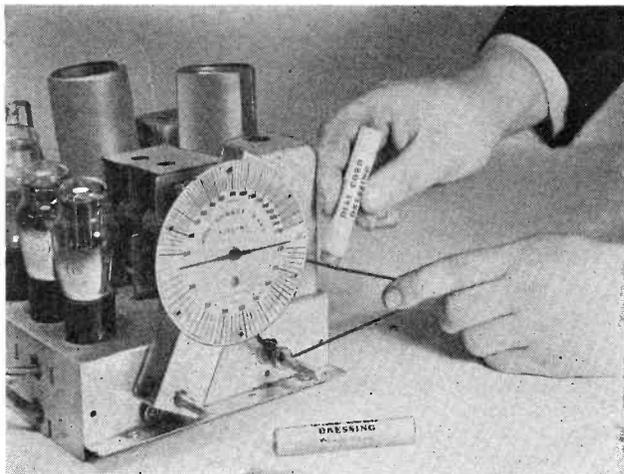
Fig. 6. Remedying a slipping dial cord by applying a stick of dial cord dressing to it. (Courtesy General Cement Mfg. Co.)

brush; it penetrates easily and also causes the cord to shrink slightly. Such compounds are also obtainable in handy stick form. The illustration in Fig. 6 shows a stick of cord dressing being applied to the slippery dial cord of a receiver.

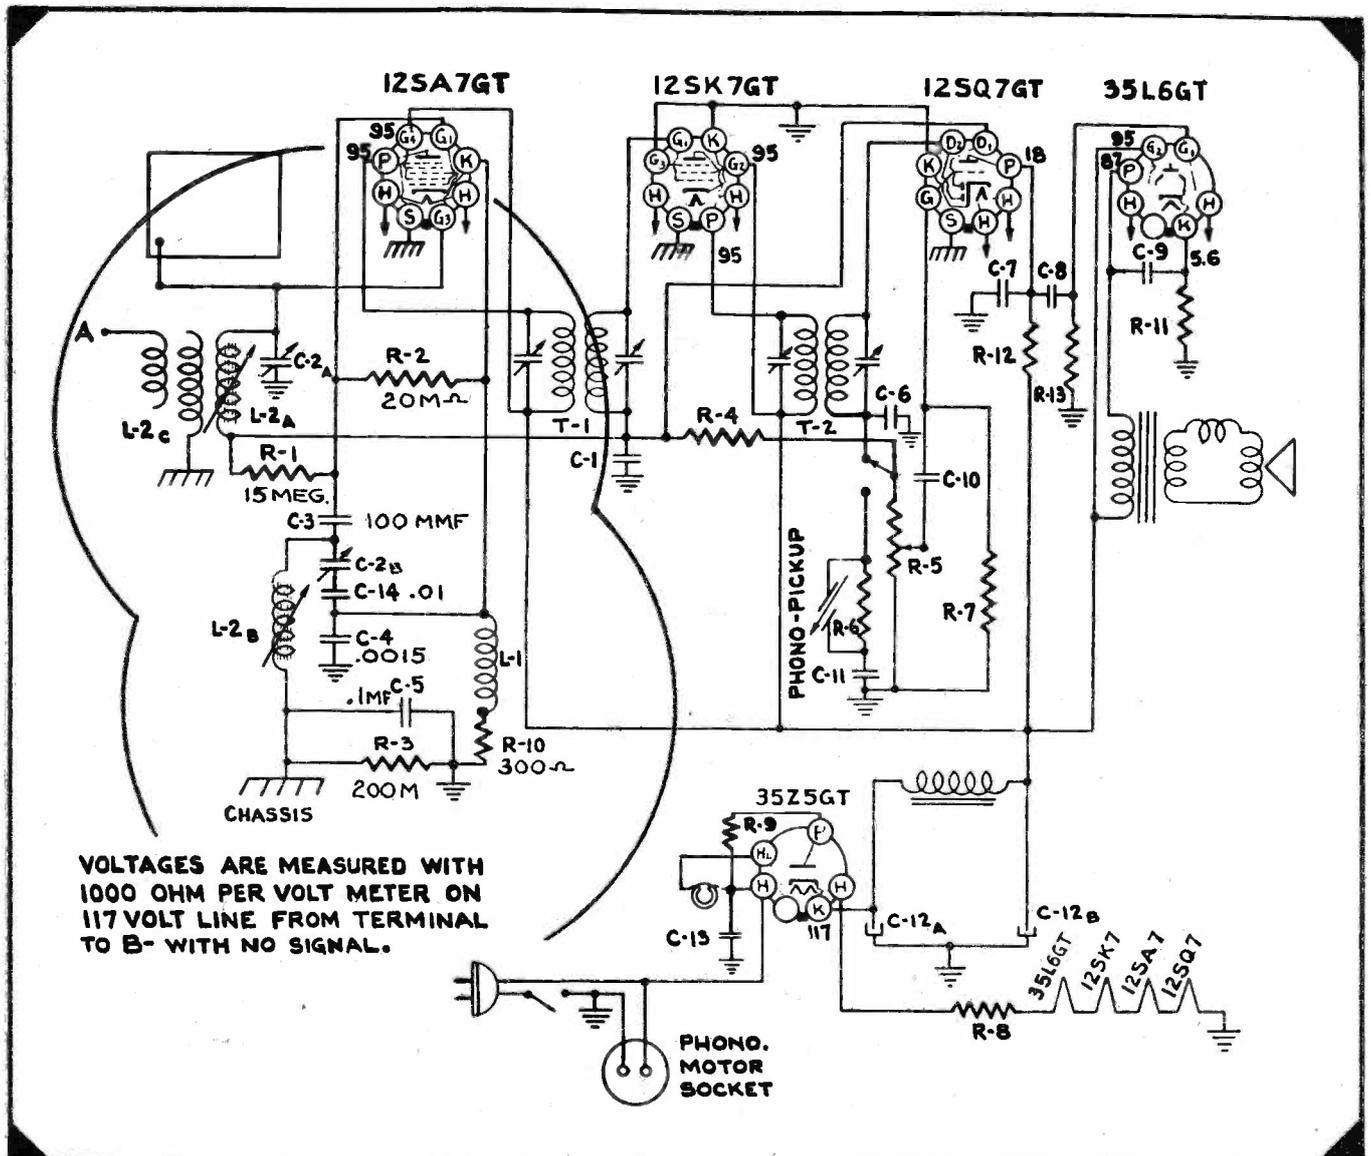
Fig. 3. Silvertone 57RL391 (Model 7188) 5-tube receiver with permeability tuning. Antenna transformer has an interrupted primary.

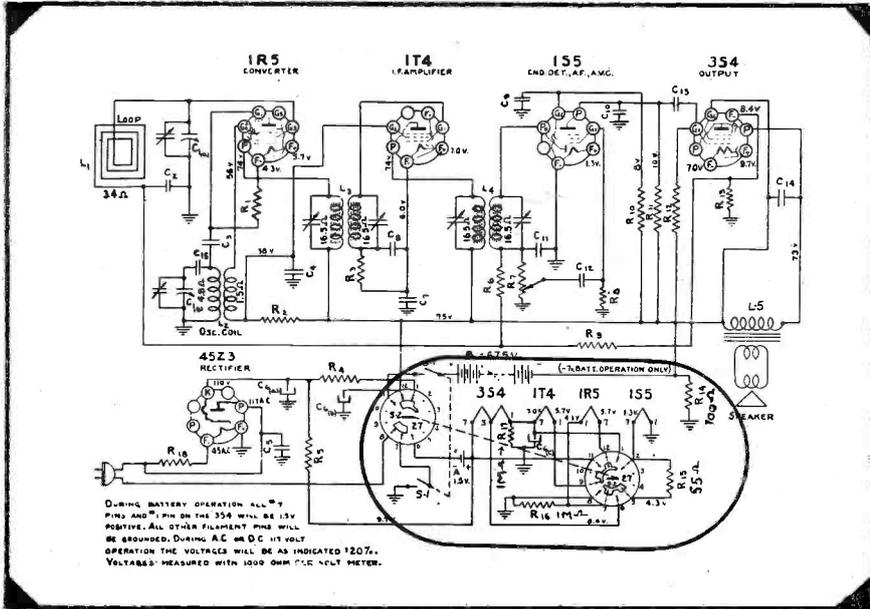
Fig. 1. Silvertone, Model 57RL390 (7189), an a-c/d-c portable, in which filaments are run in parallel, while on the line they are switched to a series connection.

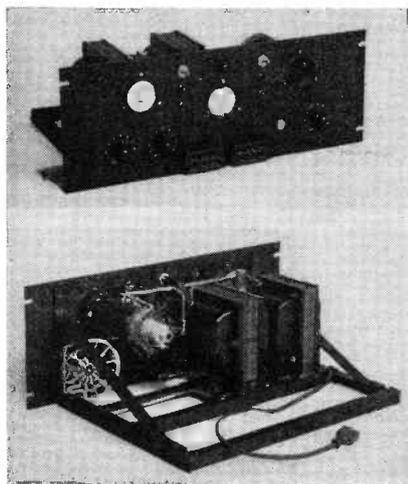
Top and bottom views of the voltage regulator unit.

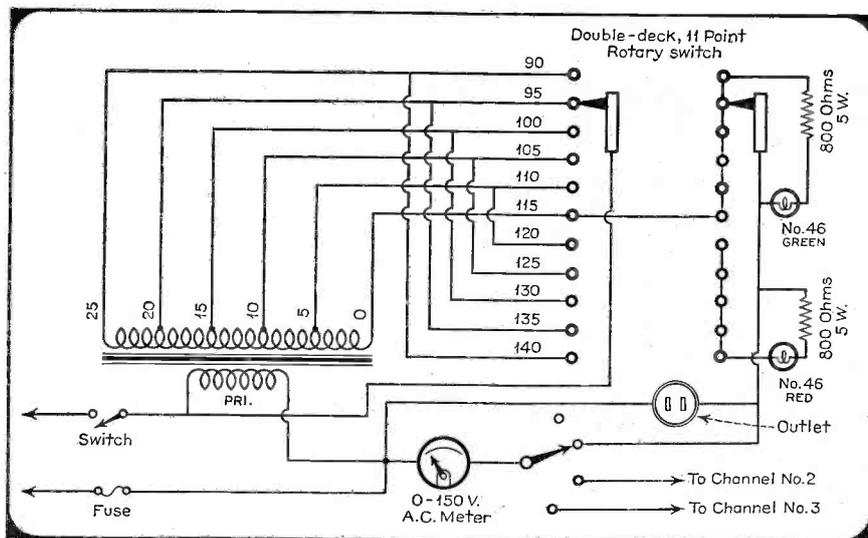
Circuit diagram of the voltage regulator.

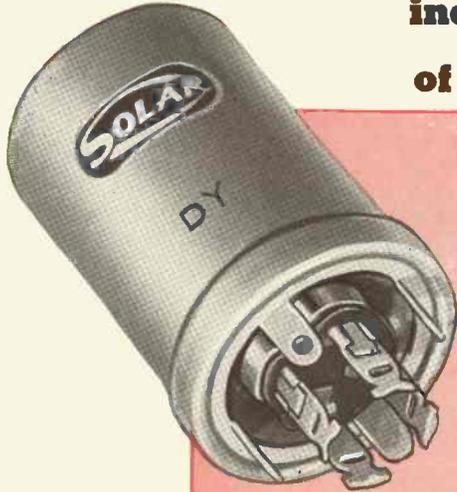
Wet electrolytic condensers—and screw-base aluminum cans—**are SCARCE!** War restrictions make it impossible for any condenser manufacturer to obtain the necessary screw-base aluminum cans in sufficient quantity for all replacement purposes.

To immediately offset this handicap, Solar presents two effective and economical types as practical substitutes, available promptly from your Solar distributor.
