VINTAGE RADIO

The Sky Buddy Saga

By Marc Ellis

Here is a typical restoration project that you will enjoy reading about.

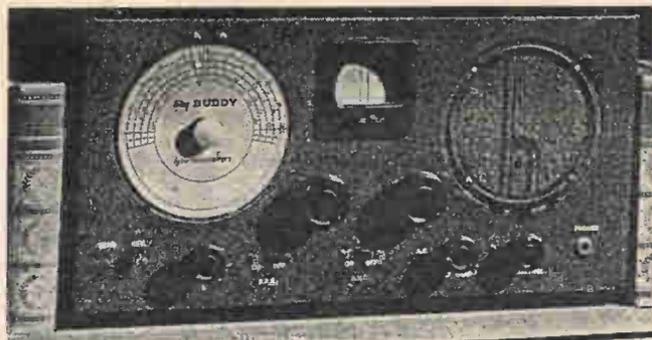
A detail from an October 1939 QST ad shows features of the improved (S-19R) Sky Buddy.

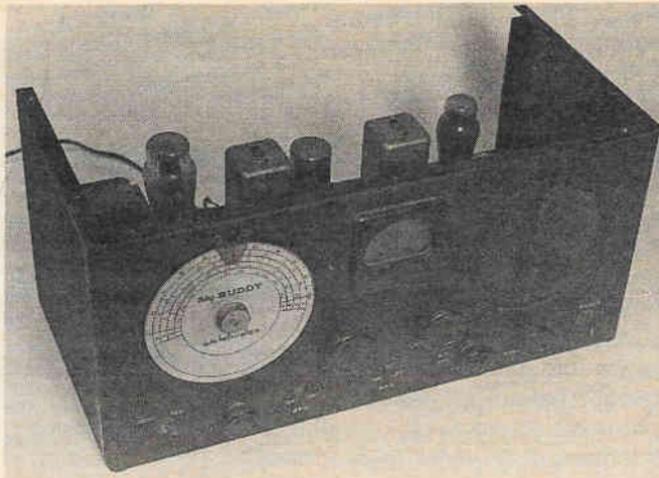
Front view of the model S-19R Sky Buddy with its covers removed for inspection and cleaning. The front panel has a very neat, attractive, and businesslike appearance.

With the covers off, I could see that the set is evidently complete and in reasonable condition. Except for a missing tube (an easy-to-replace 6SK7), all of the parts seem to be present. I couldn't see (or smell) any burned components and none of the wiring appears to have been modified or tampered with.

About the worst thing I can say about the appearance of the radio is that it definitely has a tired look. The finish is dirty and scuffed; the chassis is covered with a sticky grime and—here and there—shows signs of corrosion; the bright metal parts, including the IF transformer cans and dial, have coatings of that varnish-like yellowish

deposit often found on old radios (maybe it's grease from cooking or tar from cigarette smoke). Finally, the presence of some neatly opened seed hulls suggests that a small rodent may once have made a comfortable home under the chassis.

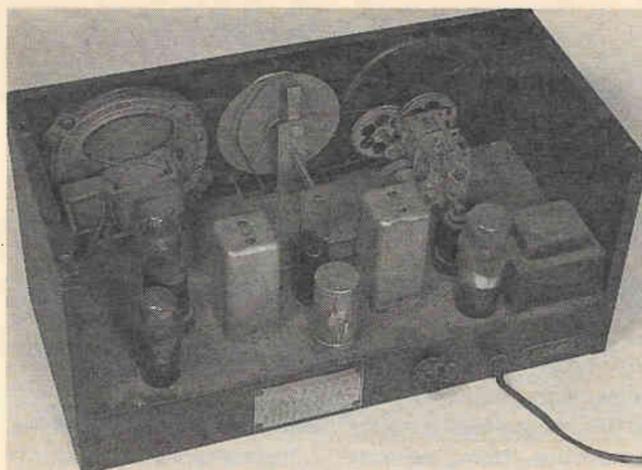
The rear view of the opened-up Sky Buddy shows the dirt and grime that has settled into this set. The chassis is not a separate unit, but a shelf-like assembly spot-welded to the cabinet front and sides.

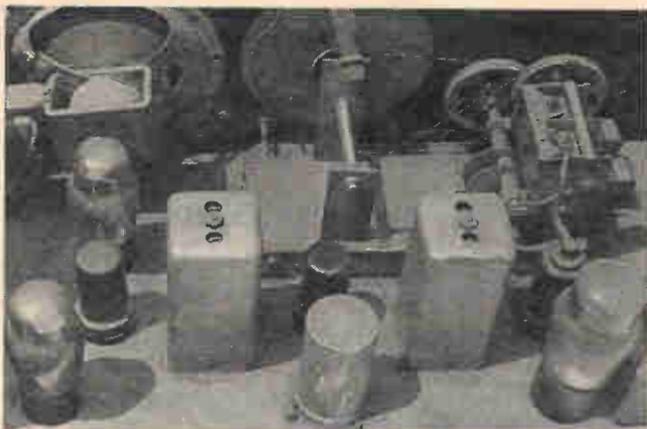
To facilitate the cleaning process, both the loudspeaker and the tuning capacitor/bandspread drive subchassis to the right of it would be removed.

The loudspeaker was very readily removed, requiring only desoldering of its six under-chassis connections and removal of the four screws holding it to the panel. The metal-mesh speaker grille had to re-

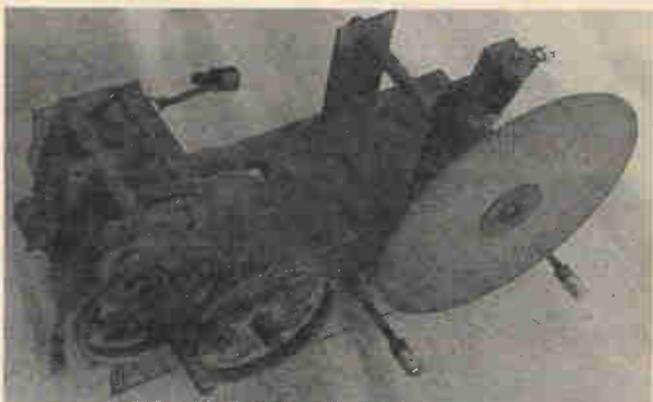
With the tuning capacitor/bandspread drive subchassis out of the set, it will now be possible to restring the dial cords.

Second, I'd be able to replace the four rubber shock-mount gaskets, which were meant to insulate the subchassis from vibration and which were now petrified to a rock-like consistency. Finally, and perhaps most important, it would give me access to the drive-pulley system, making it possible for me to replace the bandspread and main tuning-dial cords. From sad experience, I've learned that these cords are very likely to break soon after a long-unused set is put back into service.

Removing the unit would also make it possible to replace the dial cord in both the main-tuning and bandsread drives. While both drives were functioning when the radio came into my hands, experience has shown that dial cords in long-unused sets frequently break soon after being placed into service again.

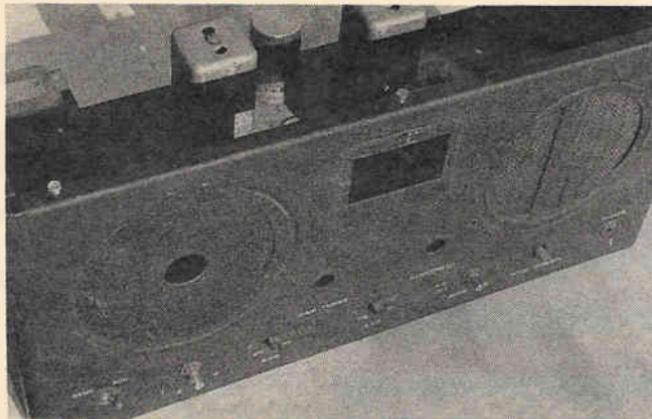
The front panel of the S-19R as stripped for cleaning. Note the filler plate (see text) reducing the diameter of the round dial opening at left.

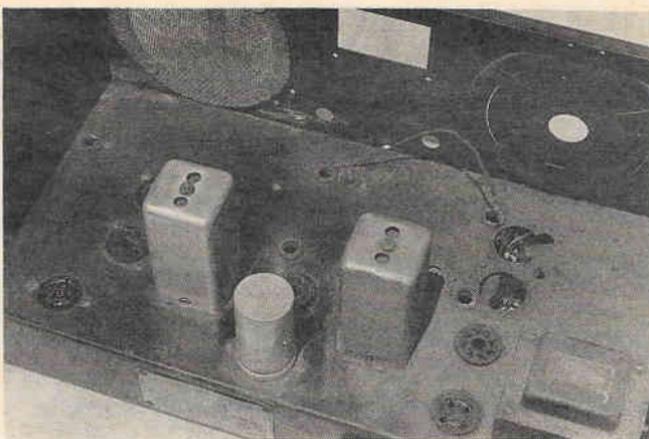
While our S-19R was not really in bad condition cosmetically, it had obviously spent some time stored in a less-than-ideal location. The top surface of the chassis, as well as all of the above-the-chassis parts, were coated with heavy grime combined with a touch of corrosion. The first area to

The partially cleaned main chassis. The area shown at the left has been washed and wiped; the area at the right is still "as found."

I began by wiping down the chassis with a rag soaked in a mild solution of dishwasher detergent, using a small screwdriver to force the rag into difficult-to-reach corners. Following that were a couple of wipe-downs using rags dampened with plain water. This left the painted surface clean, but splotchy and dull looking. There were also a couple of small areas that were extra rough due to patches of corrosion under the paint.

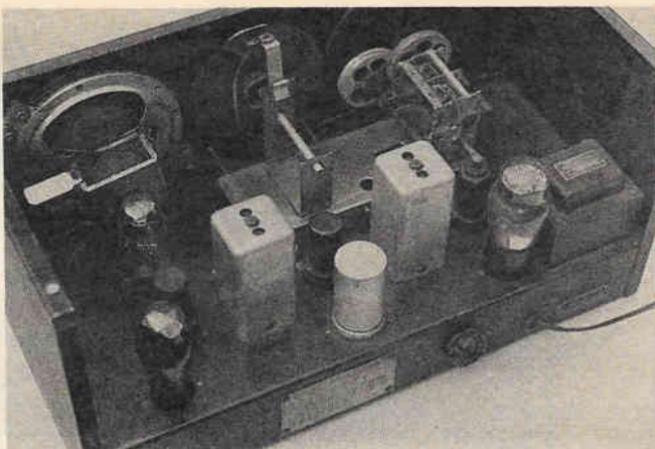
The newly reassembled Sky Buddy as seen from the rear. The tuning control subchassis (behind the IF cans) was a bear to get back in!

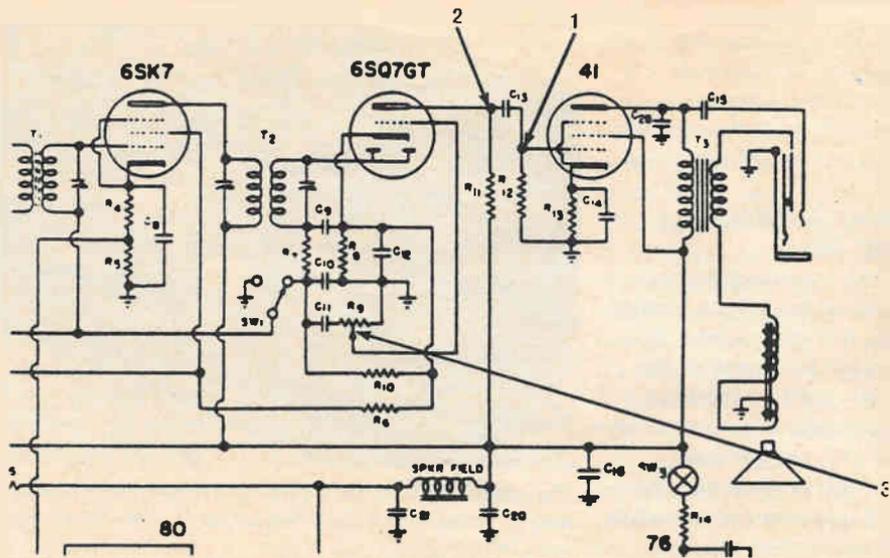
The audio was quite weak—scarcely above a murmur—and would occasionally fade out entirely. Although the level could be adjusted with the volume control, audio could still be heard with the control in its full counterclockwise position.

This schematic shows the Sky Buddy's audio circuitry. The connections labeled "1," "2," and "3" are those that were checked by the "finger probe" method (see text).

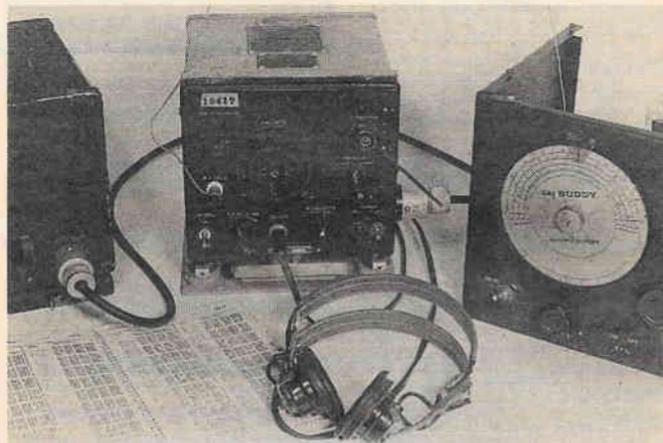
Here's the LM21 at work providing alignment signals for the Sky Buddy repair project. The power supply is at left; the calibration book is partially under the headphones (which are used to zero-beat the frequency-meter output with the signal from the internal reference crystal).

The LM21 (there are also earlier and similar models with lower "LM" numbers) and BC221 generate a signal whose frequency is within a percent or two of that indicated by the setting of the smooth-operating vernier dial. The official usable frequency range is 125–20,000 kHz, though higher frequencies can be attained through the use of harmonics. Accuracy is maintained through comparison with calibration signals generated by an internal 1000-Hz crystal.

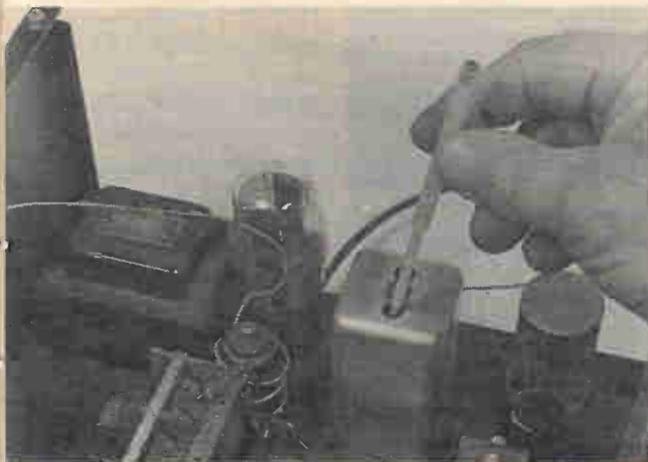
Here's one of the IF transformers in the process of being tweaked for maximum gain. Note the wire signal-injection loop wrapped around the 6K8 oscillator tube (see text).

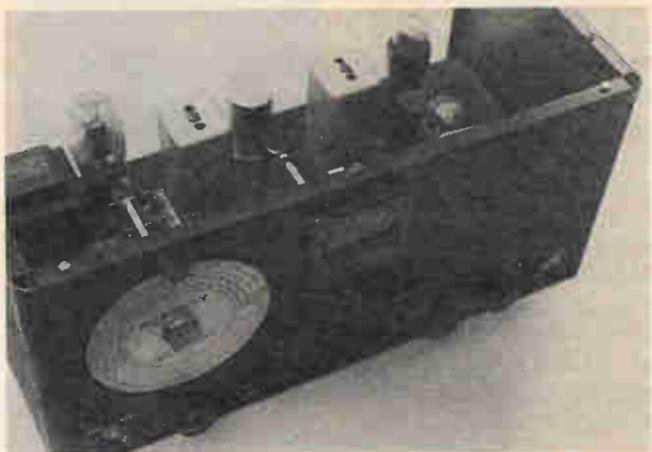
The front view of the Sky Buddy—all together again and with a problem on the broadcast band.

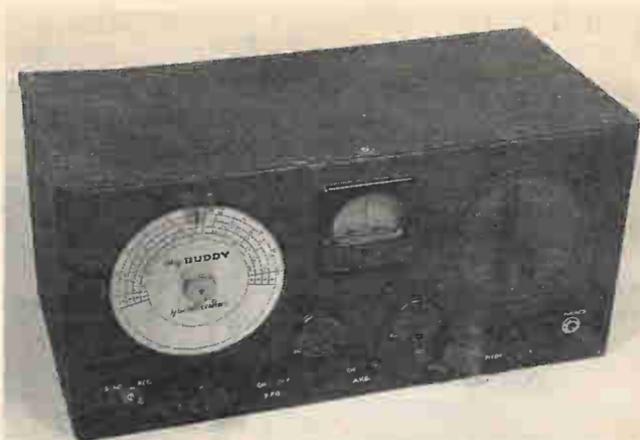
The Sky Buddy with its cover back on and ready for the display shelf. I decided to leave the original dial pointer (which has a broken tip) in place, rather than craft a replacement.
