# TV

# Troubleshooter's Handbook

- B & W TV
- Color TV
- Console Models

By the Editors of **Electronic Technician / Dealer**

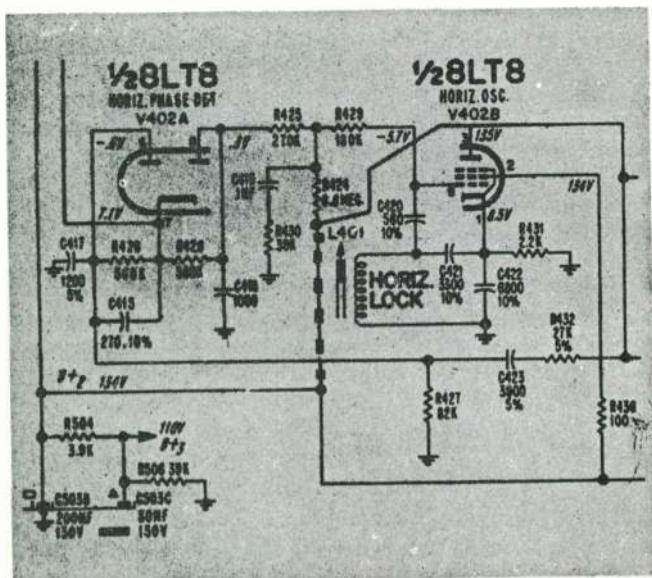
A number of 94D17-19 horizontal oscillator coils which have been returned as defective actually tested good. Investigation disclosed that these coils had been replaced in H1, H2, H3 and H4 chassis to cure slow-starting or intermittent horizontal oscillators. We suggest that you merely move the

end of R424, which is now connected to B+ 2, to the plate of V402B, the oscillator. This modification will provide more starting current. This revision has been made in production.

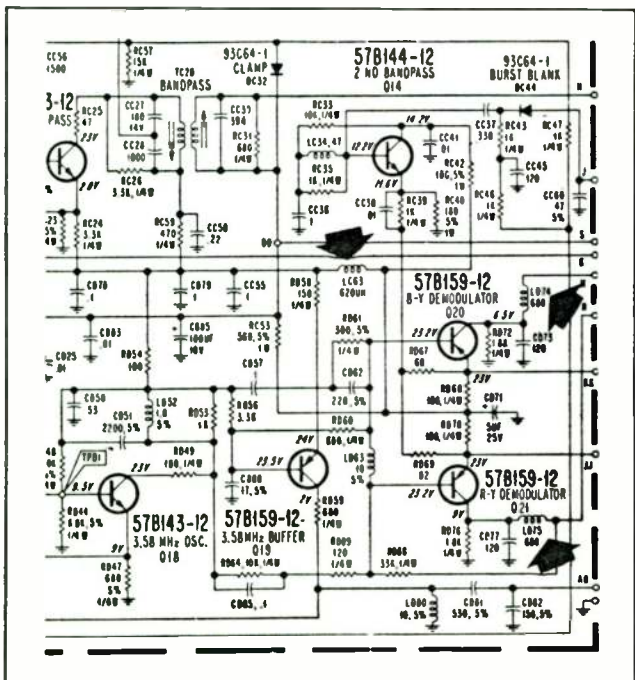
A problem of no color can possibly be caused by an open coil, LC63 (620 mh). If this coil is open, we will not have voltage at the collector of the 2nd Bandpass transistor, Q14. Replace the defective coil with Part No. 73A55-48.

If we lack some colors in the TV picture, it possibly

can be caused by an open coil LD74 or LD75 (680 mh). With LD74 open, blue will be missing; with LD75 open, red will be missing. Replace the open coil with Part No. 73A55-17.

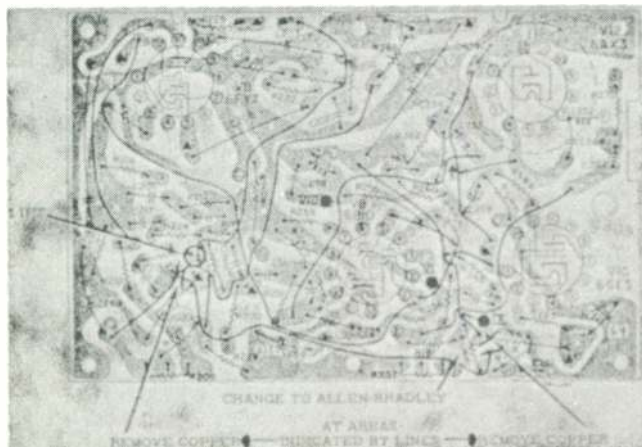
A percentage of the 23DYP4 or 23FVP4 picture tubes which fail in the above chassis have been found to have open filaments. Investigation has shown the following cause. As in the case with any type of electrostatic focus tube, occasional arcing occurs, mainly during the early life or breakin period. This arcing is normally discharged across the spark gap from G2 to ground and no harm results. On the sweep board, there are a couple of locations in the copper pattern where the islands connected to G1 and G2 are spaced close to a B+ island. If a slight misregistration of the copper pattern occurs, the reduced spacing may allow an arc over to occur simultaneously with a discharge across the spark gap. If this

should occur a heavy B+ current flows into G1 or G2 and follows the HV arc to the filament causing burnout. This type of failure may be prevented by increasing the spacing of critical conductor points according to the following instructions. We suggest you make these changes whenever an "open filament" picture tube failure has occurred in an AA or AY Chassis, to prevent a repetition of the failure. Chassis passing through your shop for other service should also be inspected for this condition. AA receivers built after Chassis Date Code 504 have the circuit corrections incorporated.

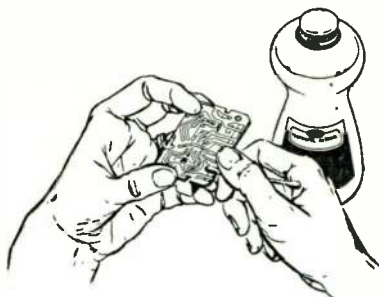
In the event symptoms are encountered which may relate to high-resistance (corroded) contacts, the printed-circuit edge-connector area of the module should be cleaned with a cotton swab dipped in isopropyl alcohol—as shown in the illustration. Never use any type of spray chemicals to clean either the edge connectors or the module sockets.

Intermittent symptoms in modular-equipped TV sets, whether associated with signal or deflection circuitry, may be the result of high-resistance module contact surfaces rather than a faulty component. High-resistance connections are particularly prone to development in atmospheres which contain corrosive substances, such as salt and/or various sulphur compounds.

Before replacing a module in its socket, inspect the socket for bent or broken contacts.

When replacing modules, always make sure they are completely seated in their sockets and that the spring-clip locks are in place.
