Television

JUNE 1976

THE
DECCA
10/30
CHASSIS
PART 1

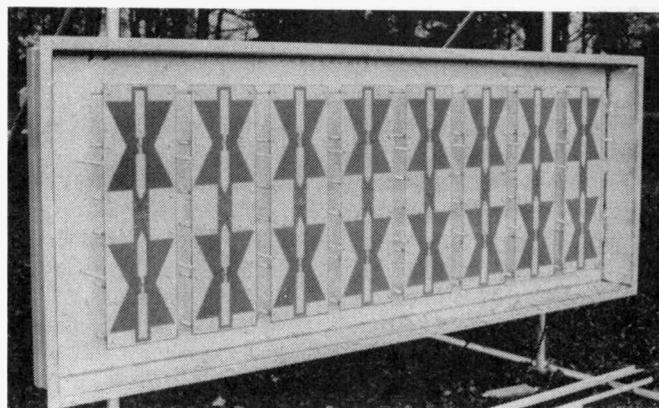
Fig. 1: A prototype single-bay adaptive aerial, shown with protective cover removed.

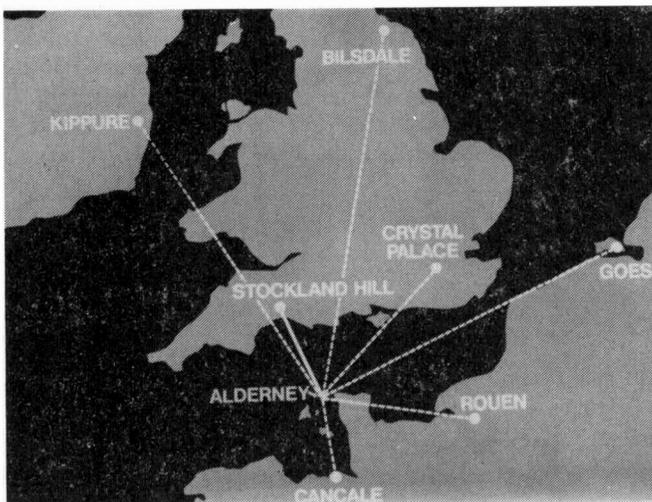
Fig. 4: This map shows likely sources of interference with the link receiving station at Alderney.

The eventual Alderney off-air receiving station will employ two aerial systems, the dish assemblies (modified for u.h.f. working) and the SABRE system, the latter being mounted on the lattice mast. It was feared at one stage that aircraft flutter would be experienced from the island's busy airfield, but in practice the vertical acceptance angle and the time constants of the system are sufficient to reduce this hazard to a negligible figure. Selective fading within a single channel spectrum can be compensated with both luminance and chrominance correction by means of an equalising filter system originally designed by the BBC.

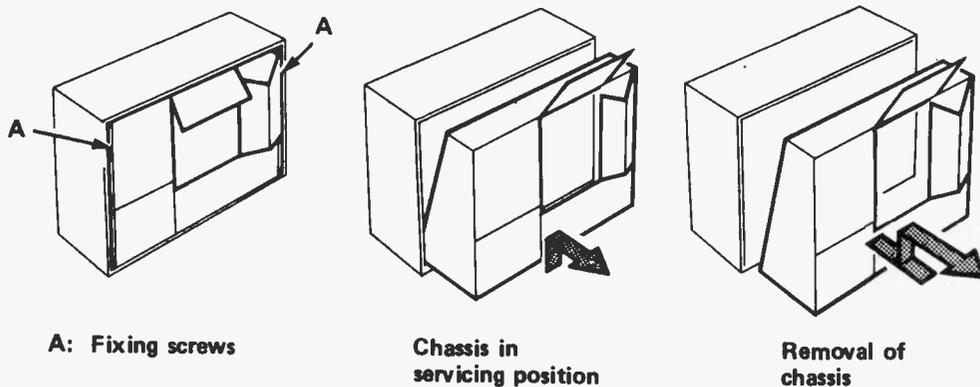
Fig. 1 (left): Method of lowering and removing the chassis. The bottom of the chassis is supported on nylon rollers: make sure that they are in their runners before withdrawing the chassis too far – otherwise you could end up with a cracked c.r.t. neck.

The chassis itself is very easy to remove, being attached to the cabinet by only two screws in the top corners. The bottom of the chassis is supported on nylon rollers, permitting the chassis to slide out to a hinged down position that just allows valve and fuse replacement. All connections to the tuner, speaker, front controls and deflection coils are via plugs and are reasonably accessible. Above all, the plugs are foolproof: it just isn't possible, with the exception of the audio wiring from the volume control, to connect the wrong plugs to the various sockets.

A little care is called for when removing and replacing the chassis, if only to avoid a few choice words being uttered. No attempt has been made by the manufacturer to round off the edges of the pressed steel supports and chassis members, so that nicked fingers and scratched hands are something of a hazard. Care should be taken to see that the nylon rollers are actually in their runners. It's quite on the cards that they won't be, or that one of them has come

adrift from the chassis itself. If this happens and the chassis is moved too far out, a broken c.r.t. neck and the possibility of a lethal dose of flying glass can be expected when the chassis clears its supports. You've been warned then of this dangerous and expensive possibility!

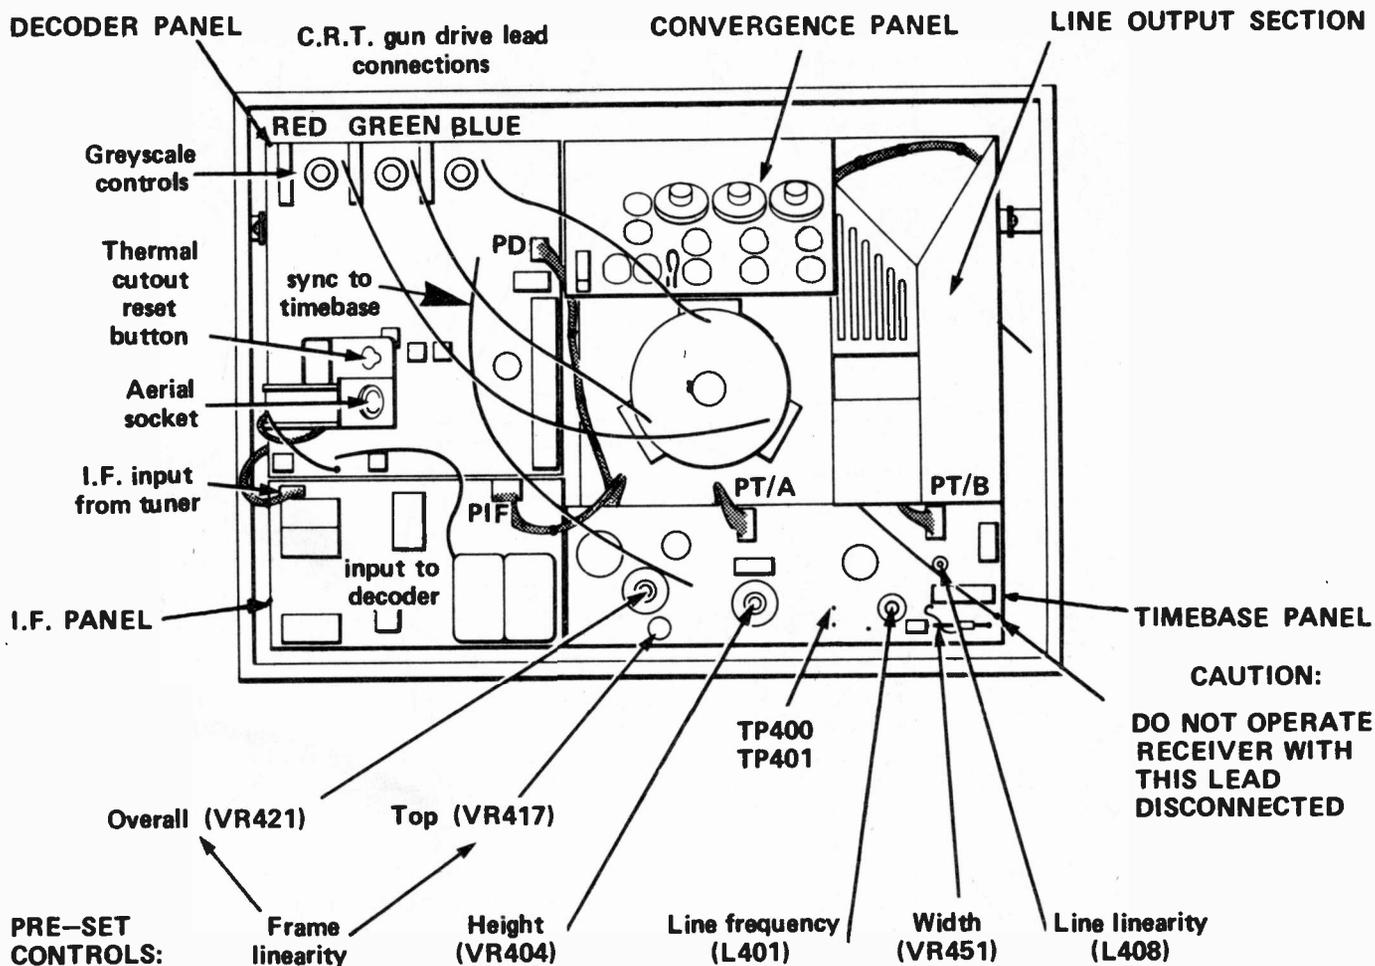
Fig. 2: Rear view of the series 10 chassis, showing panel and control layout. The series 30 chassis is basically similar.

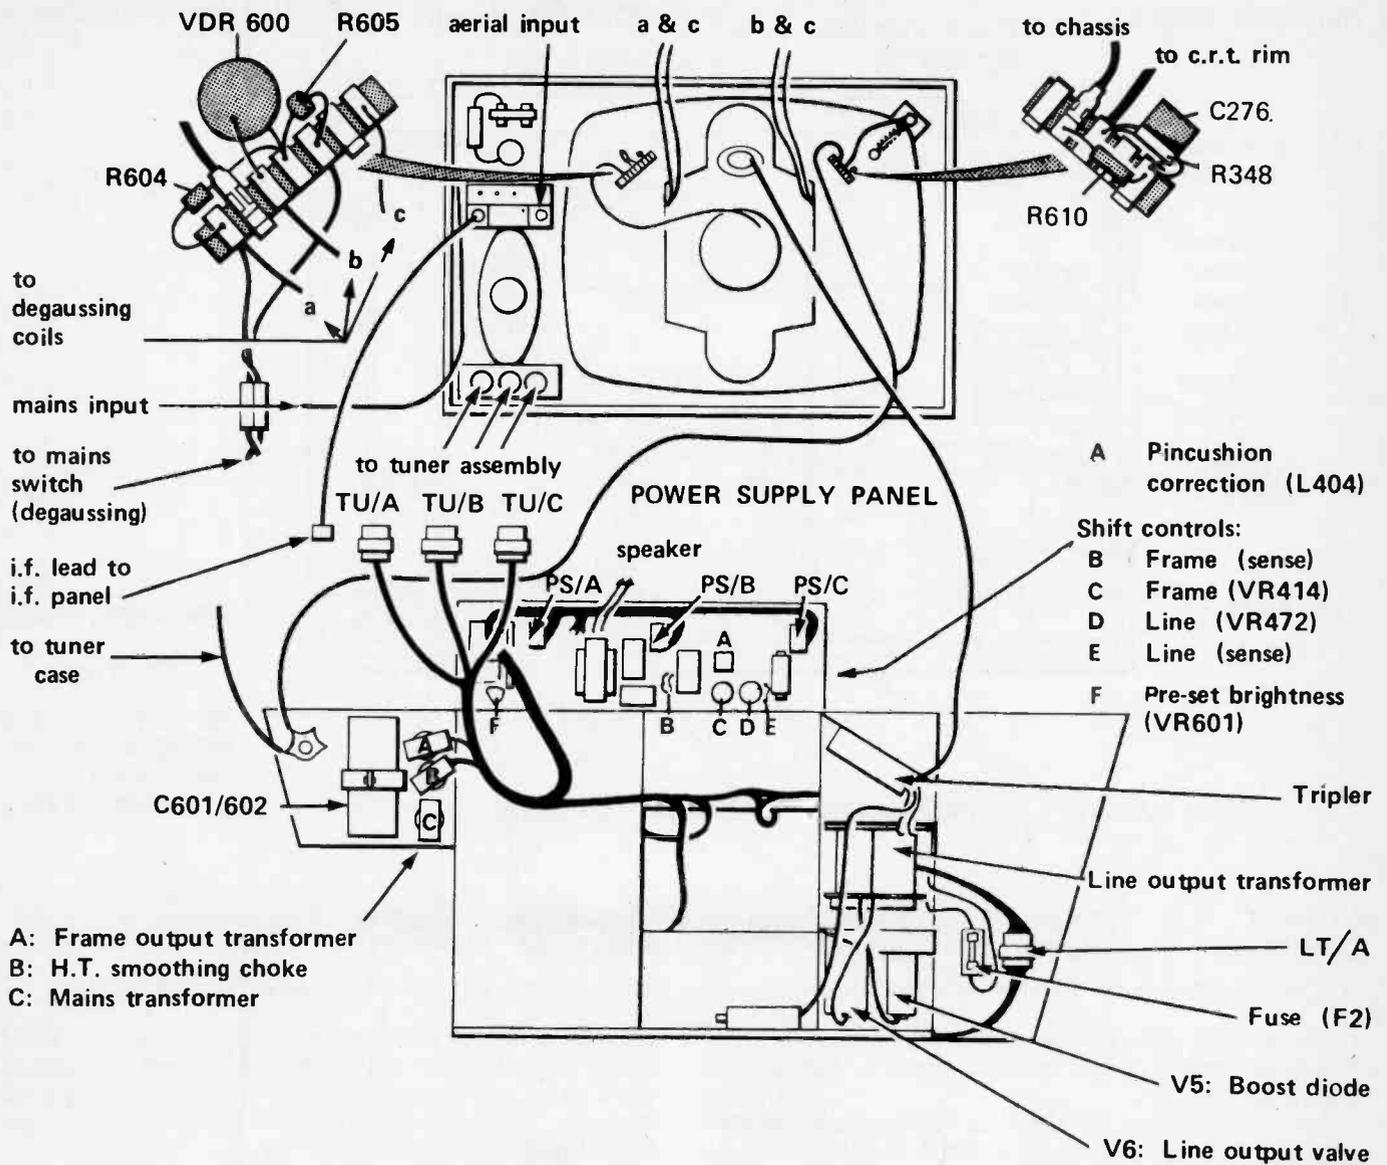
Fig. 3: Internal view, with the chassis folded flat.

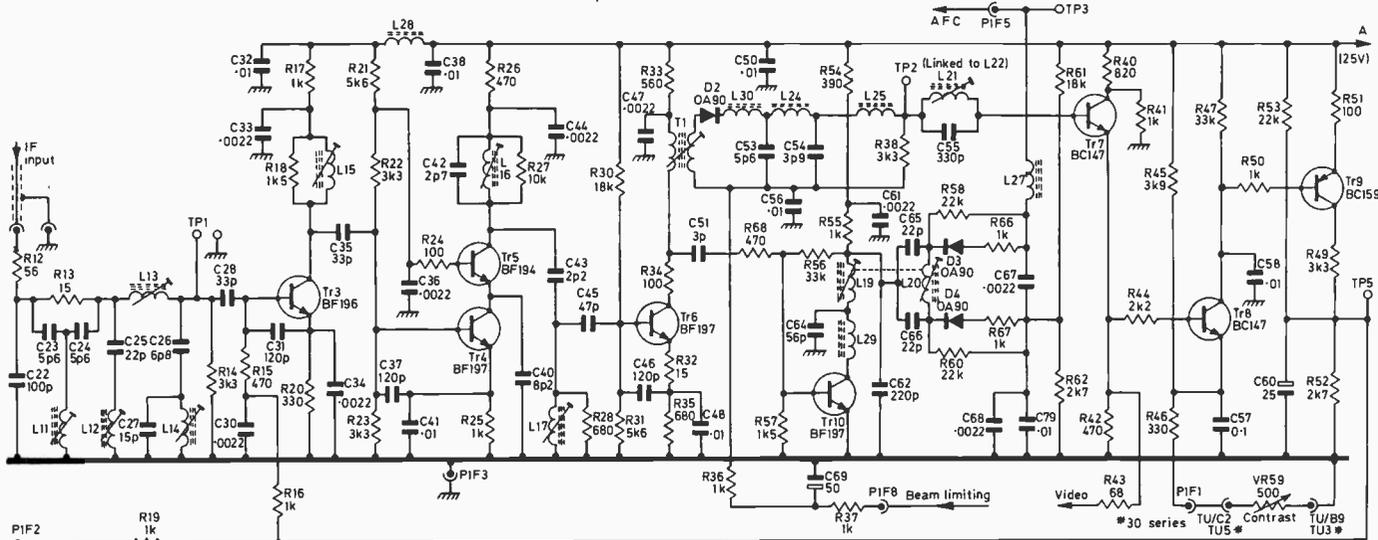
Fig. 4: Circuit of the i.f. strip. In the 30 series chassis R68 and C79 are omitted and a 41.5MHz trap is added in the detector circuit. With varicap tuners R58 and R60 are 100kΩ, R61, R62 and C68 are omitted and the junction of R60-C67 is connected to chassis.

It's for this reason that I recommend a check on the voltage at R37 before deciding for example that a grey, watery picture is due to a gain fault. Under normal test card conditions, with the contrast and brightness controls adjusted for a good, clean picture, the voltage at R37 should read 2.2V on the 10V scale of an Avo Model 8 or similar 20k Ω /V meter. Any notable increase in this voltage should lead to an investigation of the line timebase, a "notable increase" meaning one outside the normal 10% tolerance allowed on this type of equipment. Under no signal conditions a reading of 2.4V should be obtained at the positive end of C60, rising to approximately 5.5V when a good signal is being received, thus biasing Tr3 into a lower gain condition. It is vital then to check that the low-gain condition is not caused by a.g.c. action through excess line output stage current. The PL509's cathode voltage is the key, and the most convenient point to measure it is at R37 on the i.f. strip.

R453 goes high resistance is lack of contrast and brightness. The suspicious will have noticed that there are two electrolytic capacitors that could cause trouble. When C69 which decouples R37 dries up the brightness changes from one side of the screen to the other. When C434 which decouples the PL509's cathode dries up the symptoms are uncontrollable contrast, or picture instability when the brightness and contrast controls are set higher than normally. Finally, consider what happens should the PL509's cathode bias resistor go open-circuit. Its cathode current will then pass via R36 and R37, which will burn out. This condition can even occur if the tripler shorts and none of the fuses blow.

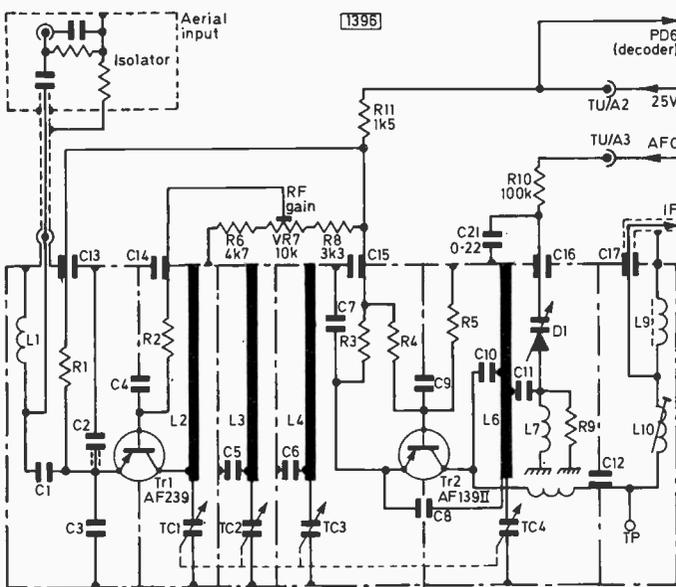
Fig. 5: Circuit of the Telefunken mechanical tuner.

Though manufacturers throw up their hands in horror at the mere idea of removing a tuner cover, or even worse an actual tuner repair being carried out by a non-boffin, nevertheless transistor replacement is not beyond the capabilities of a careful operator, given a steady hand, good eyesight and slim fingers. Provided the transistor leads are cut to the same lengths as those of the original, and that the transistor is positioned as nearly as possible in the same place as the original, any misalignment will be unnoticeable – particularly as few tuners are called upon to track all the way from the bottom of Band IV to the top of Band V.

The same remarks apply to the mixer/oscillator transistor, failure of this being very uncommon though not unknown. The symptoms are a blank raster and no sound, with some sound hiss because the i.f. stages are operating at full gain. With this symptom however the writer would again first advise a check of the voltage on R37, as the unusual beam limiting/a.g.c. system can cause similar symptoms – but more of that later.

Apart from the two transistors there is just one other semiconductor device in the Telefunken tuner, the varicap diode which provides a degree of a.f.c. This seldom fails but is hardly noticeable even when it does, because of the tuner's inherent stability.

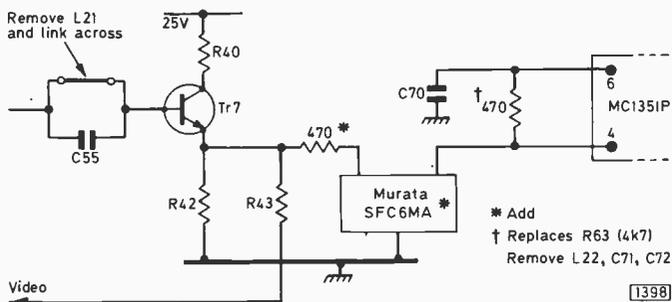
Fig. 6: Modification to remove caption buzz under difficult reception conditions. This should be tried only where normal adjustments fail to produce any improvement, and will not remove buzz due to signal overloading.

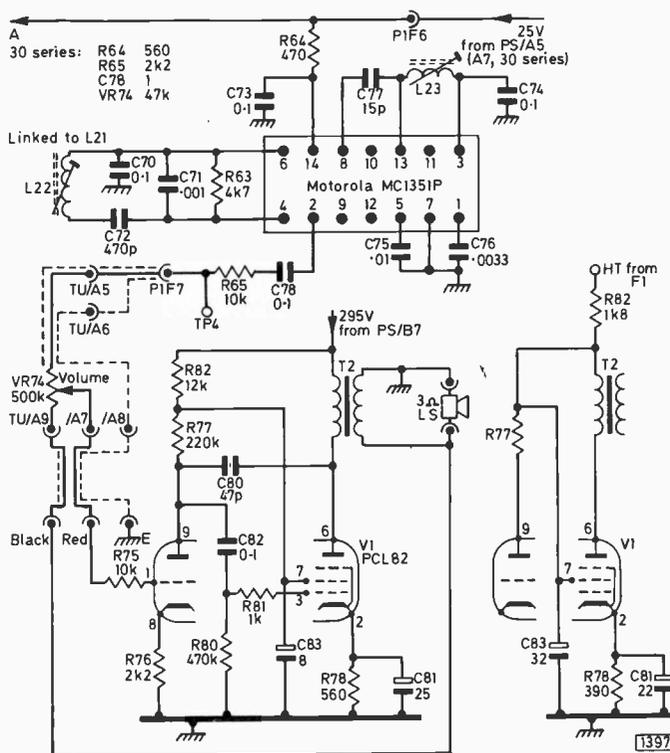
Fig. 7: The sound circuits. Modifications to the audio output stage in the 30 series chassis are shown on the right.

The PCL82 has a reputation for ruining bias resistors, screen grid feed resistors etc. due to internal faults which cause sudden increases in the operating currents. This was taken into account in the later 30 Series chassis by introducing several modifications. These, in order of importance, are as follows: the use of a stand-off type valveholder, provision of ventilation holes in the printed circuit board around the PCL82, use of a modified output transformer, and the uprating of some of the more vulnerable resistors in the circuit.

Intermittent sound on either panel can usually be traced to cracks in the print around the heavy and totally unsupported output transformer, particularly if the panel has been removed and replaced a few times. In cases of distortion try a new PCL82, check its pentode cathode components R78 and the decoupler C81 and also its screen grid feed resistor R82, and if necessary check the anode and cathode resistors R77 and R76 in the triode circuit – these also tend to change value.

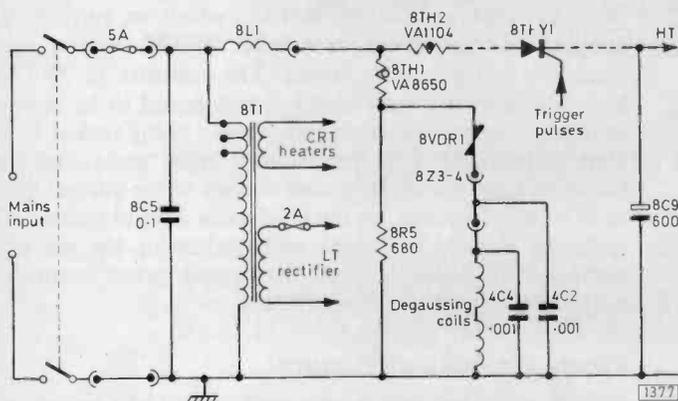
Fig. 1: Mains input circuit, Rank A823 colour chassis. Failure of the 5A mains fuse was found to be the result of a fault in the degaussing circuit.

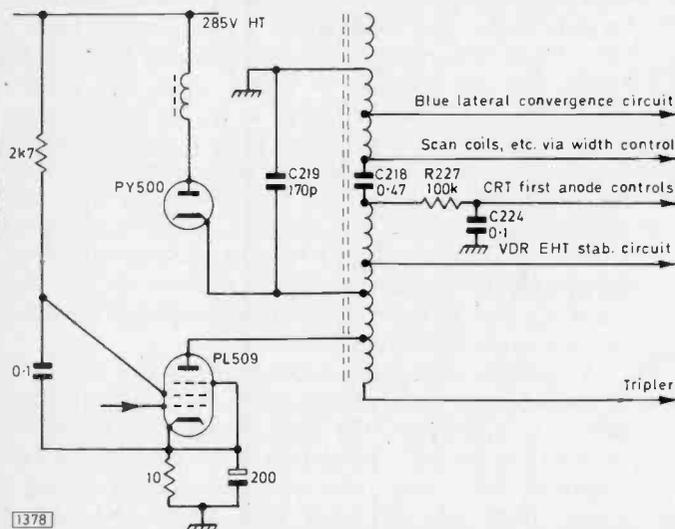
Fig. 2: Main elements of the line output stage in the Pye 691 chassis. The c.r.t. first anode voltage smoothing capacitor C224 going short-circuit blew the mains fuse. Up-rating this component from 1kV to 1.5kV gives improved reliability.

A 26in. Pye colour receiver fitted with the 691 chassis had a blown 2.5A mains input fuse. The fuse and the 0.02 μ F mains filter capacitor are on the mains side of the on/off switch in this chassis. The resistance reading across the mains side of the switch with the set switched off was infinity, so the filter capacitor wasn't shorted (in recent weeks we've had a succession of these capacitors going short-circuit in a variety of makes of set). There was no sign of a short from the h.t. rail to chassis, so attention was turned to the line output stage where a reading of only about 100 Ω was obtained between the anode of the PL509 line output valve and chassis (see Fig. 2). Our first suspicion was that there was a heater/cathode short in the PY500 efficiency diode, but both this and the PL509 turned out to be o.k. Our next suspect was the 0.47 μ F boost capacitor C218 which is connected between the line output

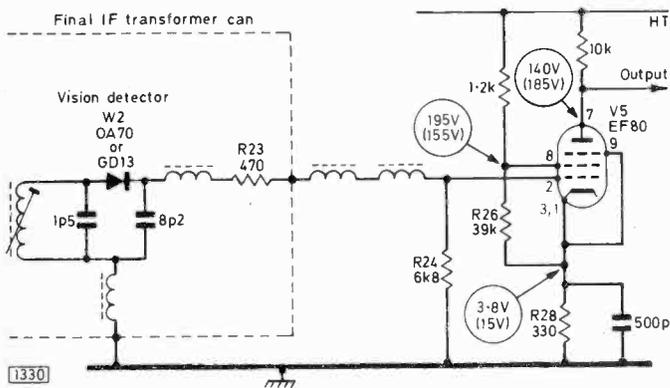
Fig. 3: Method of biasing the video output valve (V5) in the Thorn 980 chassis. Incorrect voltages, shown in brackets, were due to the bias stabilising resistor R26 having fallen in value to less than 3kΩ.

be checked since (see Fig. 3) the diode's output (cathode) is returned to chassis via three chokes, a 470Ω resistor and its 6.8kΩ load resistor R24 while its anode is returned to chassis via the secondary of the final i.f. transformer and a filter coil. Thus connecting an ohmmeter between the control grid of the EF80 video output pentode and chassis should measure the load resistor value one way (when the detector is reverse biased) but only the 470Ω resistor and the forward conductance of the diode the other way (diode forward biased). These tests showed that the diode and the associated resistors were in order, so next we checked the voltages in the video output stage.

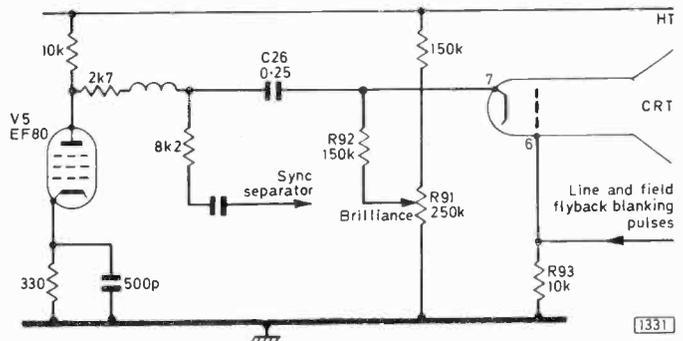
Fig. 4: Method used to bias the c.r.t. in the Thorn 980 chassis. The grid is at chassis potential while the d.c. level at the cathode is set by the brilliance control, the a.c. coupled video signal being superimposed on this bias.

The cause of the trouble was an intermittent short in C26. Varying the setting of the brilliance control under the fault condition made no difference because of the inclusion of R92 (150kΩ). The fault was unusual since this is about the only time I have come across a voltage carrying capacitor that intermittently short-circuited itself and then healed up. Normally a capacitor which has gone short-circuit breaks down on application of its working voltage, even if it reads o.k. on an ohmmeter test.

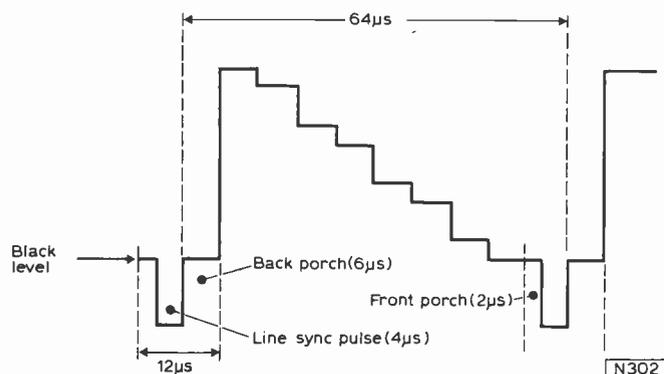
Fig. 1: The grey scale video signal. Each step lasts approximately $6.5\mu\text{s}$.

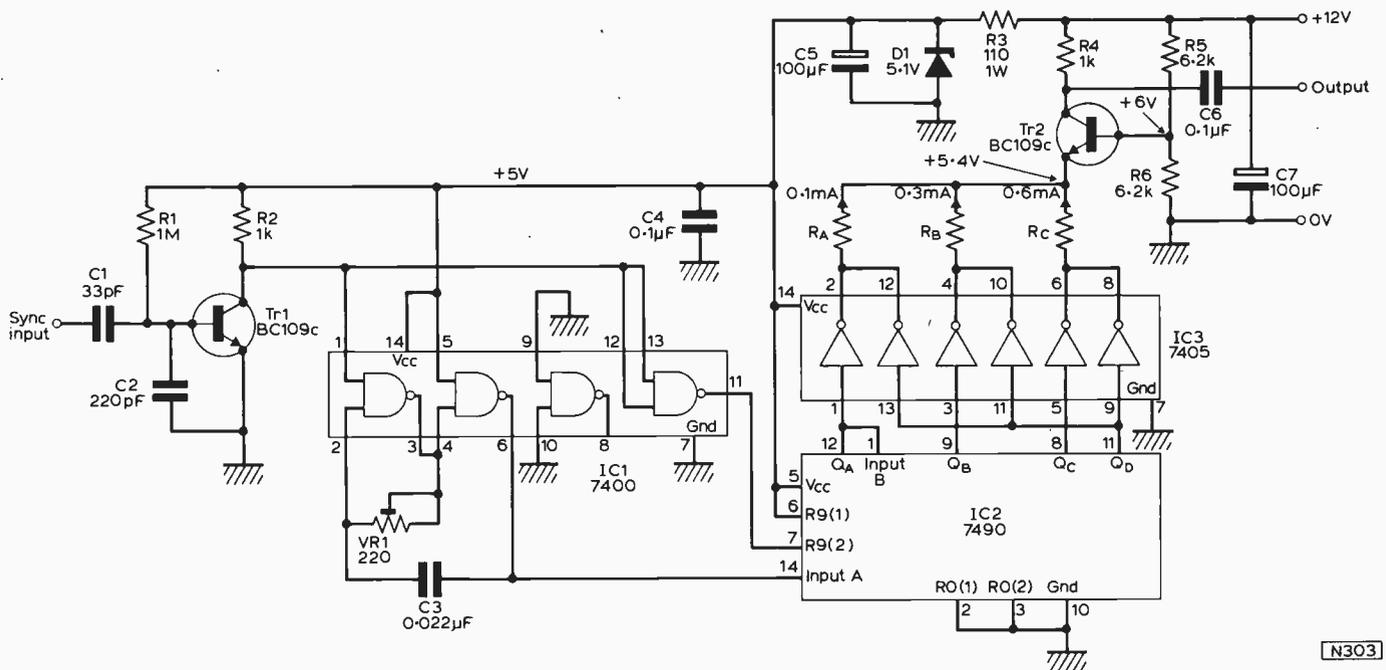
Fig. 2: Complete circuit of the simple grey-scale generator. The currents shown for RA, RB, and RC, are those required to produce an output signal of 1V peak amplitude. See section "Modifications".

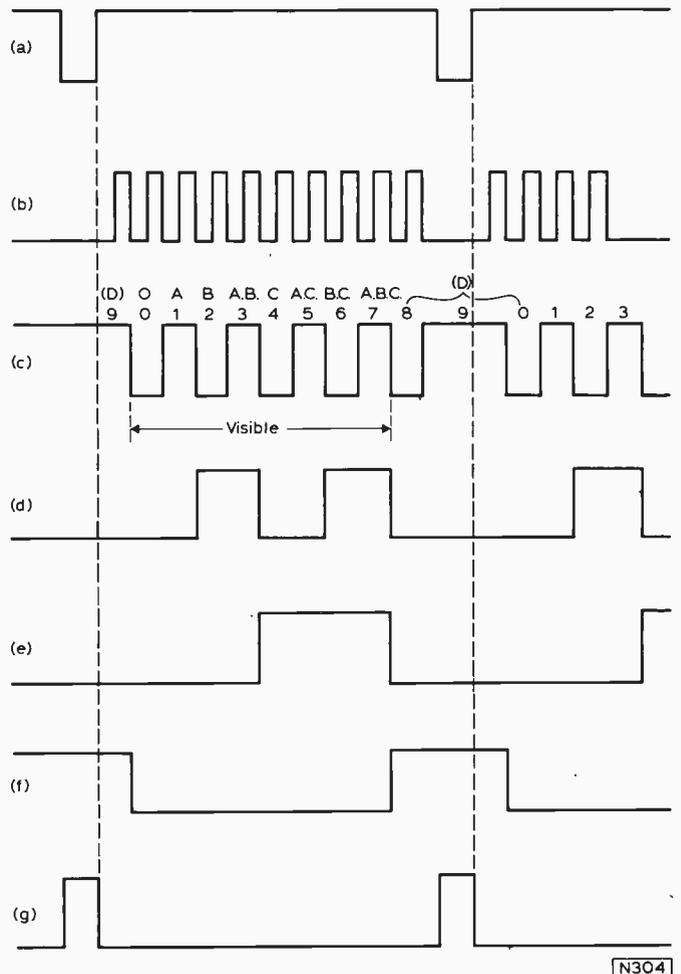
Fig. 3: Idealised waveforms. (a) Tr1 collector pulse. (b) IC2 input, pin 14. (c) IC2 output A, pin 12. (d) IC2 output B, pin 9. (e) IC2 output C, pin 8. (f) IC2 output D, pin 11. (g) Reset pulse, IC2 pin 7.

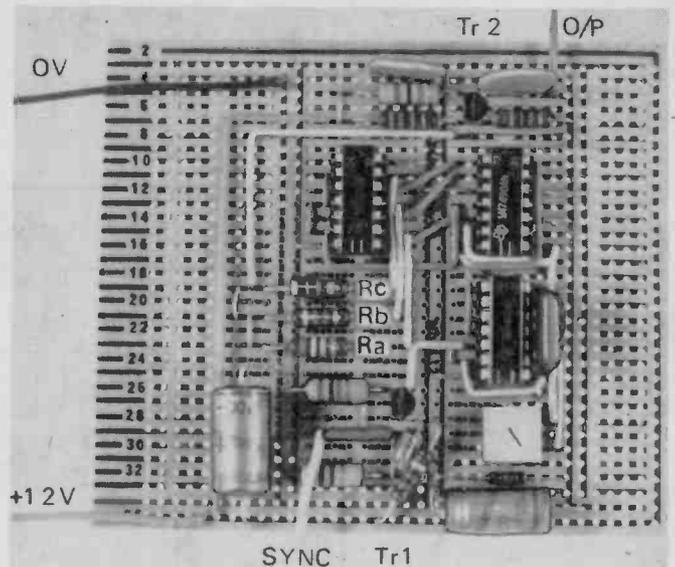
The completed generator, constructed on a West Hyde Prototype board.

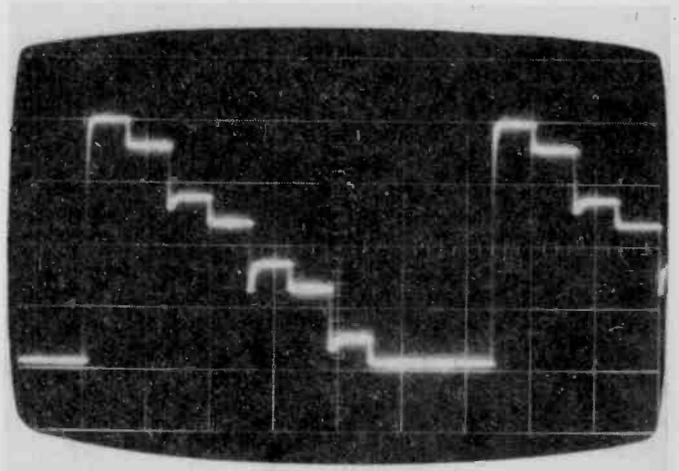
The generator output waveform. (Scale – Vertical: 0.5V/cm, Horizontal: 10μs/cm.)

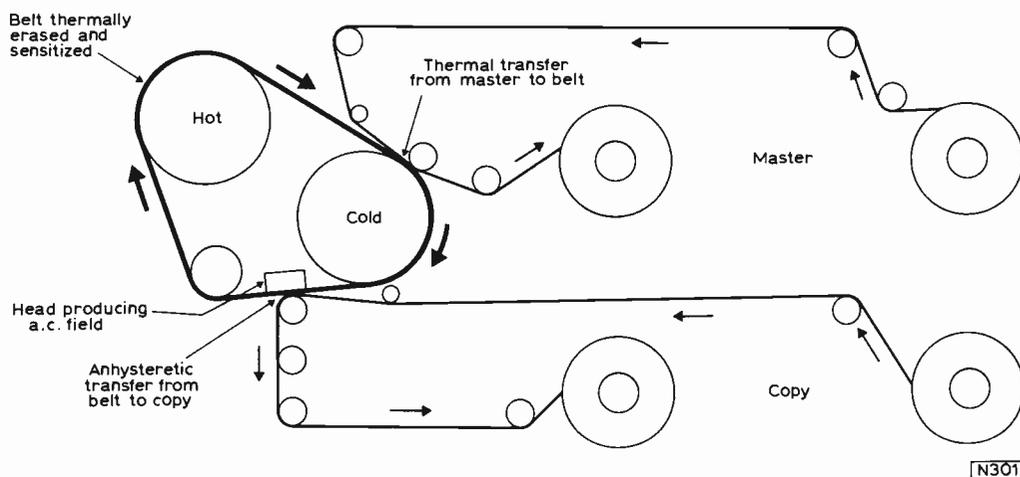
Fig. 1: Basic principle of the STAM high-speed contact copying process.

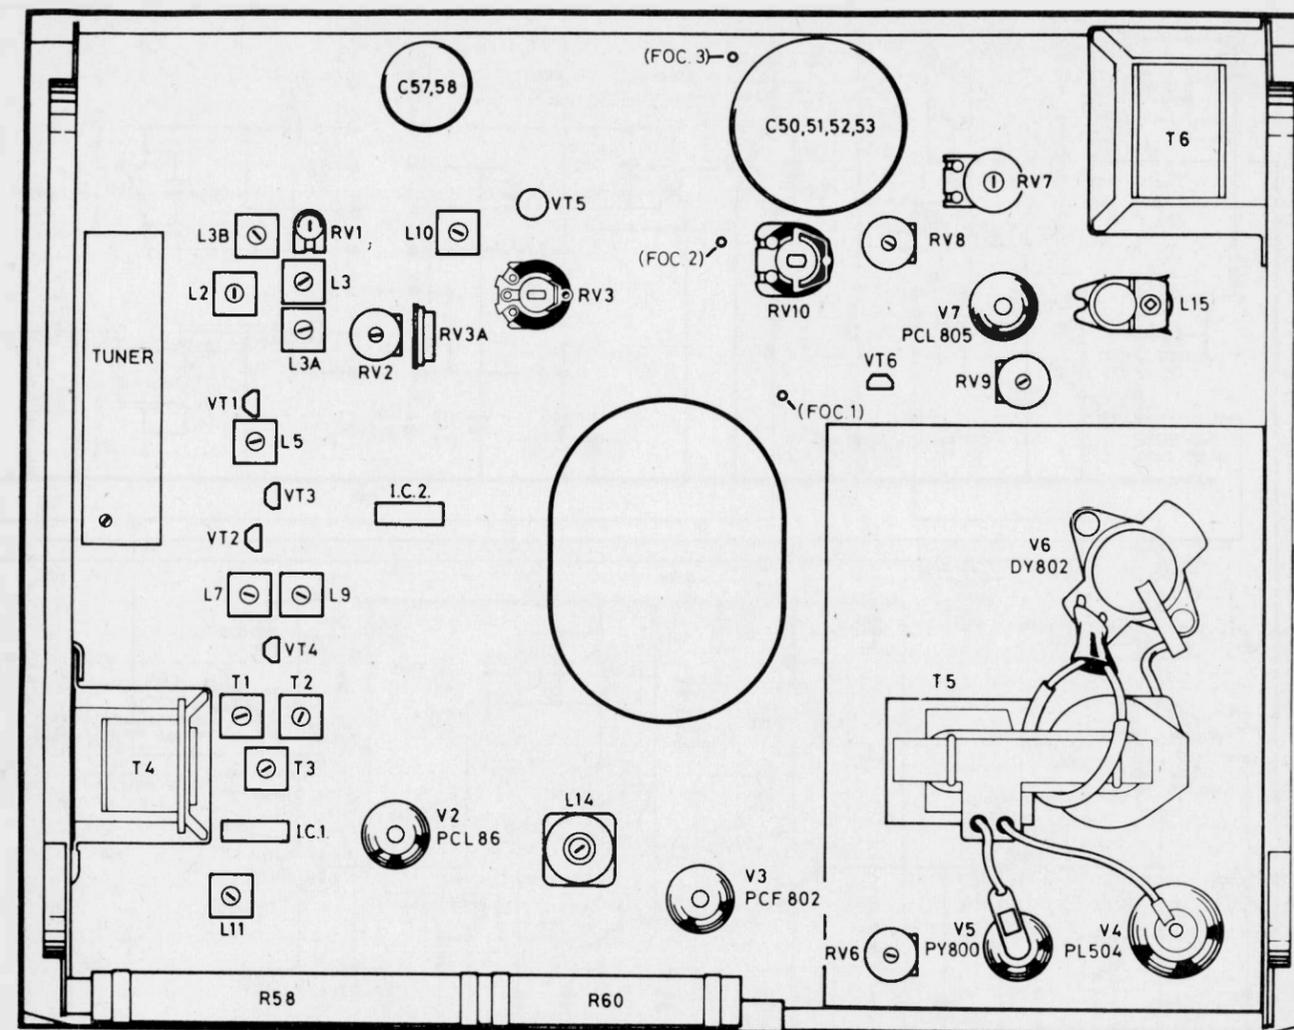
Fig. 1: Plan view of the chassis.

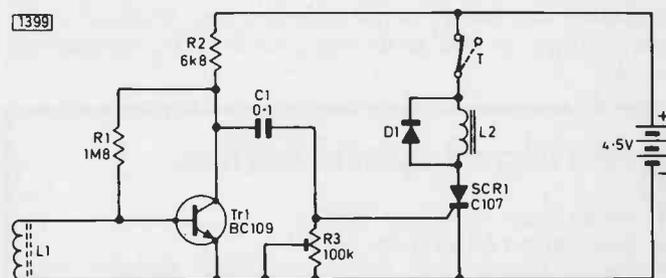
Fig. 1: Circuit diagram of the extension telephone bell, using pickup coil, devised by J. J. Herbert. The pickup coil L1 consists of 300 turns wound on a ferrite rod and placed near the telephone. T is the doorbell make and break contacts — these must be of the normally closed type — and L2 the doorbell solenoid. Diode D1 provides protection against back-e.m.f. spikes. Suitable batteries: three SP2 or a bell battery. The circuit can be easily built on a small piece of Veroboard and the bell made to plug in on a long lead.

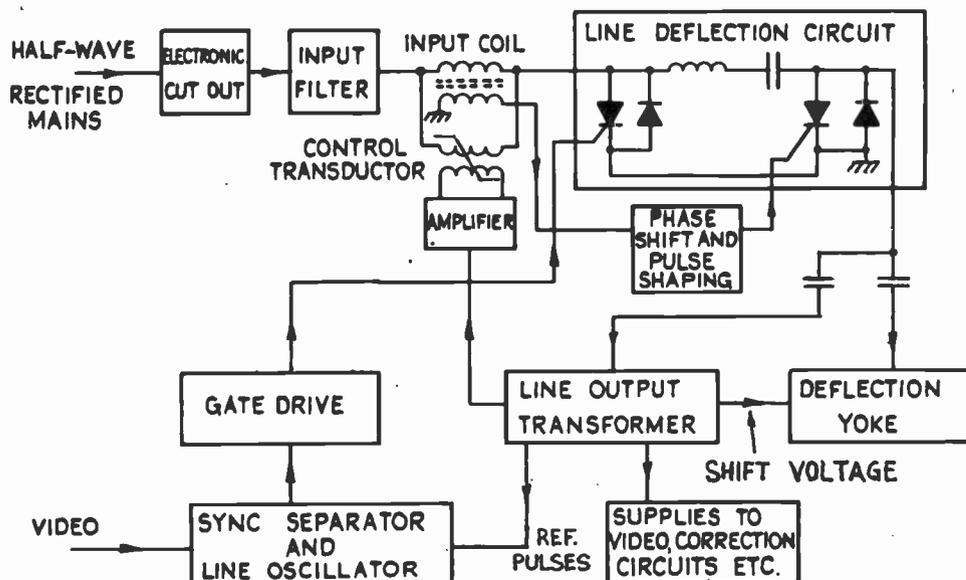
Block diagram of a thyristor line timebase, showing how it fits into the complete receiver circuit. Stabilisation is achieved by using a transductor to control the input power. Any supplies derived from the line output transformer will also be regulated therefore. Courtesy I.T.T.

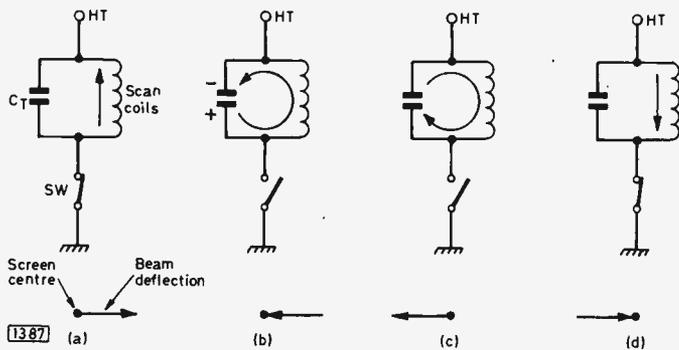
Fig. 1: Basic Blumlein line output circuit, which acts as a tuned circuit during the flyback period. (a) When the switch is closed a linearly increasing current flows through the scan coils in the direction shown, deflecting the beam to the right-hand side of the screen. Magnetic fields build up around the coils. (b) When the switch is opened the magnetic fields collapse, charging the tuning capacitor. The beam returns rapidly to the centre of the screen. (c) The capacitor then discharges via the coils, rapidly deflecting the beam to the left-hand side of the screen to complete the flyback. The circuit energy is once again stored in the form of magnetic fields around the coils. (d) If the switch is now closed, no further oscillatory action can take place and as the magnetic fields collapse a decaying current flows through the coils in the direction shown, deflecting the beam from the left-hand side of the screen towards the centre. This is known as the energy recovery part of the scanning cycle.

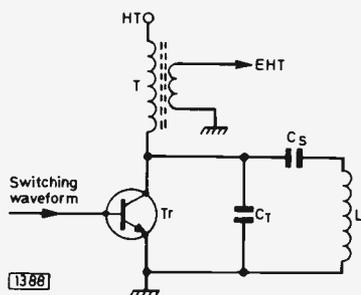
Fig. 2: Transistor line output stages usually take the form shown here. The transistor acts as a bidirectional switch, acting as efficiency diode (energy recovery) during the first half of the forward scan, then driving current through the primary of the output transformer T during the second half of the forward scan. C_t tunes the coils – L – during the flyback, while the scan-correction capacitor C_s charges and discharges during the forward scan to drive current through the scan coils.

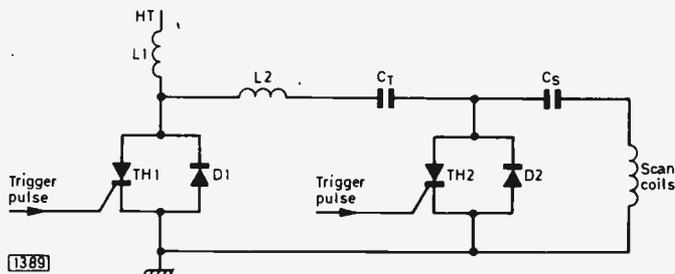
Fig. 3: The thyristor line output circuit developed by RCA, shown here stripped to the barest essentials. There are separate bidirectional forward scan and flyback switches – TH2/D2 and TH1/D1 respectively. The tuning capacitor is returned to chassis via the flyback switch. TH1 is switched on just before the flyback, current then flowing into C_t via L2: L2 and C_t form a tuned circuit, the pulse thus produced being used to switch off TH2. C_t tunes with L2 to produce the pulse to switch off TH2 (the commutating pulse), and with the scan coils to provide the flyback.

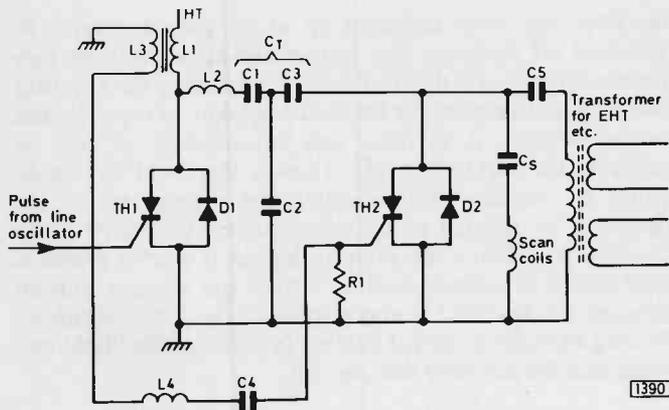
Fig. 4: A more practical form of thyristor line output stage. The tuning capacitor consists of three capacitors in a T network so that the working voltages can be reduced. C5 couples a transformer to the circuit to enable the flyback pulse to be used for the generation of e.h.t. and other supplies. The trigger pulse for TH2 is obtained from a secondary winding wound on L1, with shaping by means of L4, C4 and R1.

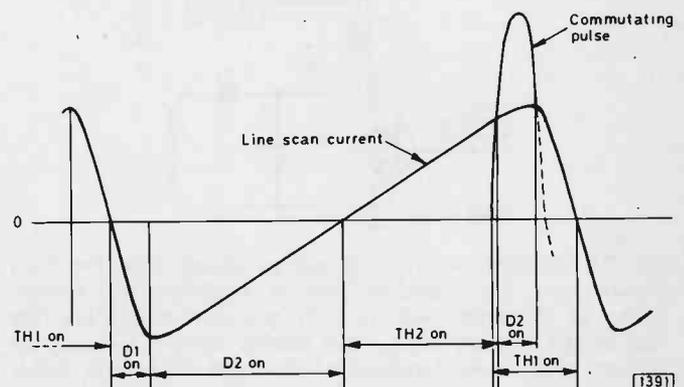
Fig. 5: Current waveforms during the scanning sequence, showing which active components are conducting during the various stages of the scan cycle.

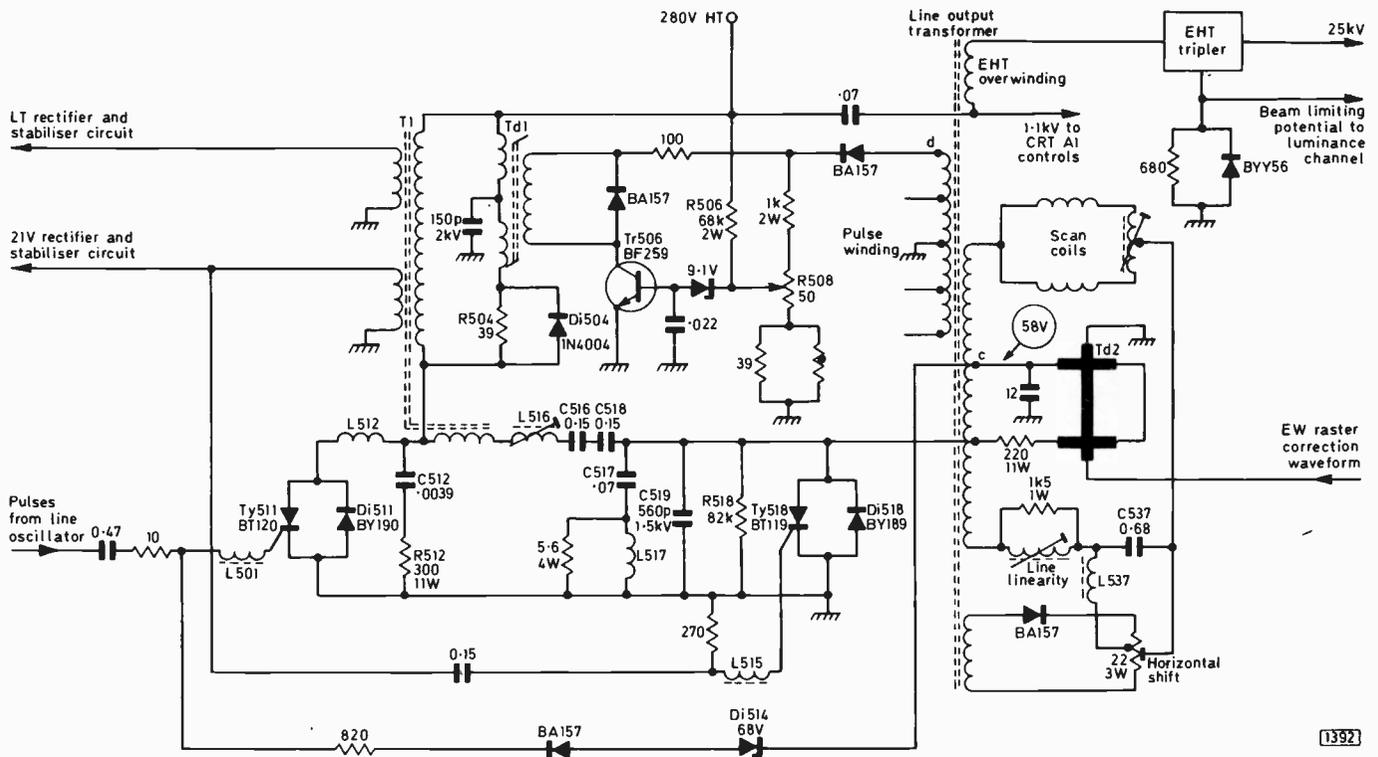
Fig. 6: A practical thyristor line output circuit – as used in the Grundig Models 5011 and 6011. Width/e.h.t. stabilisation is achieved by shunting a transducer (Td1) across the input transformer. The impedance presented by Td1 is controlled by Tr506 which senses the h.t. voltage and the pulse voltage at tag d on the line output transformer. R518 provides circuit damping; C519 provides pulse suppression to remove a shading effect across the screen.

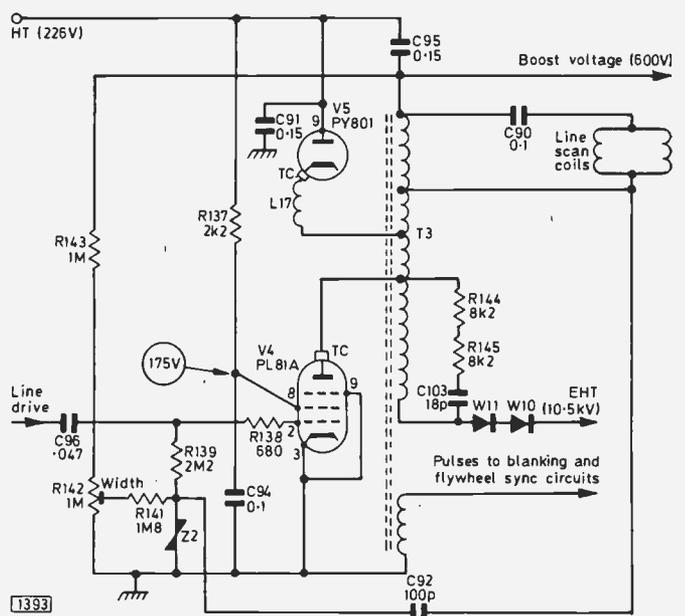
Fig. 1: The line output stage used in the Thorn 1580 chassis. This is quite conventional, with the boost reservoir capacitor C95 returned to the h.t. line. R144/R145/C103 form a damping network, C103 also providing third harmonic tuning.

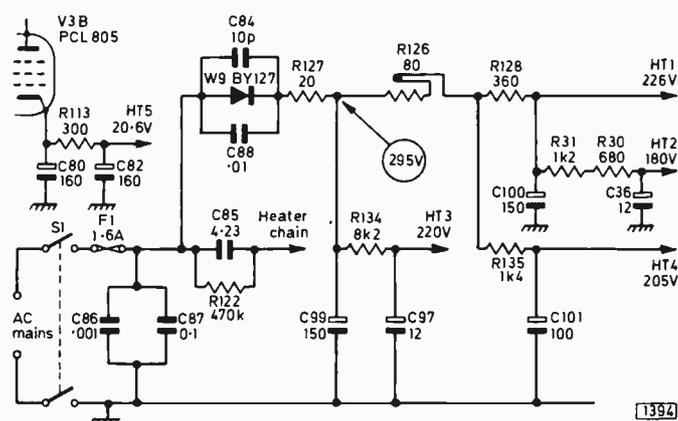
Fig. 2: The power supply arrangements used in the Thorn 1580 chassis. Capacitor C85 forms the heater circuit dropper, with R122 providing a discharge path. The field output pentode's cathode current is drawn via the low-voltage transistor circuits to provide the 20.6V supply (HT5).

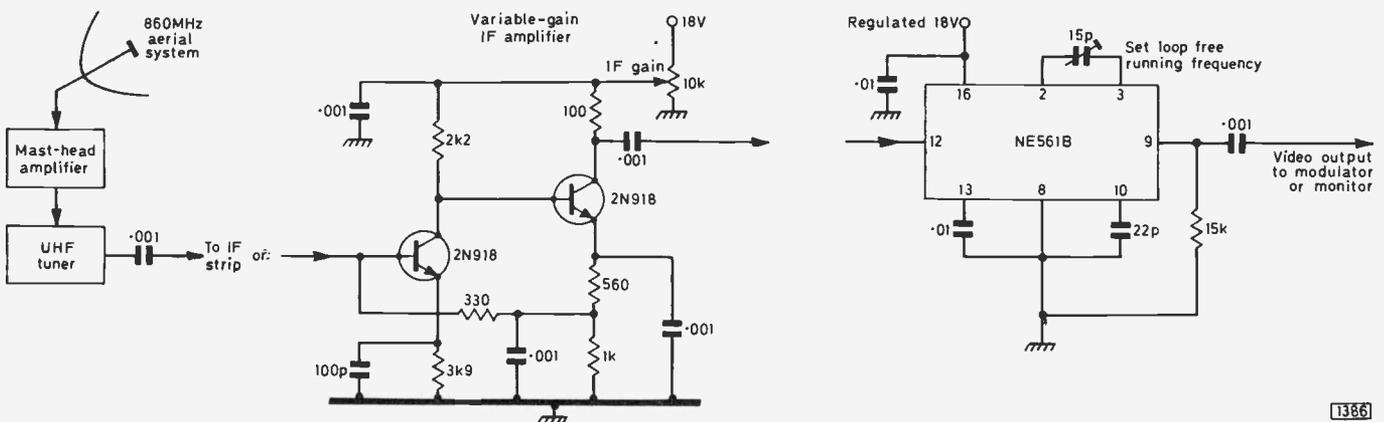
Fig. 1: Steve Birkhill's receiving system for the Indian ATS-6 satellite transmissions. The signal picked up by the dish passes via a mast-head amplifier to the u.h.f. tuner and then to either the two-stage i.f. amplifier shown above or a conventional i.f. strip. The amplified i.f. signal is demodulated by an NE561B phase-locked loop i.c.

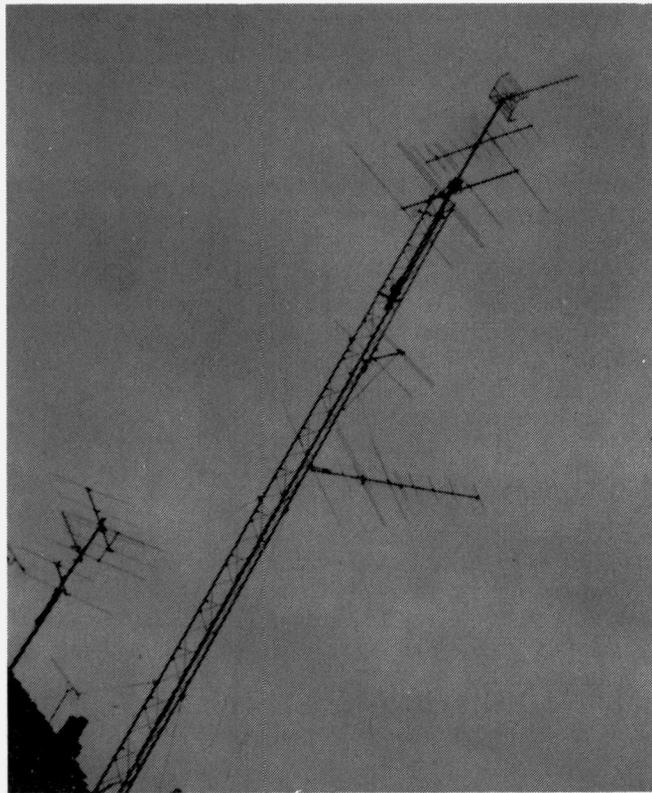
New aerials and mast in my back garden. The guy wires are at 20 and 30 feet. (No, the mast isn't really at the angle shown here!)

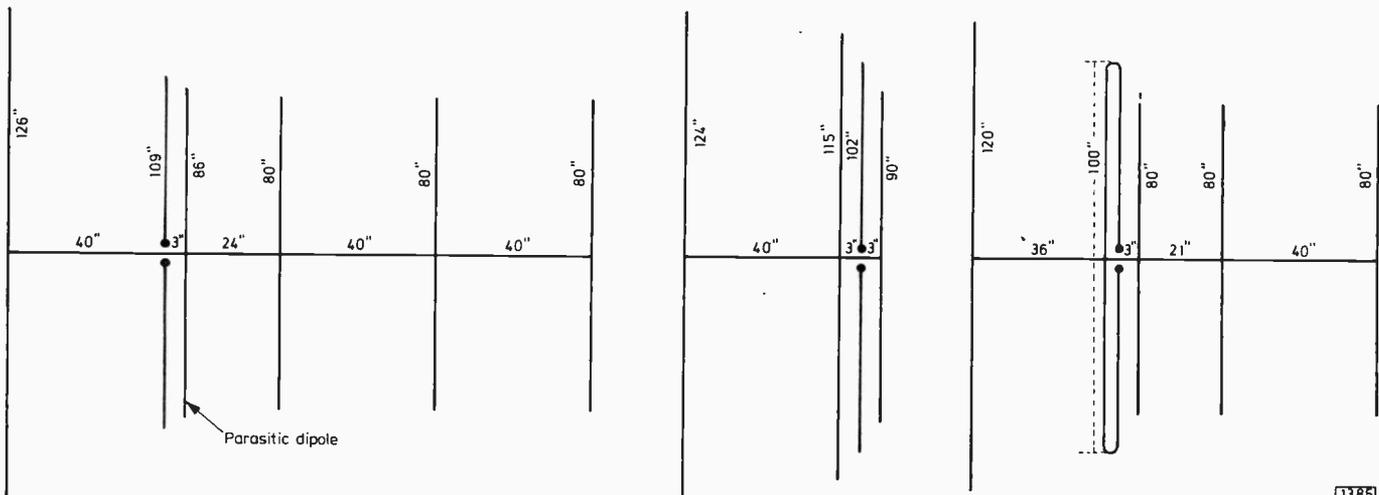
Fig. 2 (left): The Doug McFayden Band I aerial, covering New Zealand channels 1-3. Fig. 3 (centre): Ian Beckett's design for a small, wideband Band I array. Fig. 4 (right): My own recently-constructed Band I design, using a folded dipole.
