JULY 1978

# TELEVISION

**SERVICING-VIDEO-CONSTRUCTION-DEVELOPMENTS**

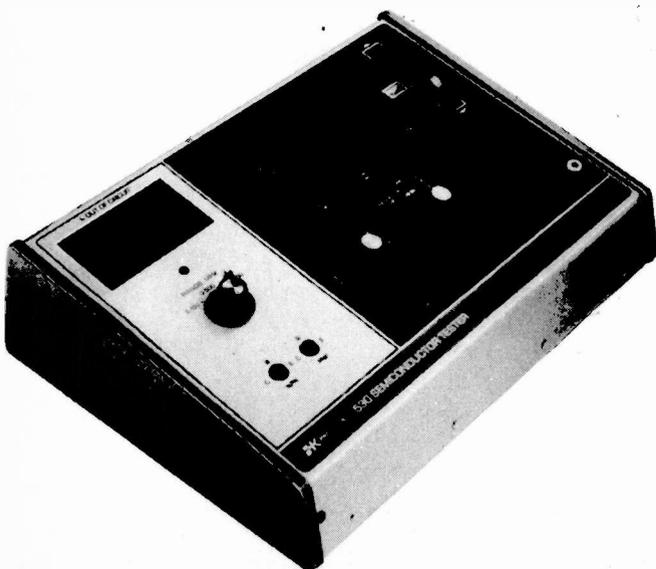
The B & K 530 semiconductor tester.

first go/no go test. Beta or Hfe is indicated by a clear meter directly calibrated, and can be measured under high and low drive conditions. In the former case, no less than 2A can be passed through the device, but the same pulse technique as in the first test is used with a 1% duty-cycle to avoid over dissipation in power transistors and obviate the risk of damage to signal types. For f.e.t.s the same meter provides a directly calibrated readout of the equivalent parameter gm.

The leakage current test is carried out by applying an adjustable d.c. potential between the electrodes in question, any resulting leakage current being indicated on the meter. Leakage in any mode may be checked, and because of the wide variations possible the meter is driven by an ingenious four-stage circuit each section of which drives a segment of the meter. This results in an approximately logarithmic current scale capable of resolving with ease any current from a microamp to five milliamps. For applied voltages up to 10V, leakage current is limited to 5mA by the internal circuitry. For test voltages above 10V the current is limited to 100 $\mu$ A.

This brings us to the breakdown voltage test. All semiconductor junctions will break down at some point of reverse-bias voltage, the most common example being the zener diode in which the reverse breakdown voltage is the primary parameter. Except for MOSFET devices, this breakdown is not destructive provided the current is limited to a suitably low value. These requirements are met in the 530, and a calibrated potentiometer is provided with which the applied voltage can be wound up to 100V. A sudden increase in the leakage current reading signifies the onset of breakdown, and the voltage at which this occurs can be determined.
