# AND HOME ELECTRONICS REPAIR SEPTEMBER 2002 £3.10

# Promax MC377+ signal analyser

# Servicing the Sony FE-1 chassis

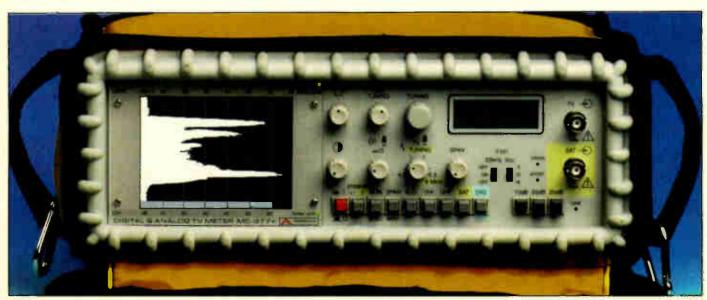
Photo 1: The front control and display panel. (dB) that's used in the spectrum-analyser mode only.

The two knobs nearest the CRT screen are for brightness and contrast control. The smaller knob to the right of the brightness control is for fine tuning, with the larger main tuning knob to the right of this.

The digital display indicates the frequency of the TV channel being received. Alternatively, when the spectrum-analyser display span is switched to maximum the tuning knob moves a cursor to the required part of the band then, when the span button is depressed, a frequency readout is obtained. A disadvantage is that there's no reference anywhere to TV channel numbers, just to frequency, so you have to be familiar with the local TV frequencies.

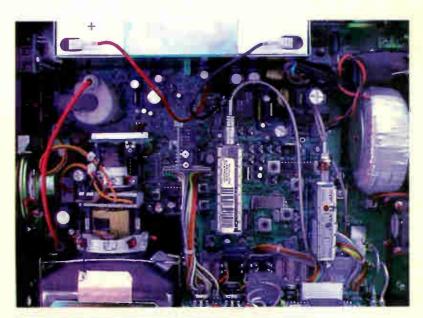
Photo 2: Internal view of the unit, showing the solid construction.

be clearly seen, near the front of the PCB, with the battery at the rear and the mains transformer at the right-hand side of the chassis. The main tuning control is the large, blue multiturn potentiometer to the right of the CRT.

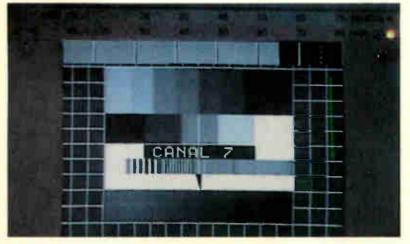
Photo 4: C-band reception of Argentina ATV channel 7.

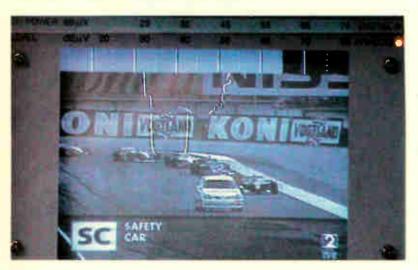
Photo 6: Close-up view of TVE-2 reception in ch. 45.

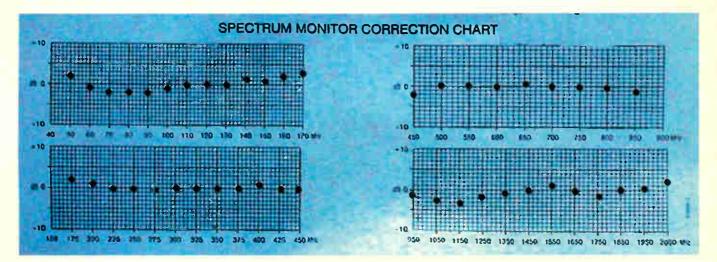
Photo 8: Reception of a Spanish DTT signal in ch. 48.

Photo 8 shows a Spanish ch. 48 (687-25MHz) terrestrial digital TV signal. We've no DTT

transmissions at present here in Portugal, so I've no experience of local reception. To measure the signal, press the blue digital button. The digital channel power can then be read directly from the top scale. In this example it's just over  $55dB\mu V$ . Virtually no correction is required.

The bottom dark blue bar display indicates the carrierto-noise ratio of the signal, at just over 25dB in this case. The noise-limit LED at the lower right-hand side of the screen is lit, which according to the manual indicates that the noise floor is below that of the receiver, so the actual C/N ratio is greater than that displayed. Digital signal measurement in the satellite band is identical.

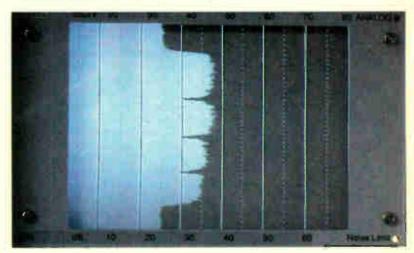
Photo 9: Spanish digital TV signals in chs. 66-69.

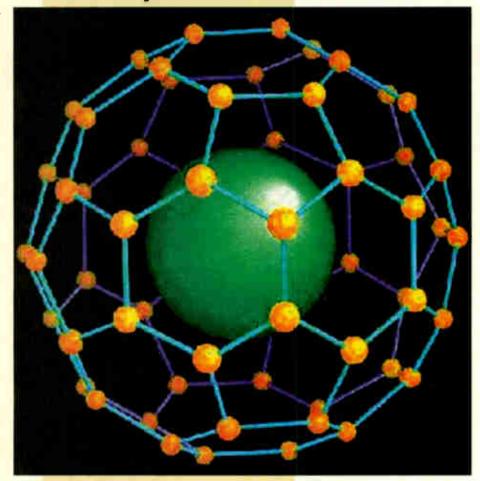
Photo 1: Basic carbon molecular fullerene structure.

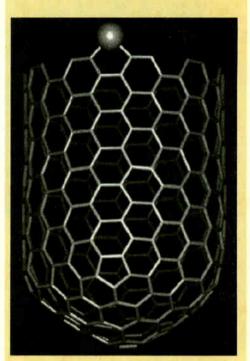
Photo 2: Basic carbon nanotube structure.

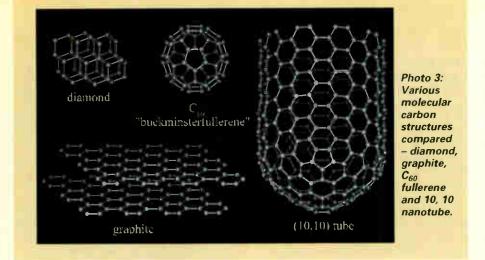
Nanotubes are a designed variant of the fullerene. The latter tend to form when a graphite sheet is 'rolled up', adding pentagons that create curvature. Each molecule becomes a cage (soccer-ball) structure. Carbon nanotubes - see Photo 2 – can be considered as elongated fullerenes with the ends cut off. This arrangement is referred to as a single-walled nanotube (SWNT), Instead of the combination of hexagons and pentagons that form a ball, the atoms in a straight-sided nanotube are arranged as sheets of hexagons. The result is a material that's quite different from the fullerene type, with extraordinary properties. A vital feature is that the properties depend on how the sheets are rolled.

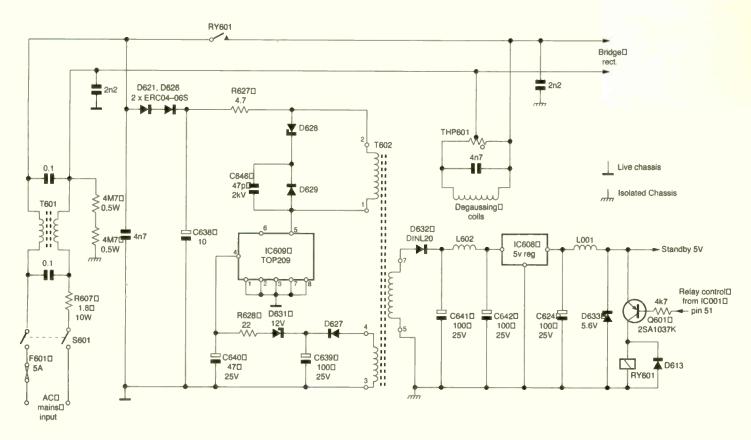
Fig. 1: The mains input circuitry and the separate standby power supply circuit used in the Sony FE-1 chassis.

The mains input is half-wave rectified by D626 and D621 (type ERC04-06S), producing about 180V across the reservoir capacitor C638. This supply is fed via the surge-limiting resistor R627 to pin 2 of the standby chopper transformer T602. Pin 1 of the transformer is connected to IC609's drain connection, at pin 5. A snubber circuit consisting of D629, D628 and C646 is connected between pins 1 and 2 of the transformer to limit spikes that might damage IC609.

Operation of IC609 is governed by the voltage at pin 4. This is used for both regulation and start-up. At switch-on there will be no voltage at pin 4. A comparator within IC609 detects this condition and connects an internal resistor between pins 4 and 5, charging C640 and C639. Once the voltage at pin 4 has risen to 5.7V, the internal resistor is disconnected and drive is applied to the internal chopper transistor. During normal operation D627 provides the voltage for pin 4 of IC609, derived from winding 3-4 on the transformer. The voltage at pin 4 is then used to control the duty-cycle of the supply. It should be

If there's an overload on the standby 5V supply the voltages produced by T602 will fall. Thus the voltage at pin 4 of IC609 will also drop. Once this voltage falls below 4.7V IC609 will revert to its own start-up mode, charging C640. When the voltage across this capacitor reaches 5.7V IC609 will attempt to operate normally again. If the overload condition is still present the trip cycle will be repeated. Tripping to the safe state will continue as long as the overload persists.

Operation of the excess-current trip can be checked by measuring the voltage at pin 4 of IC609. In the trip condition it will ramp between 4.7V and 5.7V every few seconds.

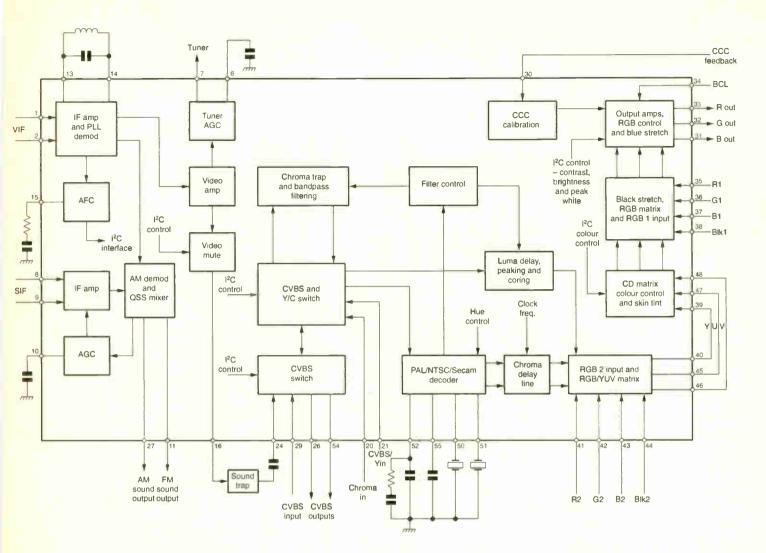
Fig. 1: Simplified block diagram of the signal-processing sections of the TDA8855H chip IV01. residual video-signal components and finally appears at pin 11 of IV01.

The FM sound carriers (6MHz mono and 6.552MHz Nicam) are generated by the QSS mixer. In this stage the FM sound is mixed with the vision PLL reference frequency. The output is then passed through a high-pass filter to reduce the

The audio outputs from IV01 are fed to IS40 for further amplification and processing. We'll return to this next month. The output from pin 11 is level-adjusted by transistor TS01 before application to IS40.

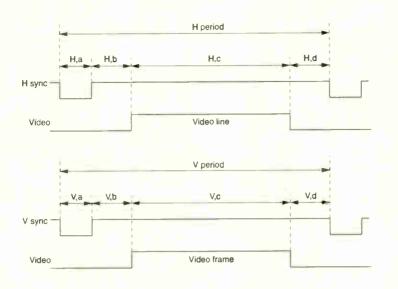
Fig. 2: Signal timing diagram, see Table 1.

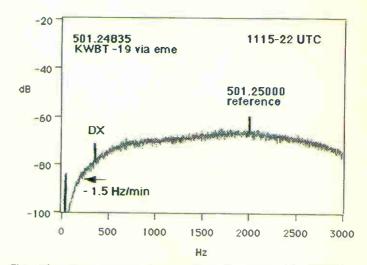
Fig. 1: Spectrum analysis showing the audio signal spike (DX) with KWBT-19 moon-bounce reception by Anthony Mann in Perth, Australia on May 26.

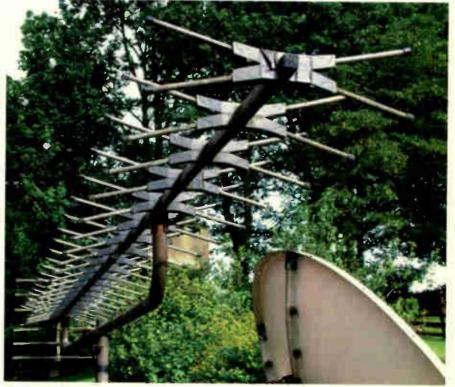
Bill Wright's Antiference XG21CD array critically mounted for reception from the Winter Hill transmitter in South Yorkshire.
