TELEVISION

AND CONSUMER ELECTRONICS

JANUARY 2005

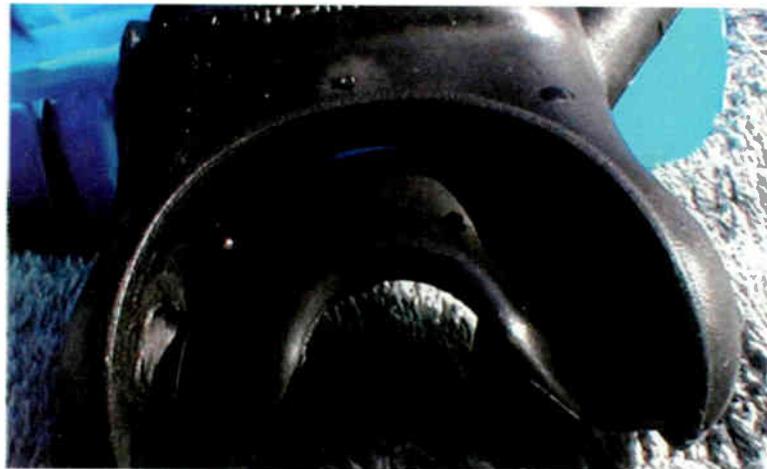
Photo 1 (top): Close-up view of the mouthpiece. The odd 'leg' on the right-hand side is the electrical connection to the radio circuitry.

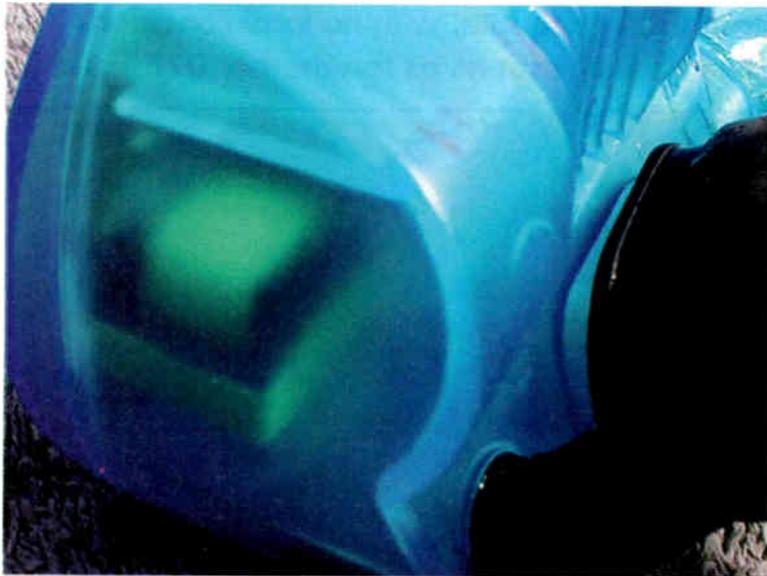
Photo 2 (middle): Close-up view of the body of the radio, showing the transducer driver transformer.

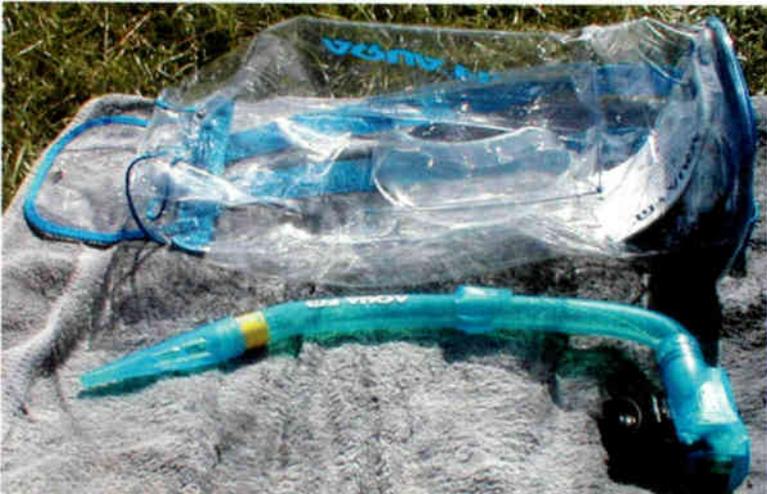
Photo 3 (bottom): The Aqua FM with its heavy-duty carrying case. That clear plastic is thick and tough.

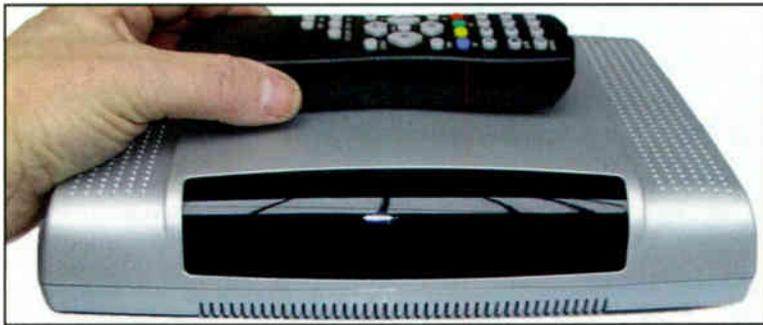
Typical example of digital picture breakup (pixellation) under poor-signal conditions, when the digital decoder can't cope.

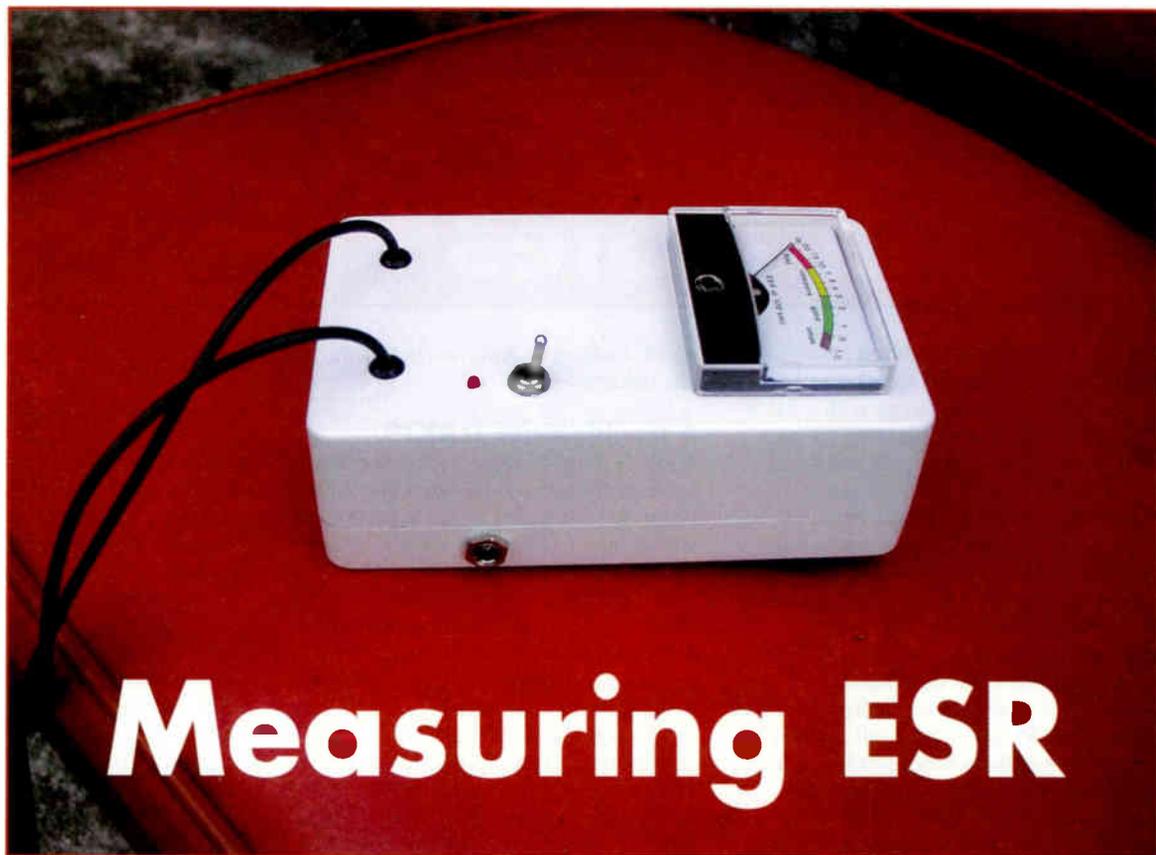
This second, concluding instalment completes the description of Alan Willcox's latest ESR meter, with a suggested stripboard layout and component specifications

In Part 1 last month I dealt with ESR and its measurement, and described the significant features of my latest ESR meter design. I'll start this month with a description of the basic circuitry used.

Fig. 4 (see page 78 last month) shows the basic ESR meter circuit. The important features of the oscillator and test interface sections were covered last month. There is no need for a regulated power supply. Just to remind you, the amplitude of the HF output waveform obtained from the oscillator (IC1a) is set by the characteristics, which are virtually temperature-stable, of the two diodes D1 and D2 in the negative-feedback path between pins 1 and 2. The amplification and detection levels provided by the other stages are set by the ratio of the source and feedback resistor values used. This is standard operational-amplifier practice. The way in which operational amplifiers work was covered in some detail in my articles in the March/April

That is all there is to the basic circuit. But the operational amplifiers require positive and negative supplies. This requirement is provided by IC3b, see Fig. 6, which is configured as a voltage-follower. There is 100 per cent negative feedback (pins 7-6), so the output voltage must settle at half the supply voltage, set by the equal ratio of R14 and R15. I was pleased to find that the circuit remains stable with outputs as low as $\pm 3.1V$. This lower supply voltage range is quite consistent.

quick in-circuit location of faulty electrolytic capacitors. If anyone contemplates the design of a PCB for the project, it is important that separate operational-amplifier chips are used for the oscillator and the first amplifier stage – to avoid interference between the oscillator and the sensitive first amplifier stage. Fig. 7 shows a stripboard layout for the meter's circuitry. Fig. 8 shows the meter scale.

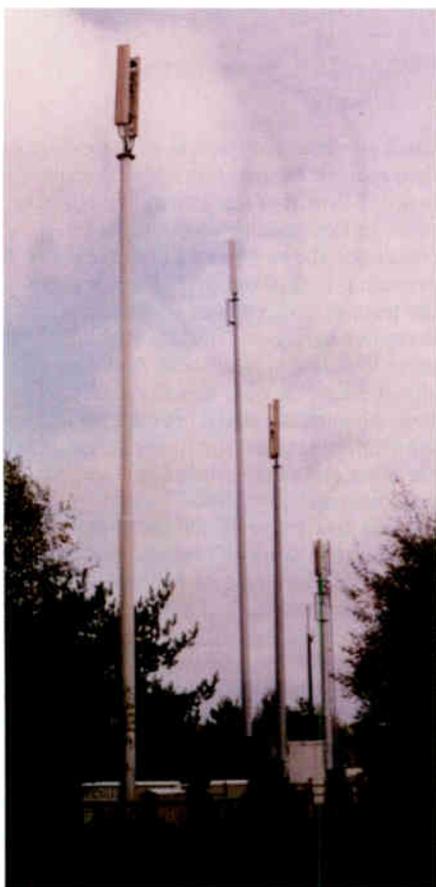
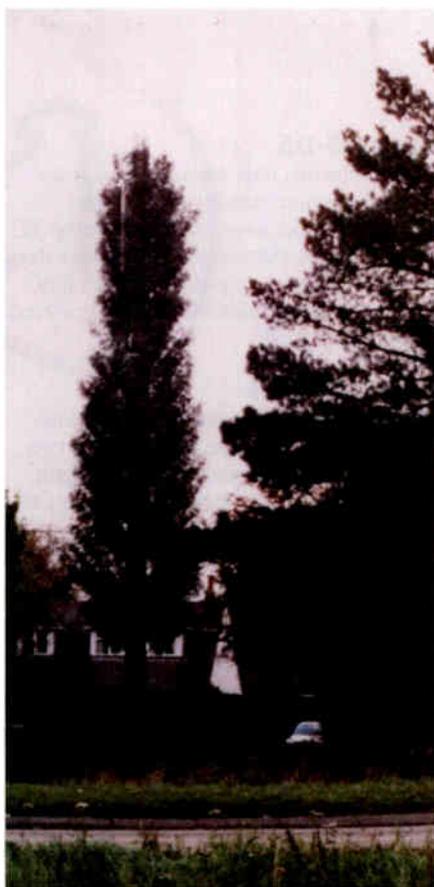
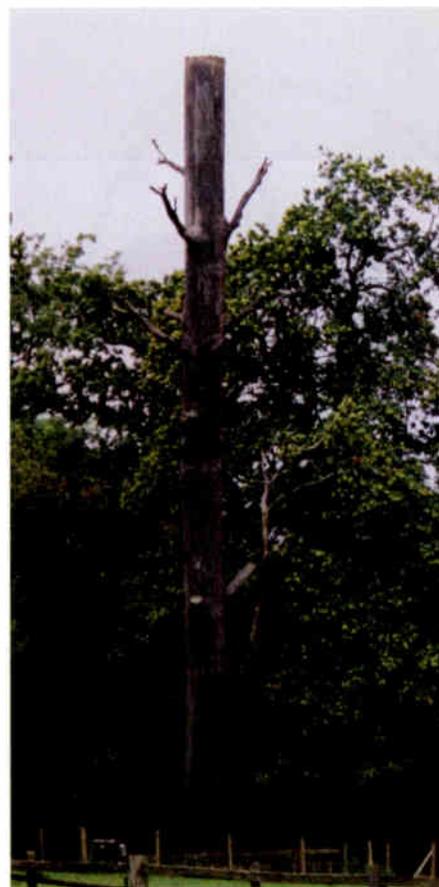
Left: A row of cellular phone masts adjacent to the M27 at Copythorne, the entrance to the New Forest. Centre: An Alan Dick Company Treepole mast near Fawley, Hants (A326). Right: A Lightning Treepole mast near Dorking, Surrey.

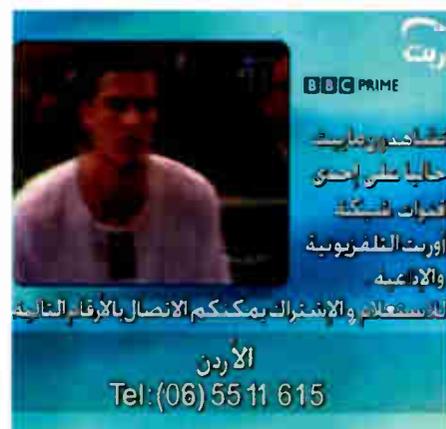
Photo 3: A Nilesat feed at about 12.202GHz.

Newsfeeds are uplinked between 12:19-12:3GHz, with vertical polarisation, 3/4 FEC and a symbol rate of 2,894, 5,788 or 6,111. Photo 3 shows a feed received at about 12:202GHz with a symbol rate of 5,788. The Palestinian channel at 12:192GHz is used to uplink signals to the multiplex at 11:804GHz.

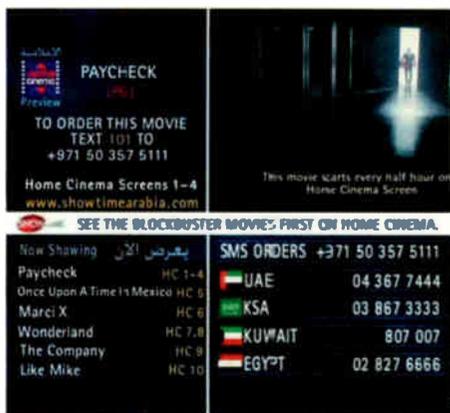
Photo 4: Promo channel from Nilesat at 11.938GHz.

11.919GHz/H	27,500	5/6	Show Net.
11.938GHz/V	27,500	3/4	Orbit Network** plus Promo Channel (see Photo 4).
11.958GHz/H	27,500	3/4	ADD**.
11.977GHz/V	27,500	3/4	Showtime Network** and unencrypted Showtime promo channel (see Photo 5).

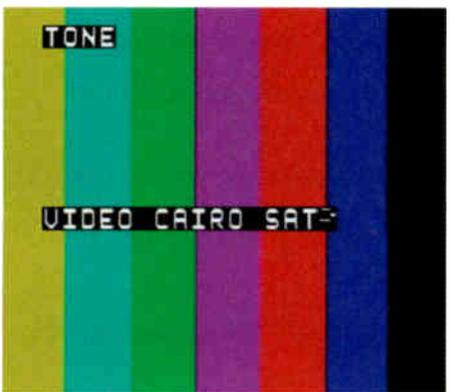
Photo 6: Saudi Arabia TV2 via Nilesat at 12-054GHz.

12.054GHz/V	27,500	3/4	Saudi Arabia TV1, TV2* (see Photo 6) and various other TV and radio stations.
12.130GHz/V	27,500	3/4	Various Lebanese TV and radio stations.

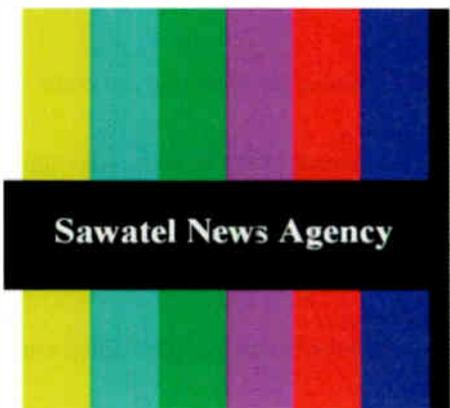
Photo 7: Video Cairo Sat feed via Nilesat at 12-149GHz.

12.149GHz/H	27,500	3/4	Sahar 1, Video Cairo Sat feeds (see Photo 7), Al Jazerra feeds, Sawatel feeds (see Photo 8).
12.192GHz/V	2,894	3/4	Palestinian Satellite channel.

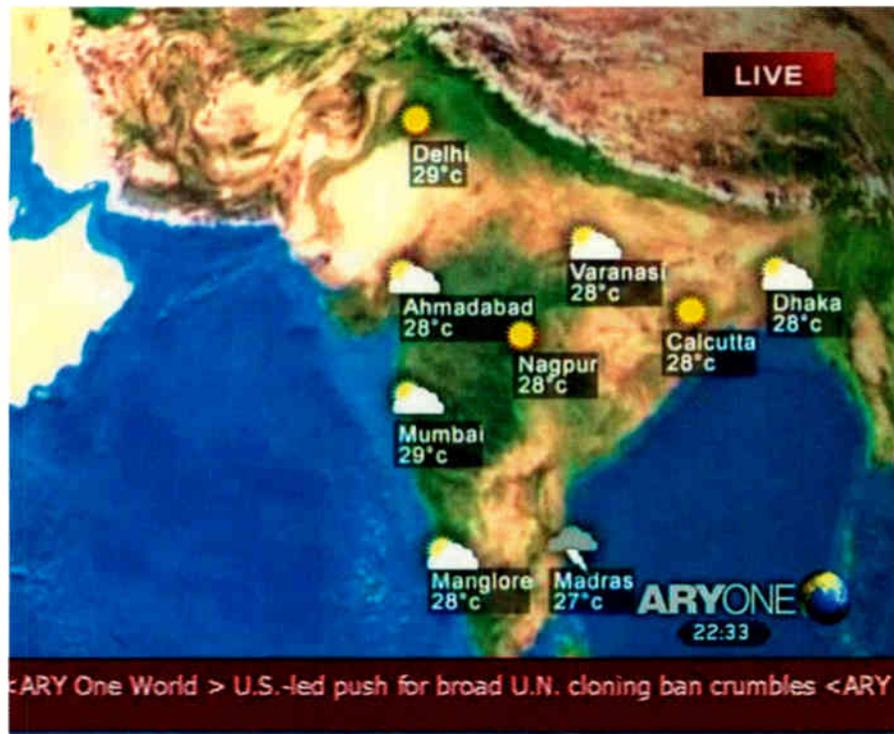
Photo 9: ARY One TV via Nilesat at 12.303GHz.

12.226GHz/H	27,500	3/4	Arabian Travel TV, Samacom, Al Fayaa, Edeera.
12.303GHz/H	27,500	3/4	NTV Bangladash, ATN Bangla, ARY One TV (see Photo 9), NDTV India and various ART feeds.
