TELEVISION

AND CONSUMER ELECTRONICS

OCTOBER 2005

Plasma TV fault-finding

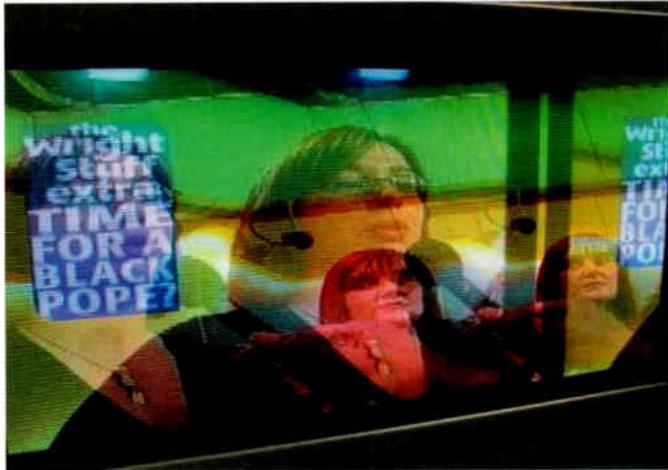
Fig. 8: Effect of a scan-converter memory fault (address line short-circuit to 0V).

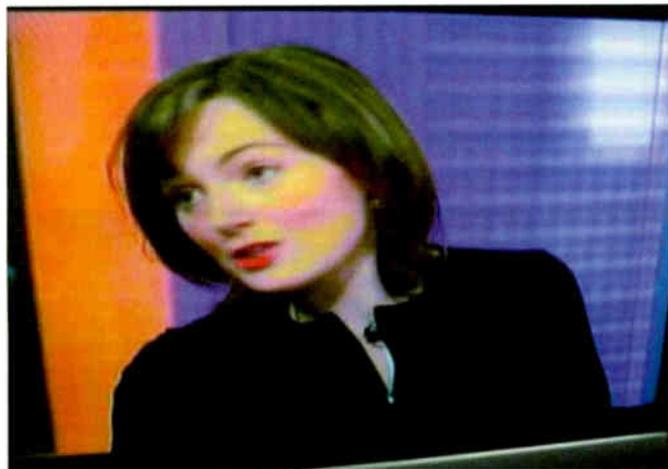
Fig. 9: Effect with one colour bit (R0) missing.

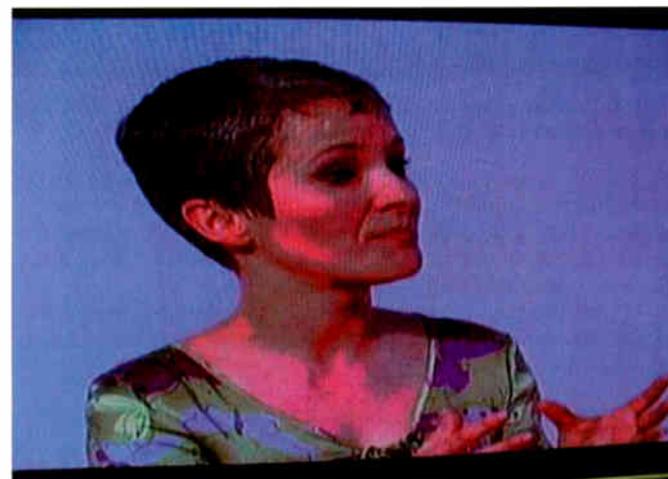
Fig. 10: Effect when one LVDS encoder data line is short-circuit to 0V.
