Television

JANUARY 1976

**The THORN
8000/8000A/8500
Colour Chassis**

PART 1

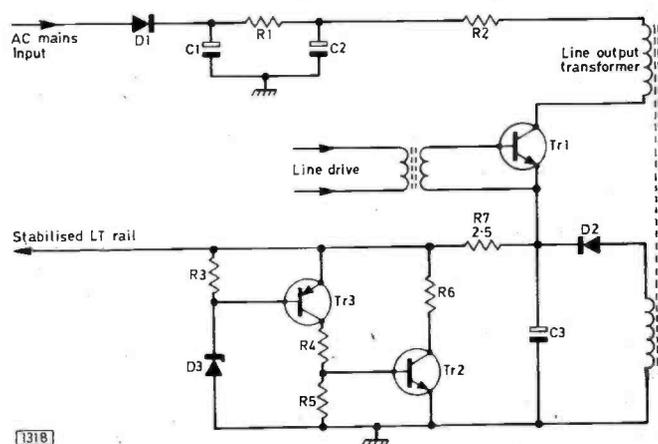
Fig. 1: The indirect method of stabilising the h.t. supply to a transistor line output stage – by means of a shunt stabilised l.t. supply in the emitter circuit of the line output transistor. If either of the three transistors goes open-circuit the result will be no sound and no e.h.t. In practice Tr1 or Tr2 or both of these tend to fail. A typical value is shown for R7.

The subject of transistor line output stage techniques and the associated power supply arrangements has been a preoccupation of ours in recent issues. One approach we have not so far illustrated is the "indirect" h.t. line stabilisation technique used in the Rank A816 and Thorn 1600 monochrome chassis. The starting point is the need with a transistor line output stage to have a stable h.t. supply – otherwise the width will change with variations in the h.t. voltage. Generally this means the use of a stabilised mains rectifier arrangement, e.g. a thyristor or chopper (switch-mode) system. In the two chassis mentioned above however a simple half-wave mains rectifier is used to provide the h.t. supply, with stabilisation of the voltage applied to the line output stage effected via the action of a shunt l.t. supply regulator. The basic circuit configuration is shown in Fig. 1. It will be seen that the anti-boost technique is used, i.e. the emitter of the line output transistor is

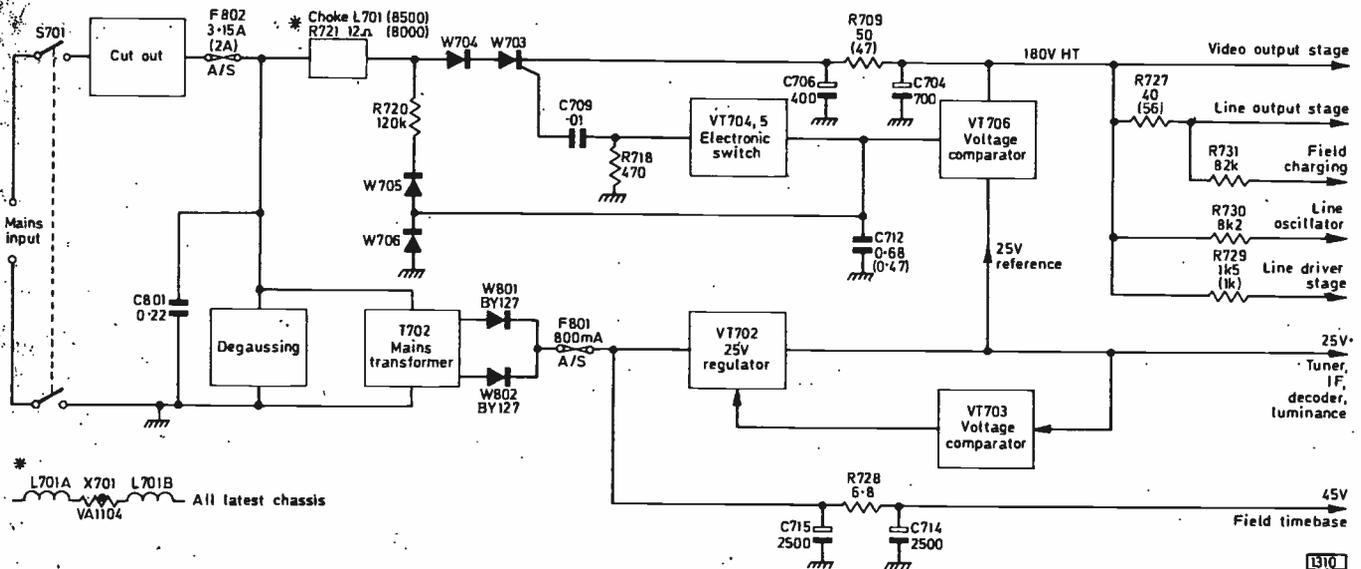
Fig. 1: Overall arrangement of the power supply board. Values in brackets apply to the 8000 and 8000A chassis, though in later 8000A chassis the ramp capacitor C712 which controls the electronic switch is 0.68 μ F as in the 8500 chassis.

Having described the chassis briefly we will now get down to the power unit which is the subject of this first article. Two types of unit are used. The 90V6-644 used on the 8000 and the 90V6-644-101 used on the 8000A and the 8500. To distinguish one type from the other, look at R730 adjacent to the 10-way socket. If R730 is mounted vertically the panel is for the 8000 series, if it is mounted horizontally the panel is the later type for the 8000A/8500 chassis. *These panels are not interchangeable.* If the later type is used in place of the earlier type no damage will occur – the same cannot be said for using the earlier type instead of the later!

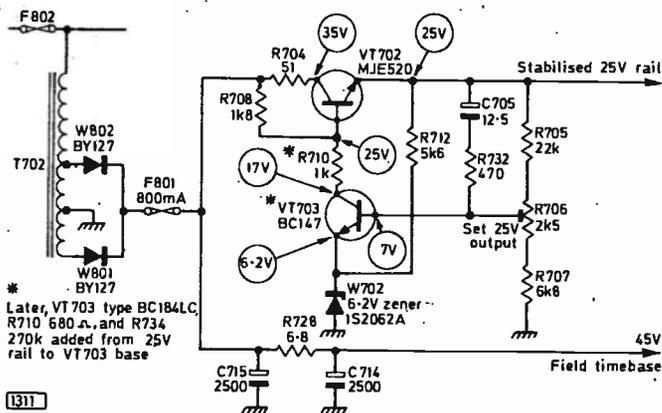
Fig. 2 The 45V supply and the 25V series stabiliser (VT702). C705 and R732 remove ripple by feedback action.

The 25V stabiliser circuit is shown in Fig. 2 – the 45V supply has already been described. VT702, connected as an emitter-follower, acts as a series regulator with its emitter

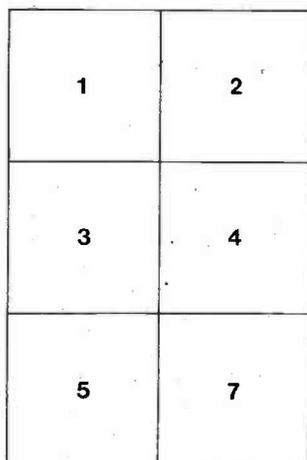
Fig. 39: The graphics symbol format. Each square can be separately addressed; the number indicates which bit of the data word controls that particular segment.

Since there are only six segments it is practicable to allocate one bit of the data word to each segment of the array. In Fig. 39 the number shown in each of the segments indicates which data bit is used to control the state of that

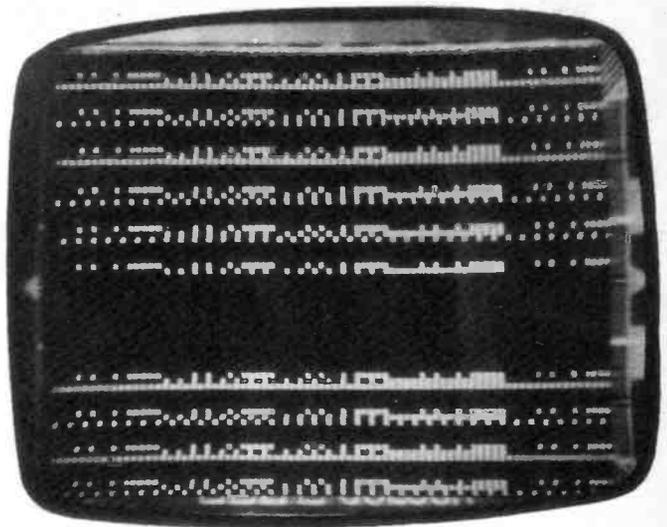
This test display shows the complete symbol set available.

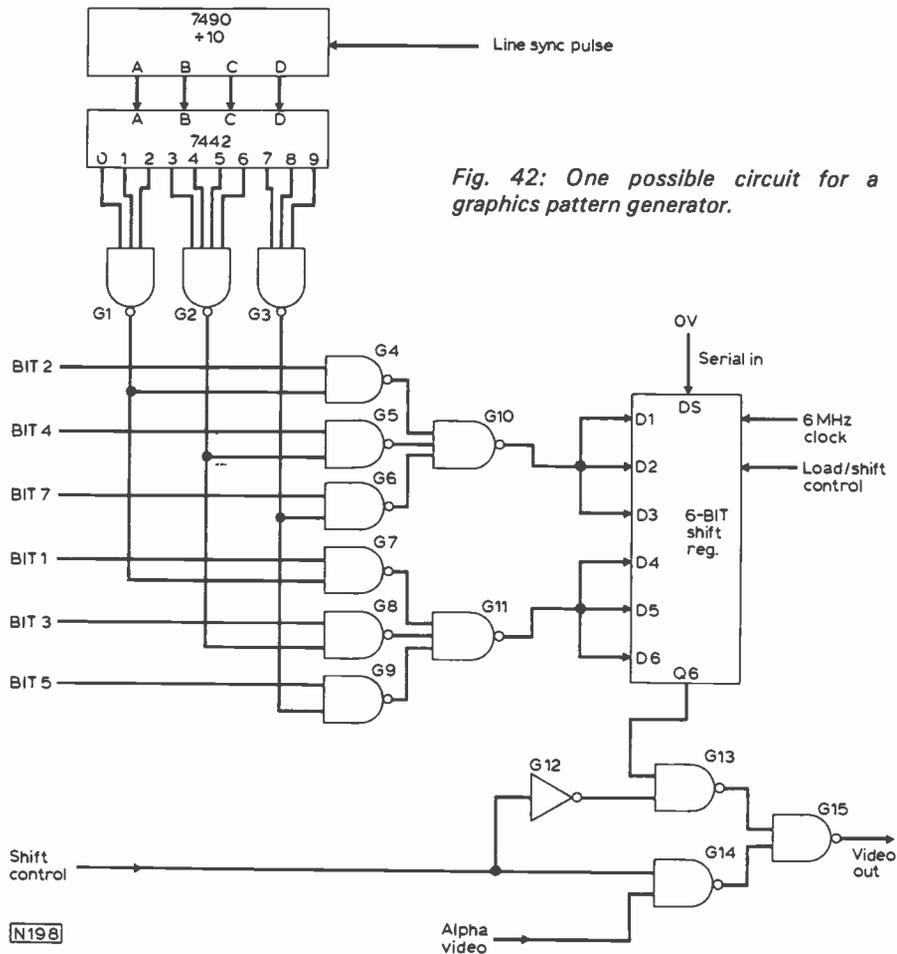
Fig. 42: One possible circuit for a graphics pattern generator.

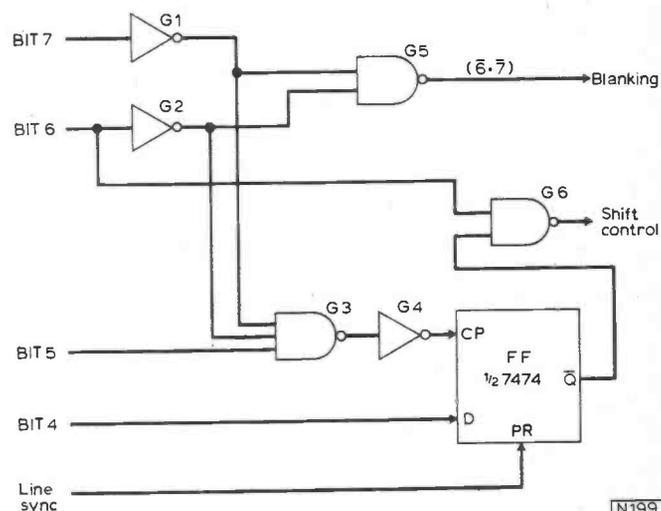
Fig. 43: A shift control logic circuit.

The logic used to provide the shift control signal is shown in Fig. 43. First bits 6 and 7 of the data word are inverted by gates G1 and G2 and these inverted signals are gated with bit 5 in gate G3 to detect the 001 combination of bits 7, 6 and 5 indicating a shift command. After inversion by G4 this detected signal is used as the clock input for a D-type flip-flop. The D input is fed by bit 4. Now when a shift command is detected by gate G3 the flip-flop will be set to the state of bit 4. The \bar{Q} output of the flip-flop will go to 1 for graphics and to 0 for alphanumerics. At the end of each line scan the line sync pulse is used to reset the flip-flop into the alphanumerics mode ready for the next line scan.

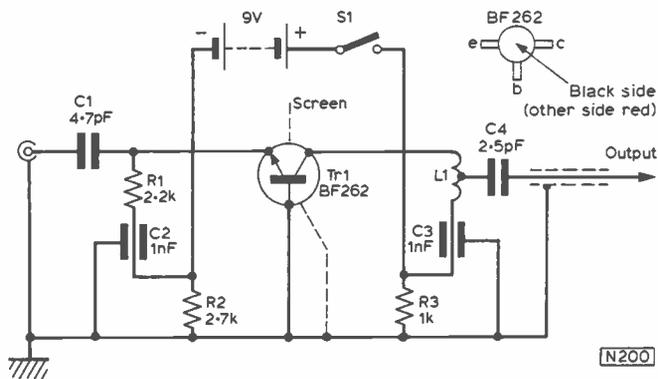
Fig. 1: Circuit diagram of the simple u.h.f. preamplifier.

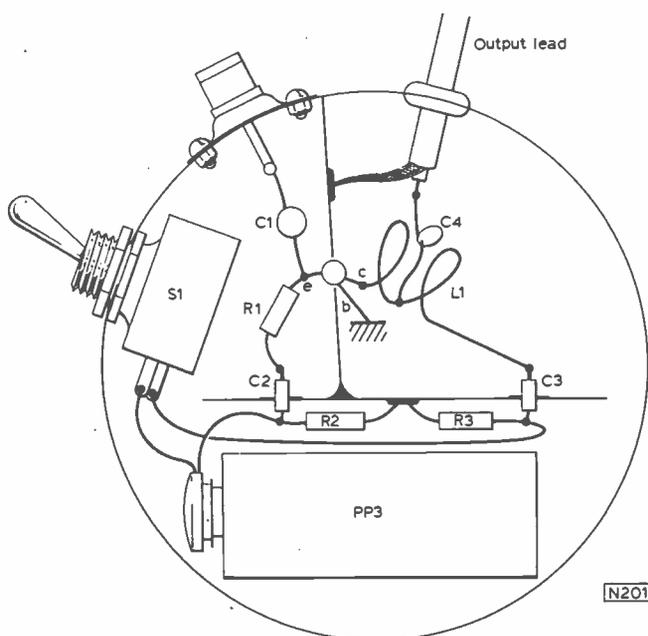
Fig. 2: Component layout of the prototype preamplifier, constructed in a 1 oz. tobacco tin. The output lead must be not less than 0.3m (12in) long (see text).

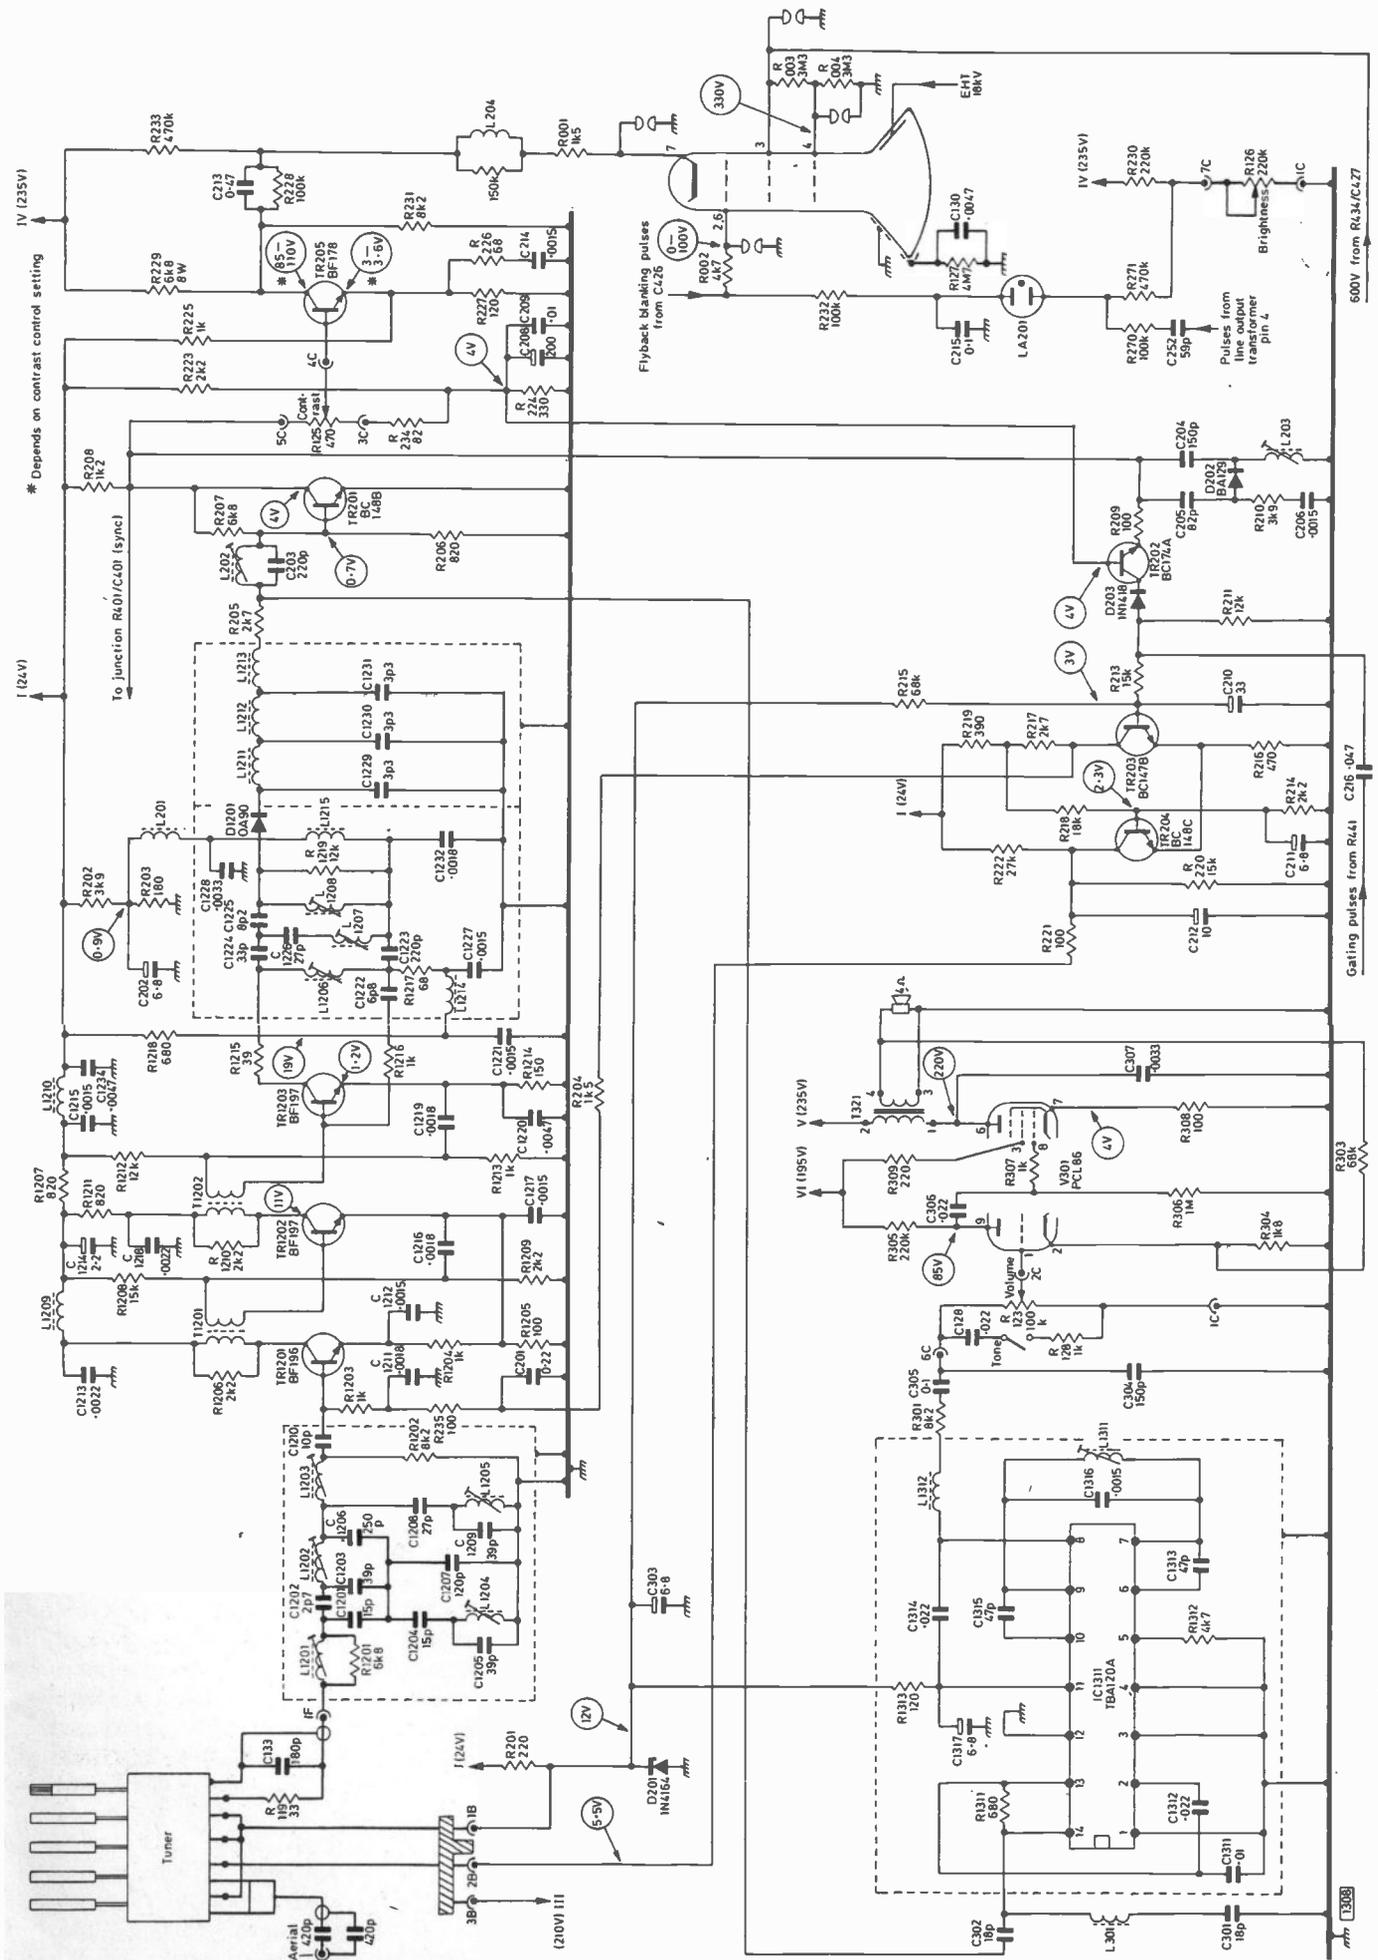
Fig. 4: Circuit of the vision and sound sections of the Indesit Model T24EGB. Voltages measured without signal, using a 50kΩ/V meter.

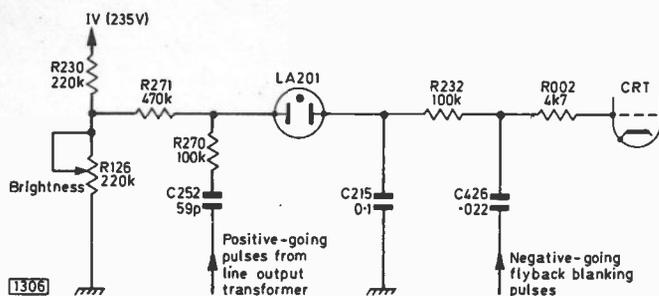
Fig. 5: The c.r.t. grid circuit is somewhat unusual in using a neon bulb (LA201), which is mounted on the main printed board, to provide switch-off spot suppression. The neon does not conduct until the line output stage comes into operation, when the positive pulses applied to it via C252 and R270 cause it to strike. The brightness potential is then applied to the c.r.t. grid and C215 charges. At switch-off LA201 ceases to conduct and the charge left on C215 results in the e.h.t. being rapidly discharged. The neon hasn't given trouble to date: if it failed to strike we would expect a plain, bright raster.

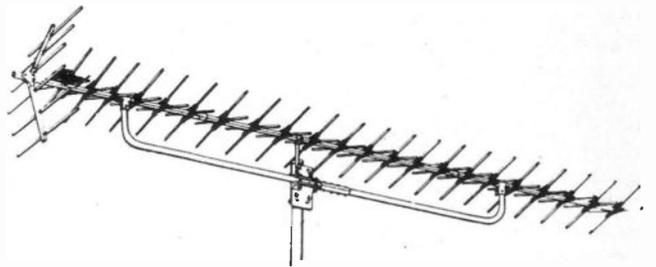
The Antiference XG21 high gain u.h.f., providing a forward gain of almost 21dB.

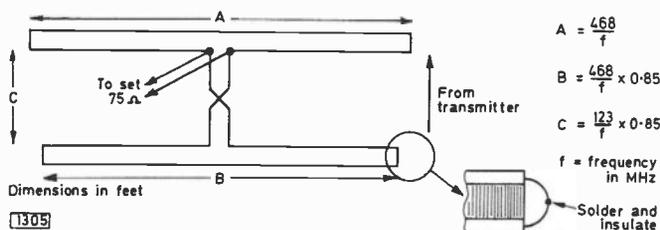
Fig. 1: The "ZL Special" aerial used by Mike Allmark. The dimensions for channel E3 are: "A" 2.6m (102in); "B" 2.2m (87in); "C" 0.58m (23in). The length of the feeder "C" is critical, since it governs the phasing between elements, and therefore the overall directivity of the array.

Mike Allmark (Leeds) has reported on his results during the past SpE season. In all he received some 17 countries, and a drawing he sent confirms reception of TVR (Rumania) on the 18th. Mike has been using a "ZL Special" aerial, details of which are shown in Fig. 1. Basically, it's a twin-dipole assembly with 1/8th wavelength spacing, driven 135° out of phase. The response is similar to that of a three-element array, but with a greater vertical angle. Mike's array is made of 300Ω ribbon feeder taped to dowelling. The information is given in case others should wish to experiment. It does seem a useful aerial, with a 60° beamwidth (–3dB points) and a forward gain of 6-7dB.

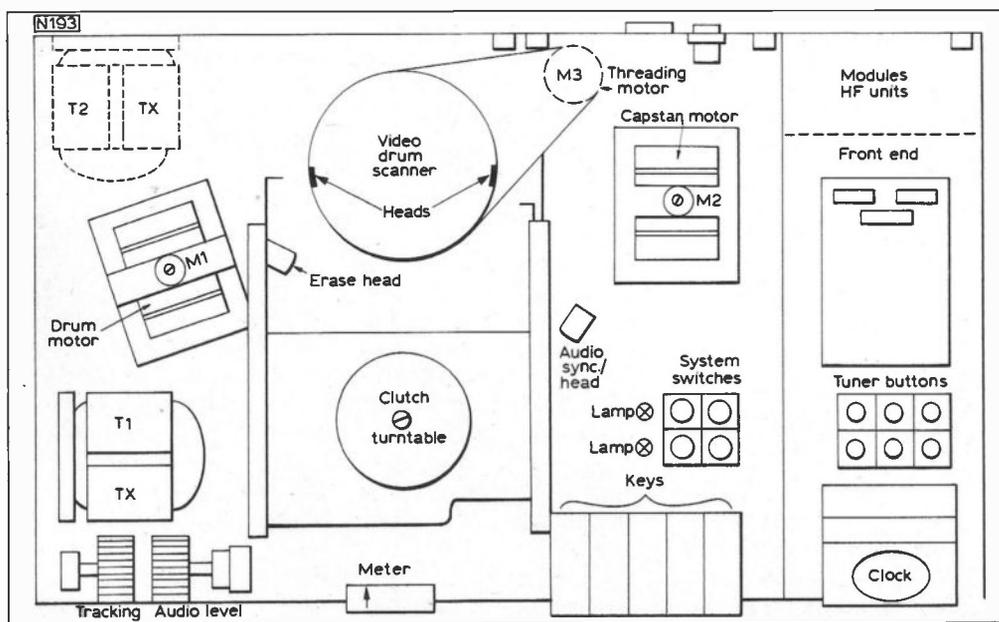
Fig. 1: View of VCR with top cover removed, showing layout of major mechanical features. Components shown dotted are mounted below the chassis.

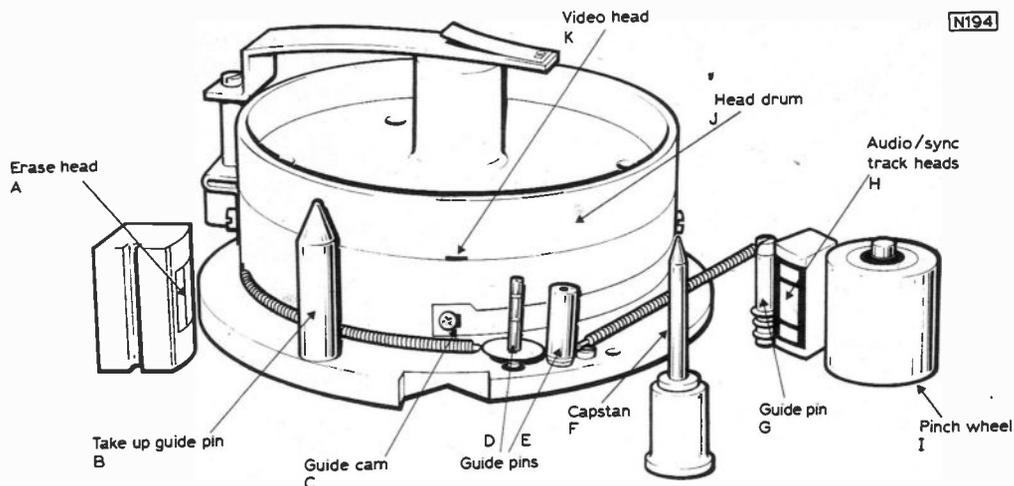
Fig. 2: Layout of heads and tape path. Only one guide cam (C) and one video head (K) are shown. Another video head and two more guide cams appear on the other side of the drum.

The layout of the heads and the tape path is shown in Fig. 2. This will assist in making clear what cleaning is required in this area. The machine is shown here in the unthreaded position, i.e., OFF. As most owners and readers will know, the helical-scan technique is used in this machine: on completion of the threading up action (red light period ON) the tape is partially wound round the video head drum. In operation the tape floats round the video head drum on a minute cushion of air. It is essential

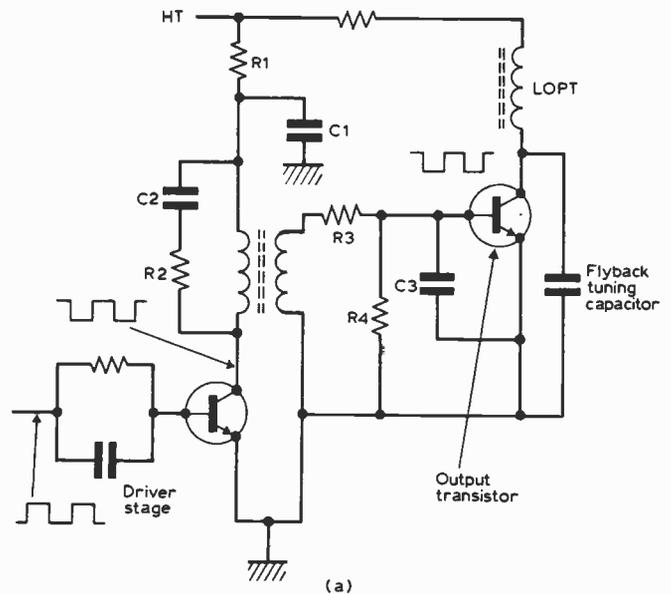
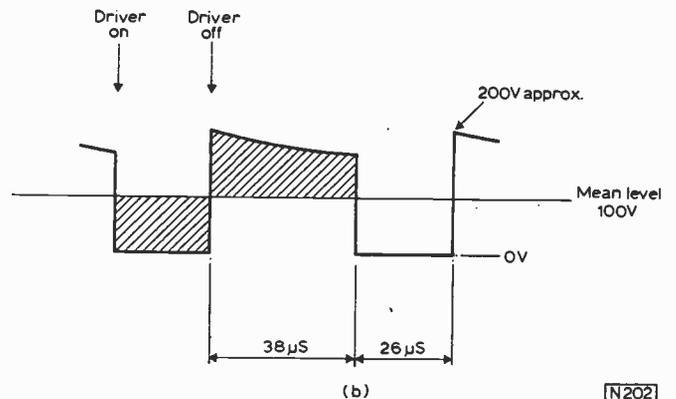
Fig. 12: Driving the line output transistor

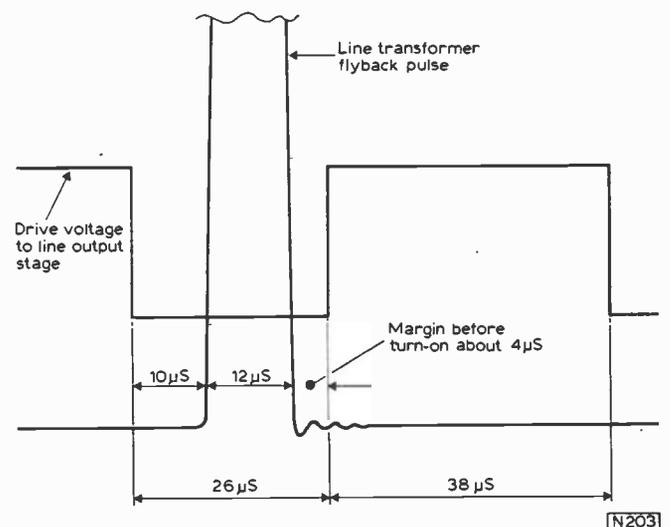
Fig. 13: Relative timing of the drive and flyback voltages, illustrating the margins needed to ensure safe operation.

As we have seen, the base of the line output transistor must be held at about -4V during the flyback to ensure that it remains completely cut off. Despite all these precautions, the transistor's total collector dissipation is quite high, typically of the order of 4W, though due to variations in turn-off time between different transistors of the same type, top limit out-of-sync conditions and h.t. line voltage differences the maximum dissipation may exceed 10W. Thus generous cooling by means of a large heatsink is essential.

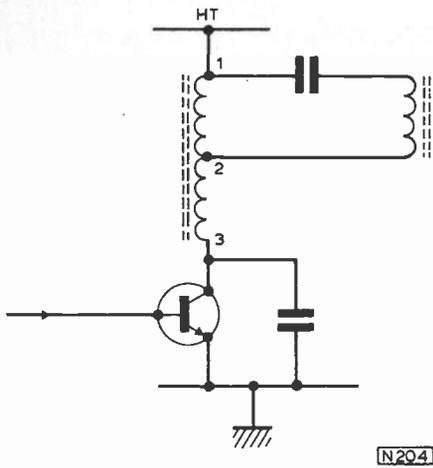
Fig. 14: A simplified line output transformer circuit.

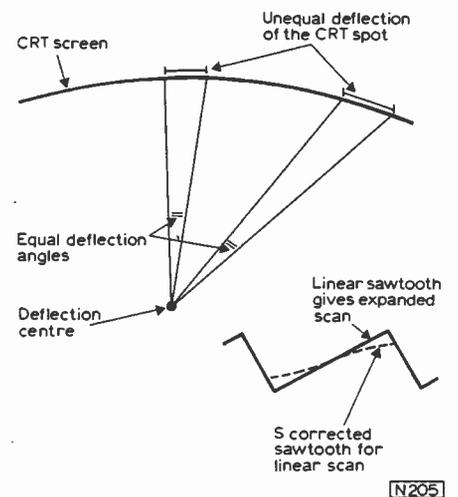
Fig. 15: The need for S correction of the line scan current.

Another important point is that the scanning current cannot be a pure sawtooth: it must be rounded off at both ends in order to get a linear picture on an almost flat screen. Fig. 15 illustrates how equal deflection angles at the

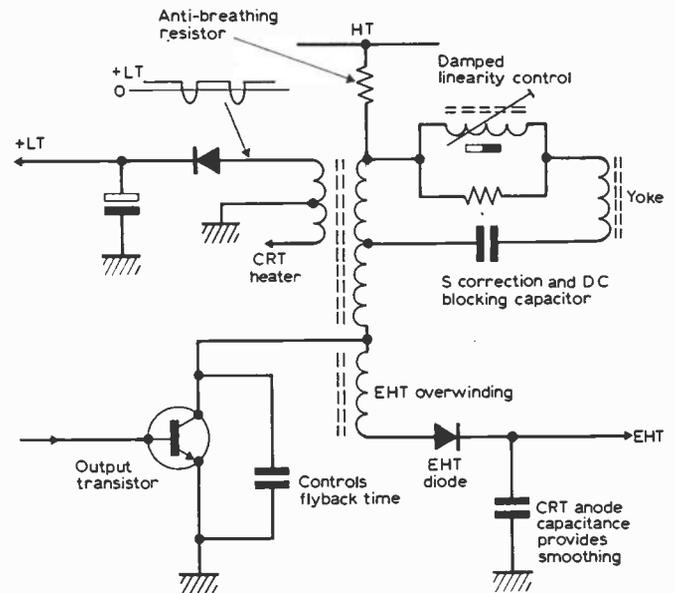
Fig. 16: A more complete line output transformer circuit, showing the various added features discussed in the text.

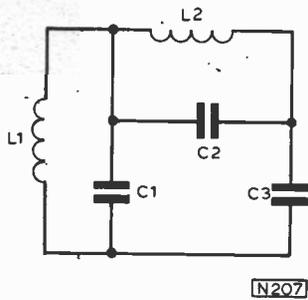
Fig. 17: The principal resonant circuits in a line output transformer

An example of this action is represented by a line linearity control. This is connected in series with the deflection coils, and its inductance resonates with its stray capacitance to produce ringing. The cure is to damp it with a resistor – commonly about 1.5Ω in value – so that the ringing stops before the start of the visible part of the picture. Followers of our servicing articles and problems solved pages will be well aware of what happens when the resistor goes high value or open-circuit – oscillations which appear as striations on the left-hand side of the screen, reducing in severity as the spot approaches the centre of the screen.

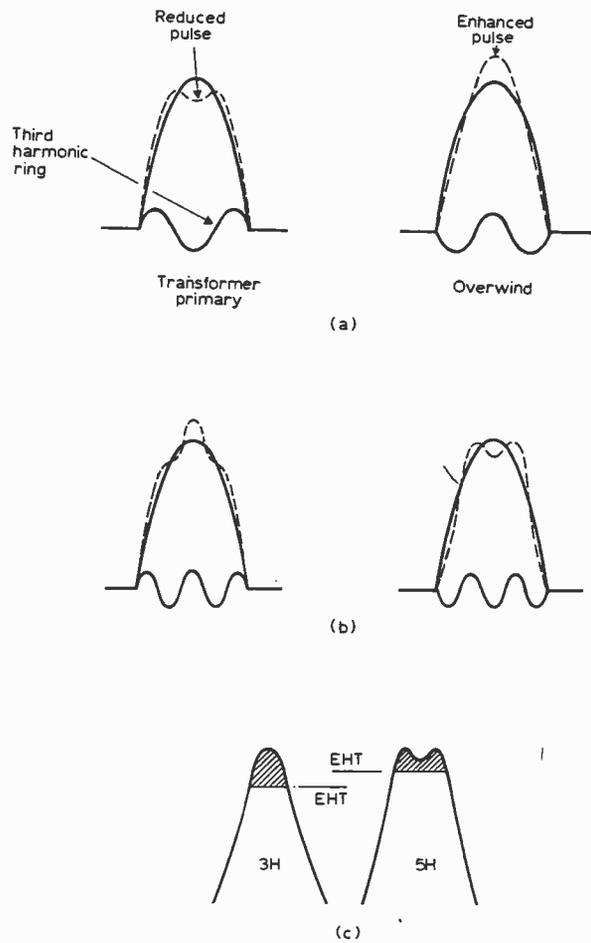
Fig. 18: The effect of harmonic tuning in a line output transformer

On the primary winding, the waveforms are in antiphase: they subtract therefore and the overall peak voltage is reduced — to the benefit of the line output transistor. On the overwinding however the voltages add, so that a larger voltage pulse is produced for a given number of turns. This means that the overwinding can be made smaller and is easier to manufacture.

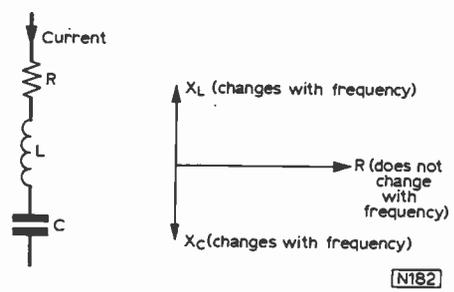
Fig. 1: A series RLC circuit and its basic phasor diagram, showing opposing phase of inductive and capacitive reactance.

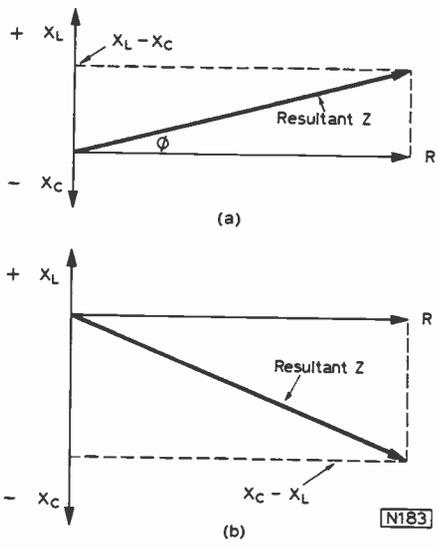
Fig. 2: (a) X_L is greater than X_C at this frequency. Circuit behaves as if it has only inductance (of a lower value) and resistance.

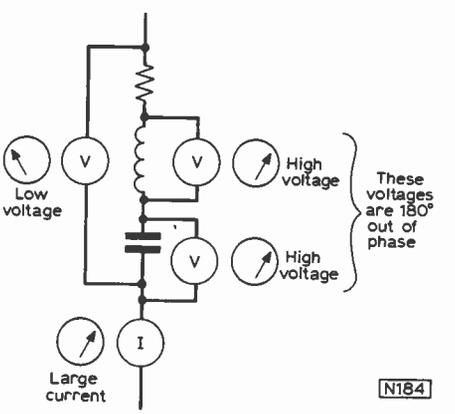
Fig. 3: Current and voltage readings in a series resonant circuit.

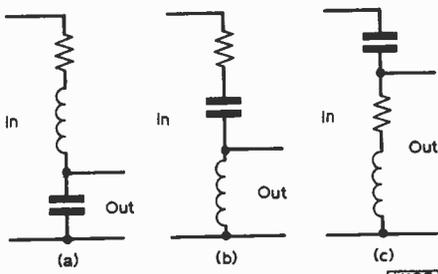
Fig. 4: Taking the signal from across one reactance, (a) is possible, (b) is not, since the resistance of the circuit is usually the resistance of the inductor. Therefore (b) must be redrawn as (c).

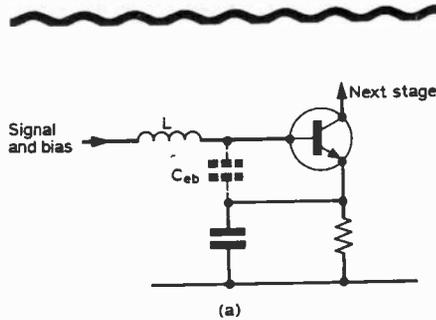
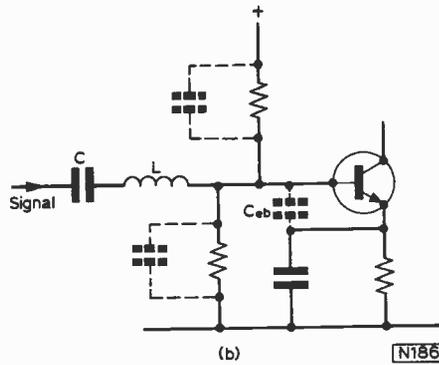
Fig. 5: In (a) the base-emitter junction capacitance forms a series resonant circuit with L . In (b) it is swamped by the other stray capacitances of the circuit.

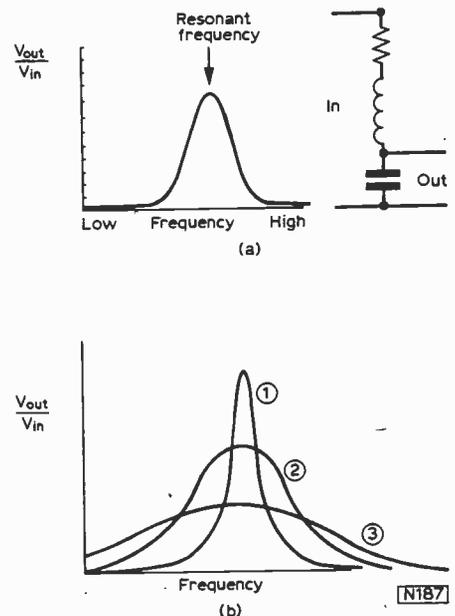
Fig. 6: (a) The basic selectivity curve of the series RLC circuit. In (b) changing circuit losses alter selectivity but not resonant frequency.

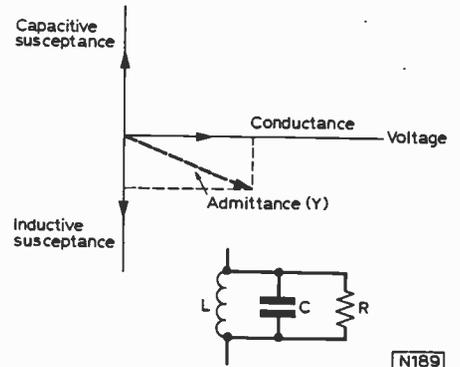
Fig. 8: A modified phasor diagram using Conductance, Susceptance and Admittance.

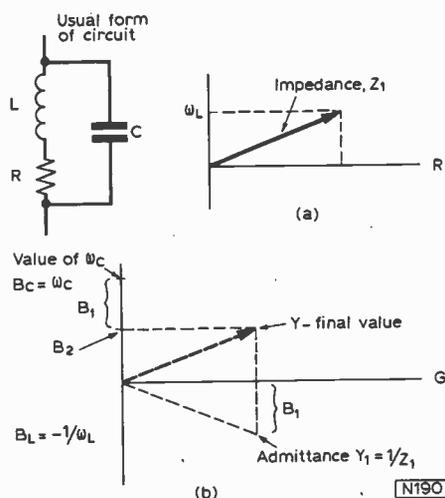
Fig. 9: In a practical parallel LC circuit with resistance in the inductor, find the impedance of R and L on diagram (a) then convert this to admittance and plot on diagram (b) to find overall admittance, and therefore impedance.

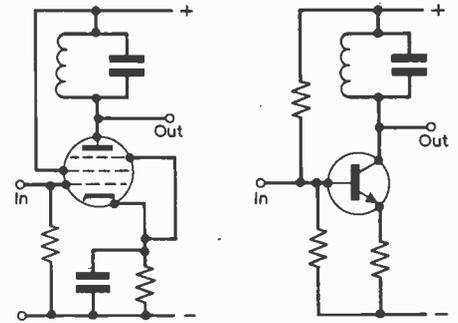
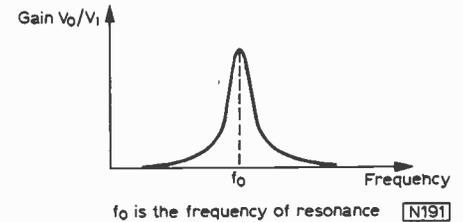
Fig. 10: Selective voltage magnification.

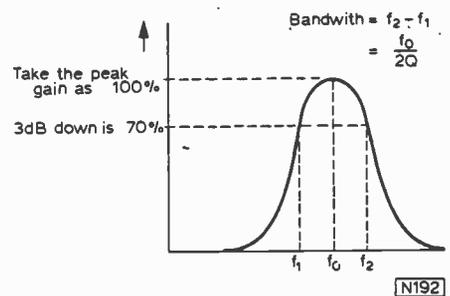
Fig. 11: Defining bandwidth.

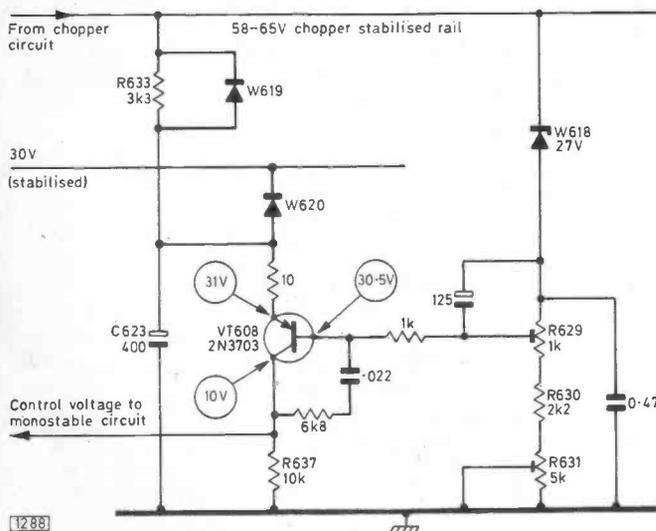
Fig. 1: The feedback amplifier used in the power supply circuit in the Thorn 3000/3500 chassis. The voltage developed across R637 determines the mark-space ratio of the monostable circuit's output waveform and thus the on/off time of the chopper transistor. At switch on C623 charges via R633: when the voltage across it reaches 30V W620 conducts, clamping the voltage at this level. This action ensures that the h.t. builds up slowly. When the set is switched off C623 discharges rapidly via W619.

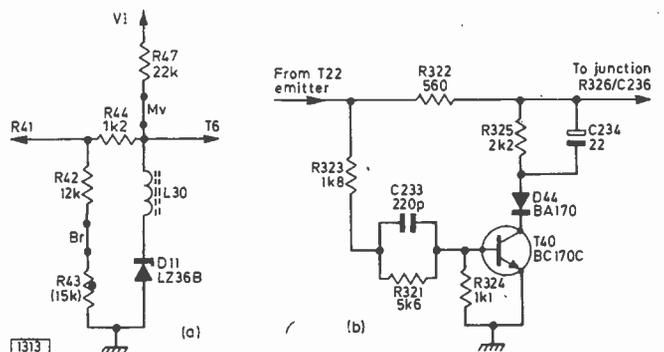
Fig. 5: Early versions of the CVC5 chassis used the tuning voltage stabiliser circuit shown at (a) and the noise gate shown at (b).

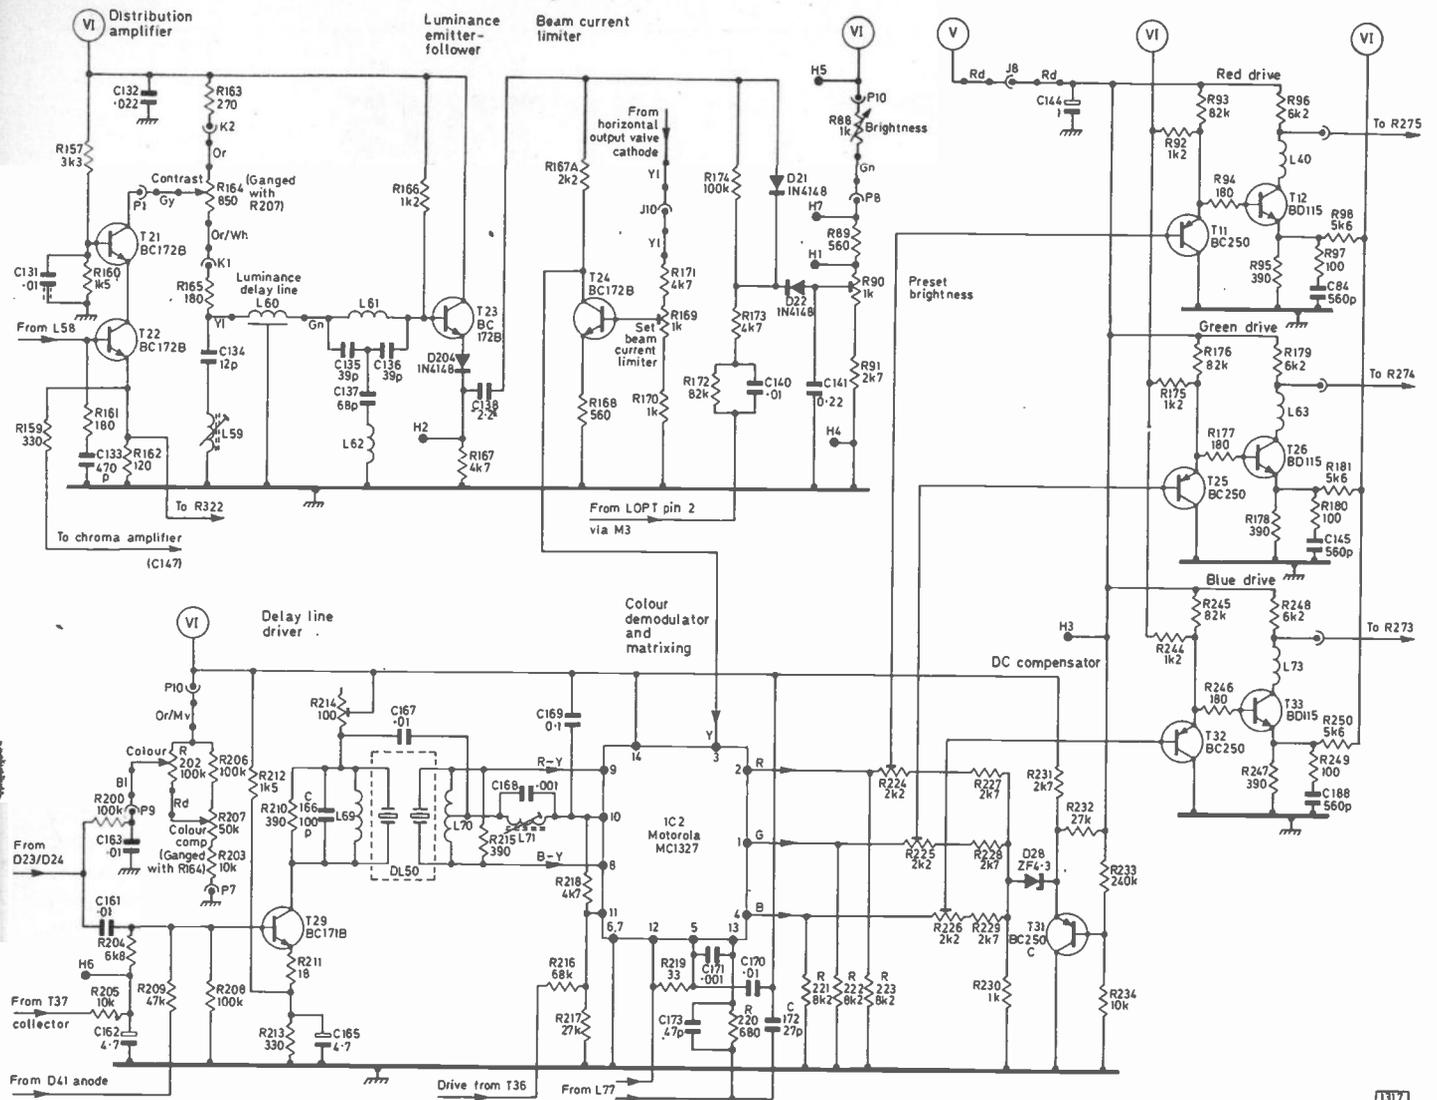
Fig. 6: Modified decoder and RGB circuitry employed when an MC1327P i.c. is used for colour demodulation and matrixing, and PAL switching. The subcarrier amplifier circuit is modified as follows: there is no tap on L77, and the feedback to the detector diodes D34/D35 is from a tap on L76 via C211 with C210 and R286 deleted.

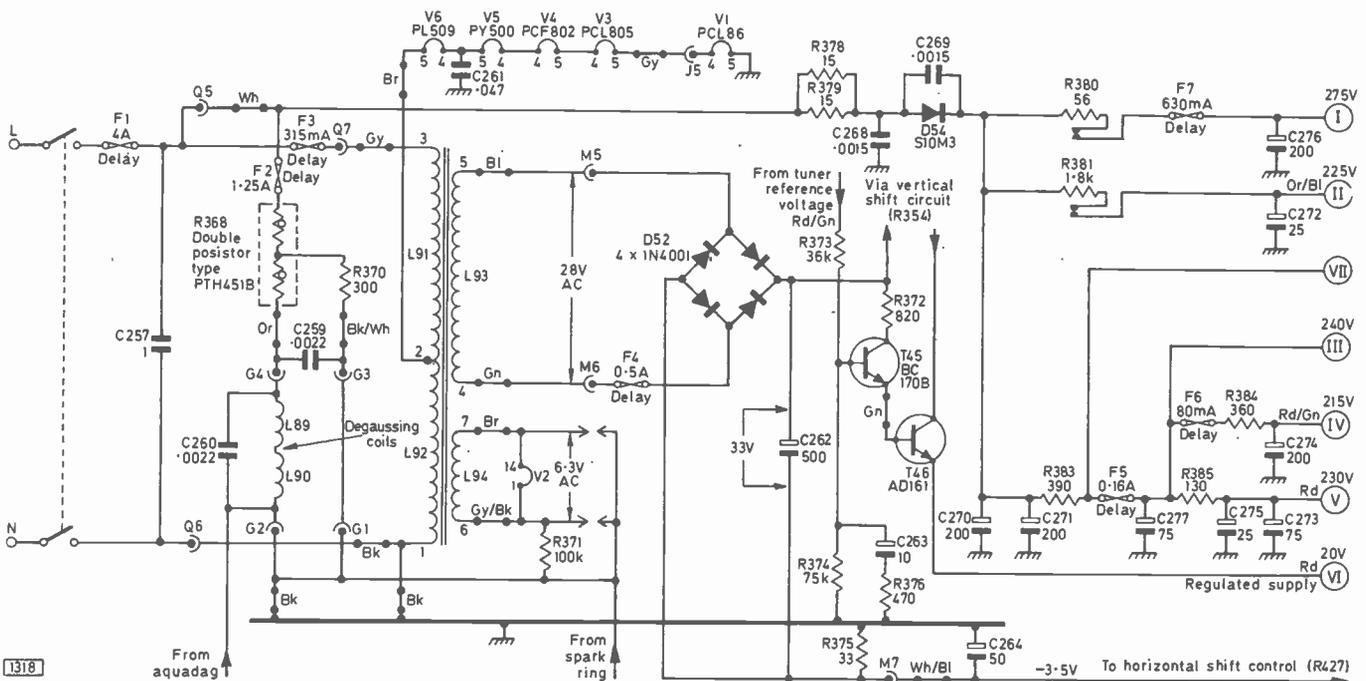
Fig. 7: Power supply and degaussing circuit used in the CVC8 chassis. In the CVC9 chassis F3 is replaced by a thermal cut-out and a pair of BY133 h.t. rectifiers may be used as in earlier sets with two BY103 h.t. rectifiers.

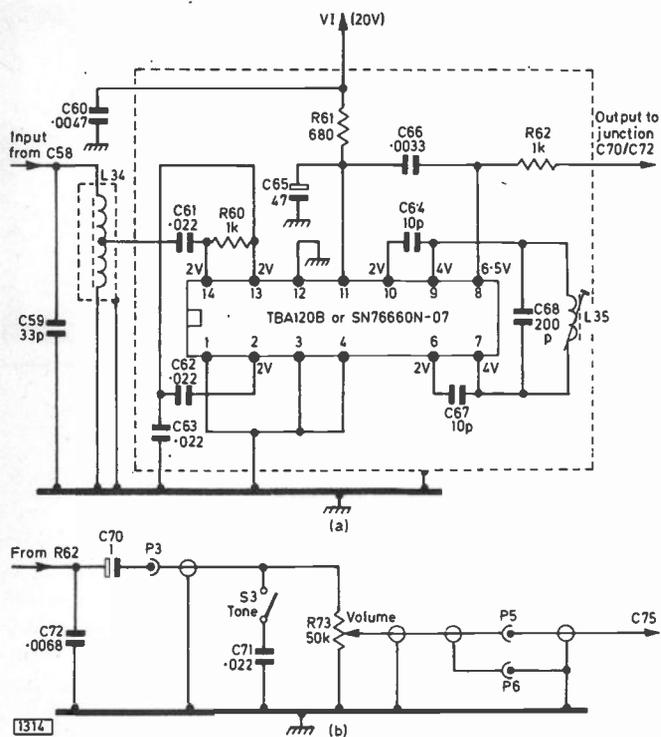
Fig. 8: (a) Intercarrier sound i.c. circuit used in later production. (b) Later a.f. coupling circuit.

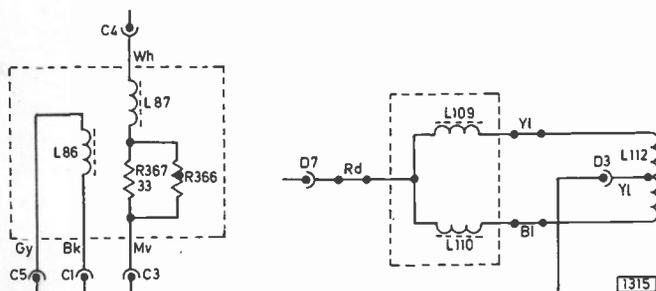
Fig. 9: Connections to Plessey deflection coils.

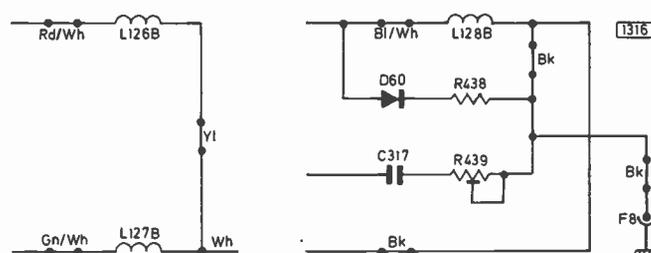
Fig. 10: Connections to Plessey convergence coils.
