# TELEVISION

JANUARY  
1974

## Curing RF Interference

# curing **RF** INTERFERENCE

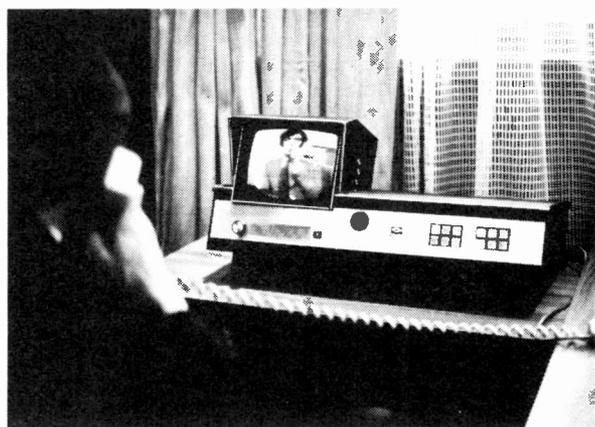
*Teleng viewphone in operation with their single-cable two-way TV system.*

The accompanying photograph shows the Teleng viewphone in use, hooked up to their two-way cable TV system. The noteworthy feature of this system is that it uses one cable only, i.e. both the transmitted and received signals travel along the same cable. This is done by using the band 54-300MHz for "downstream" signals and 5-30MHz for "upstream" signals, with a guard band of 24MHz between. Teleng is the first company in Europe to have installed and demonstrated two-way vision transmission over a single coaxial cable: the test network which links its two factories in South Ockendon has now been in operation for over fifteen months.
