Television

AUGUST 1976

- 517 Syclops Revisited** *by Barry F. Pamplin*
An investigation of the fault conditions that arise in the Syclops combined line output/switch-mode power supply circuit used in the Thorn 9000 chassis.

- 528 Electrolytic Tester** *by Alan Willcox*
This complementary design to the Capacitance Meter published in May covers capacitors in the range 10–4,000 μ F, checking both leakage and value.

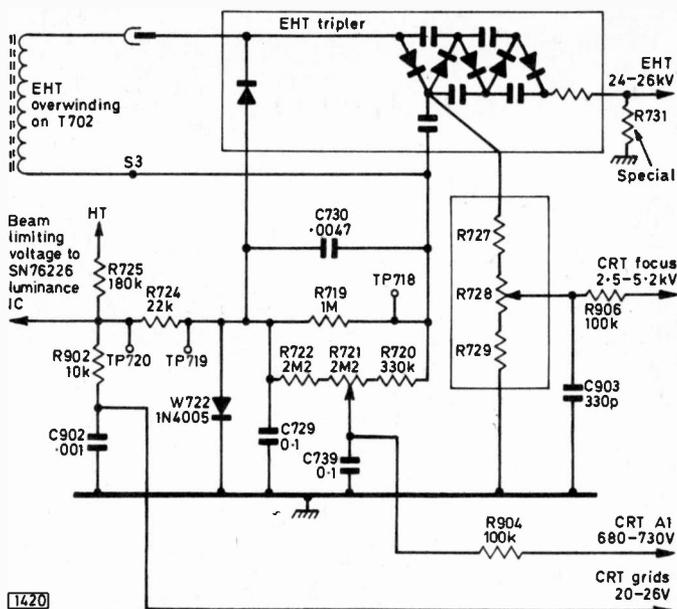
Fig. 2: The e.h.t. tripler and beam limiter circuits. C730 charges to 1kV to provide the c.r.t. first anode supply. The c.r.t. beam current returns to chassis via W722, which is forward biased from the h.t. line via R725 and R724. If the beam current is excessive, W722 cuts off and the voltage at the junction R724/R725/R902 swings negatively. This negative potential is fed to the c.r.t. grids via R902 and to pin 2 of the SN76226 luminance i.c. via a 1MΩ resistor to reduce the drive applied to the RGB output stages, thus reducing the beam current to a safe level. C903 later omitted.

- (1) Unplug the input lead to the e.h.t. tripler. If this stops the tripping suspect the tripler – also check R724 and R725 for overheating (see Fig. 2).
- (2) Replace the thick-film overvoltage unit (R704 etc.) on PC752.
- (3) If the tripping persists check the following components for leaks: C708 (if faulty replace with 2kV working unit), W706, W705, W602, W703, W723 and VT602.
- (4) If all these components are o.k. check by substitution VT411 and LR1 in the line oscillator circuit (the 1.8kΩ section can change value).

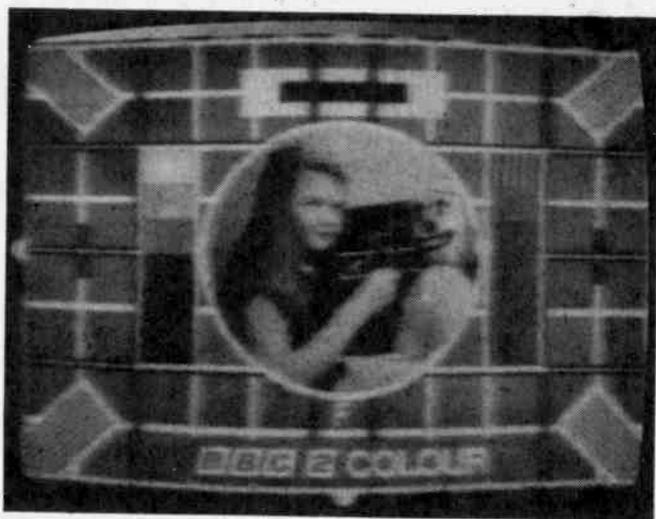
Test card F taken with 2 seconds exposure time at $f22$ with a $\times 4$ neutral density filter.
All photos taken with 125 ASA film.

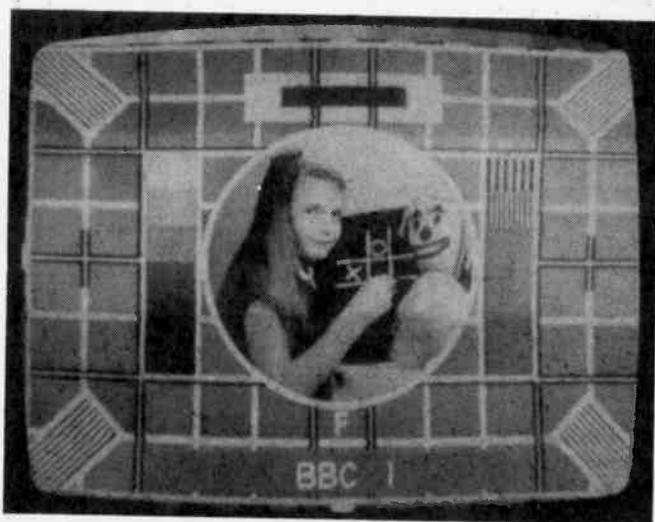
Exposure time for this photograph was $\frac{1}{30}$ of a second at $f5.6$.
Note brightness variation due to an incomplete frame being recorded.

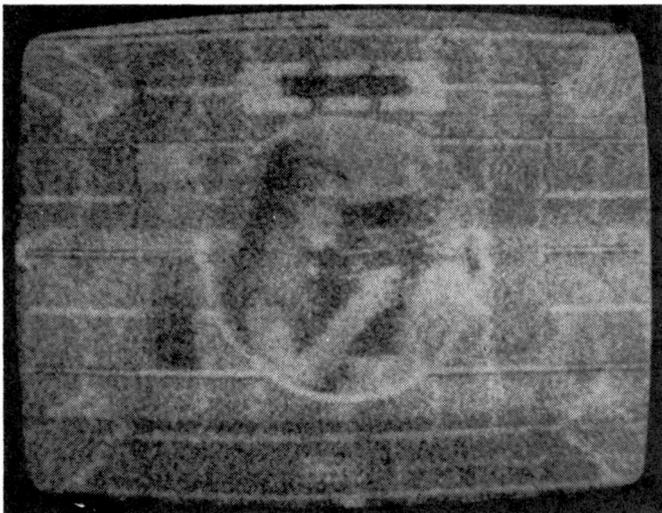
For low signal conditions, this is the result of photographing exactly what the camera sees. This was taken at $\frac{1}{30}$ of a second at f5.6.

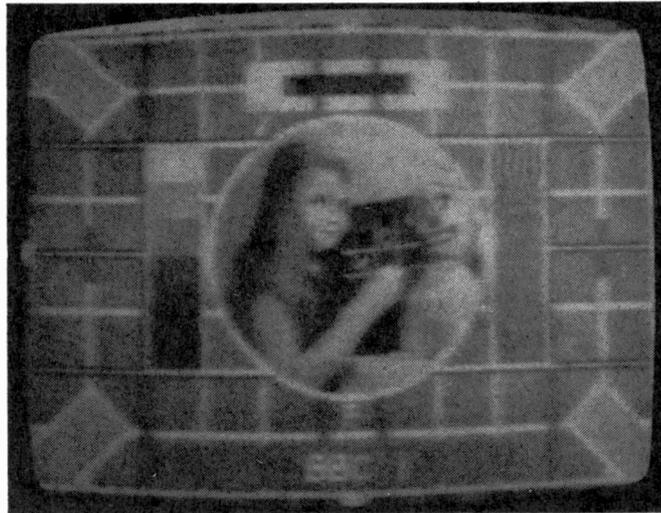
By extending the exposure time to 1 second, the instantaneous effect of noise is greatly reduced. In order to avoid over exposure the f-stop was set at f16 and a x4 neutral density filter used.

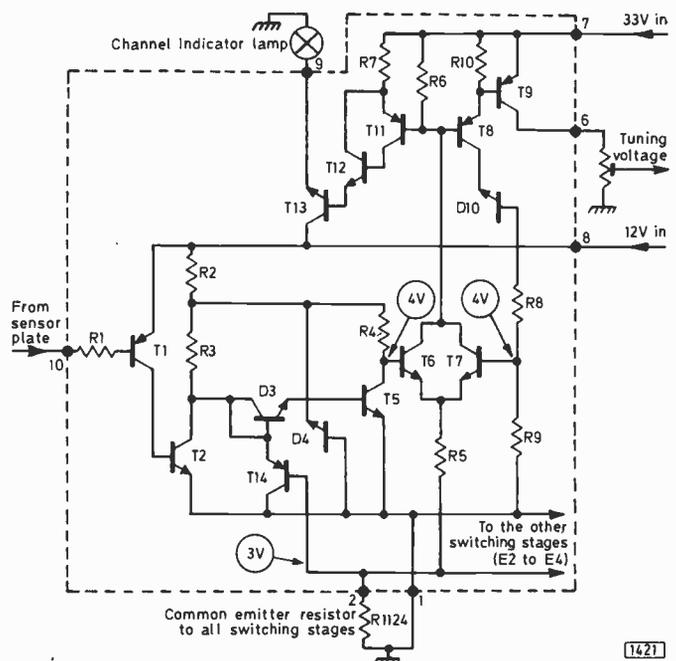
Fig. 1: Internal circuitry of one of the switching stages (E1) in the SAS560 i.c. The E1 stage incorporates the additional transistor T14 to ensure that the set automatically tunes to "channel 1" when initially switched on.

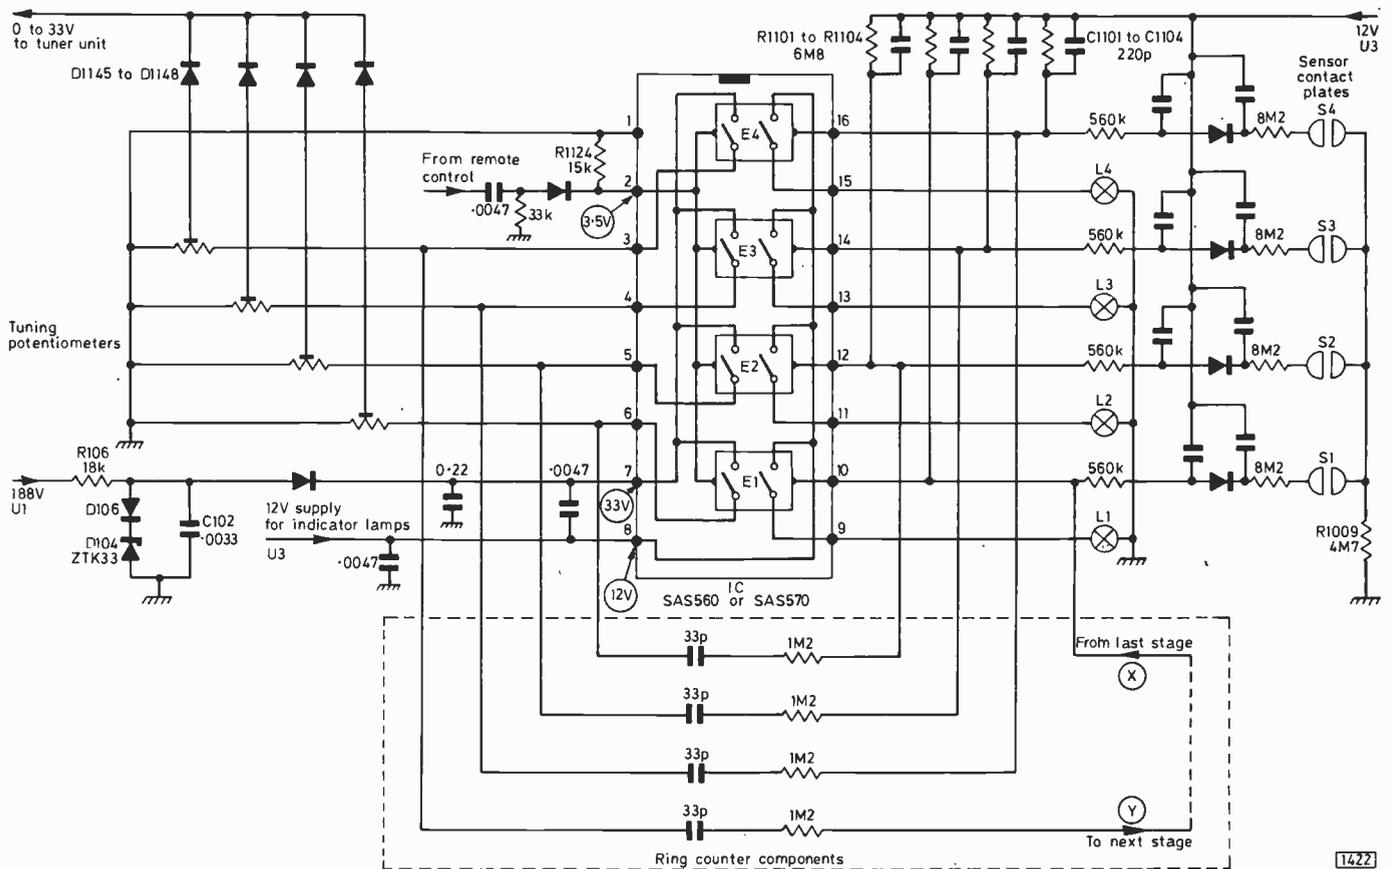
Fig. 2: Circuitry of the touch-sensitive tuning selection unit, showing in simplified form the i.c. which provides the switching action. Only one of the two i.c.s used in the unit is shown: two are used in order to provide choice of eight channel selections.

The complete external circuit of one of the two programme selection i.c.s is shown in Fig. 2. S1-S4 are the sensor contact plates which must be bridged with a finger to initiate programme change. High-value resistors are

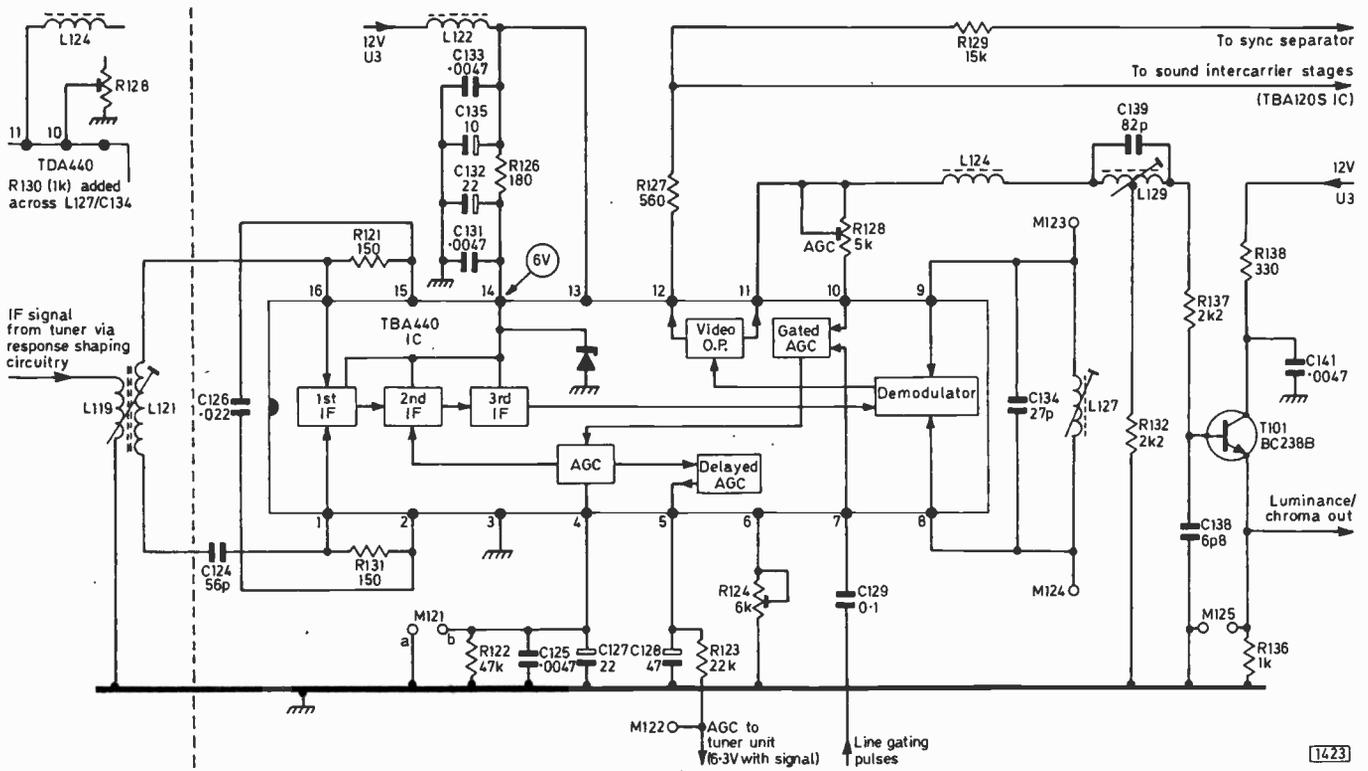
Fig. 3: Block diagram of the i.f. integrated circuit, also showing the external components.

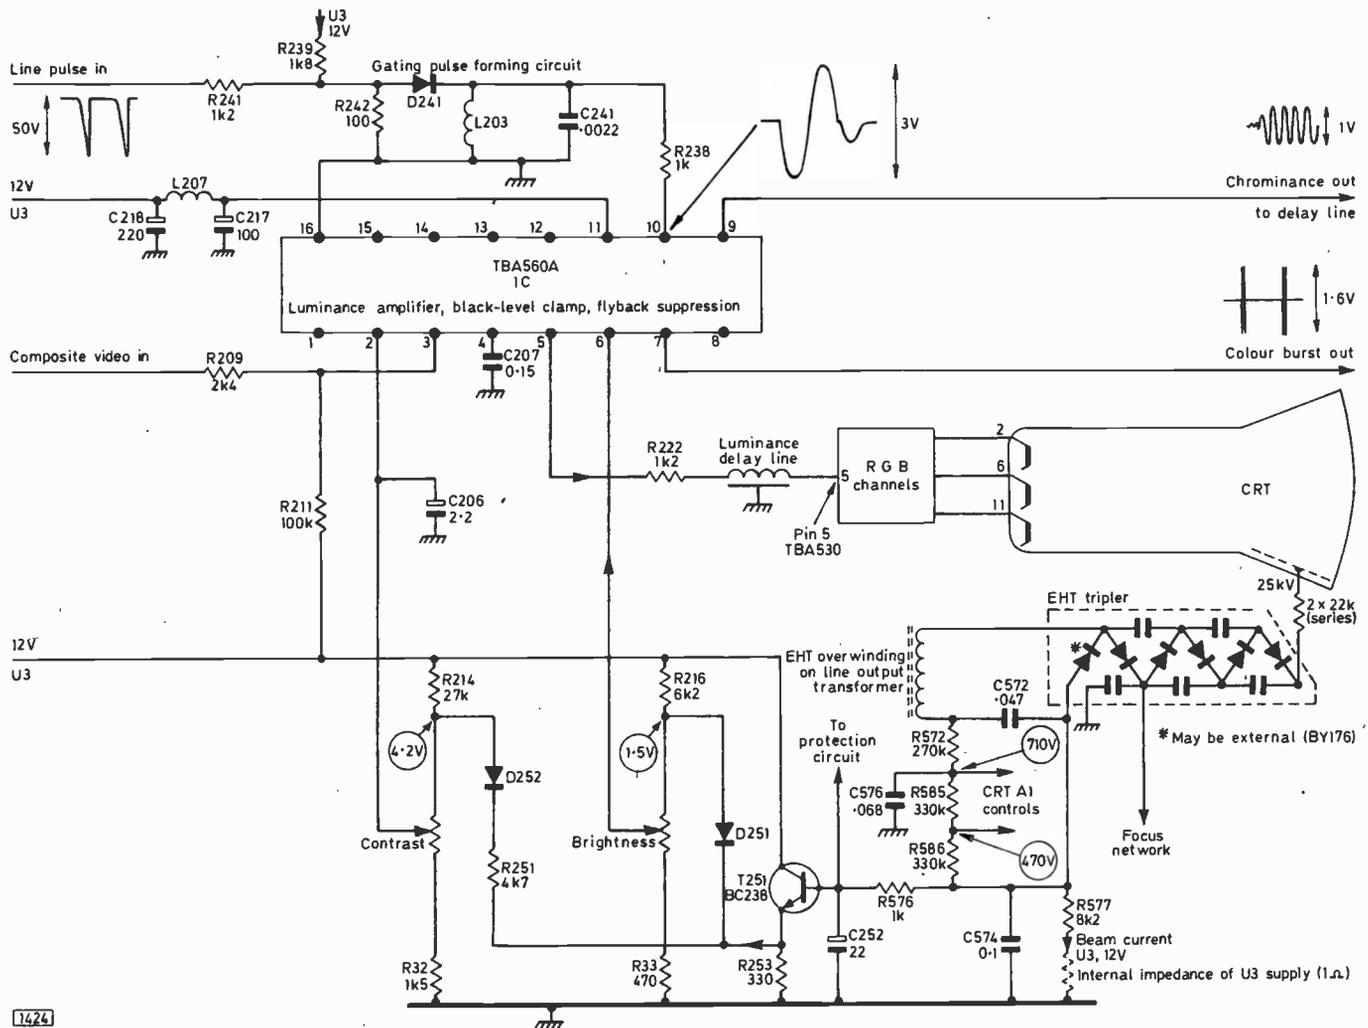
Fig. 4: Simplified diagram of the circuitry around the TBA560A luminance IC, also showing the e.h.t. and the beam limiting arrangements. The gate pulse forming circuit is shown at the top: the overswing pulse produced when L203 rings is used to gate the bursts and operate the clamp circuit in the IC.

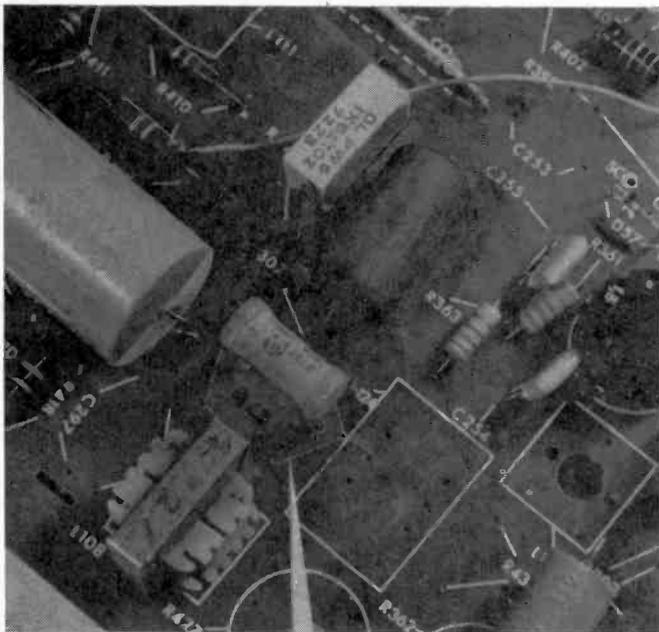
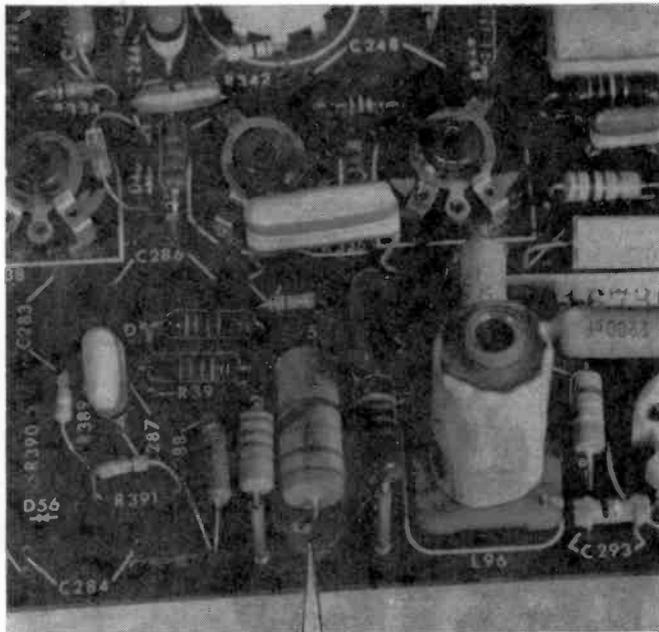
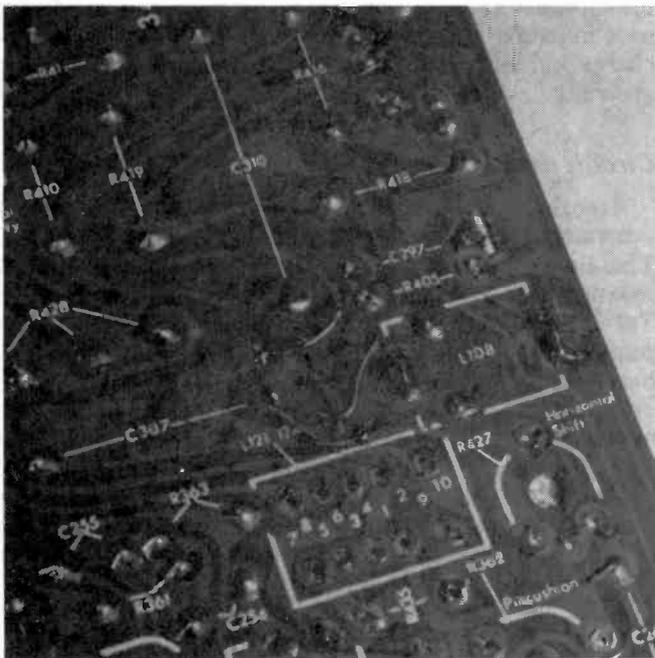
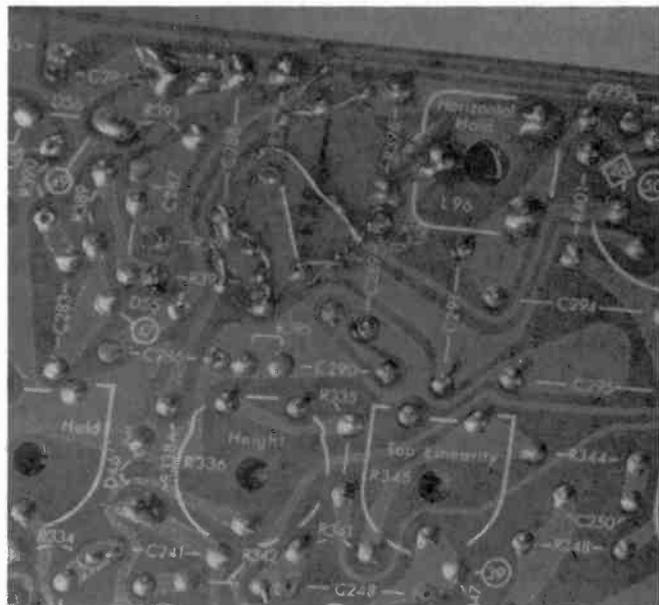
Two examples of repaired printed-circuit panels, showing both the front and back of the board in each case. Very much neater and stronger than merely suspending the components in a network of wire links.

As with most things in our trade the process takes longer to describe than to do. As the photographs show however, the results are certainly worth the effort and time, even in these days of £5-an-hour bench technicians – pardon? ■

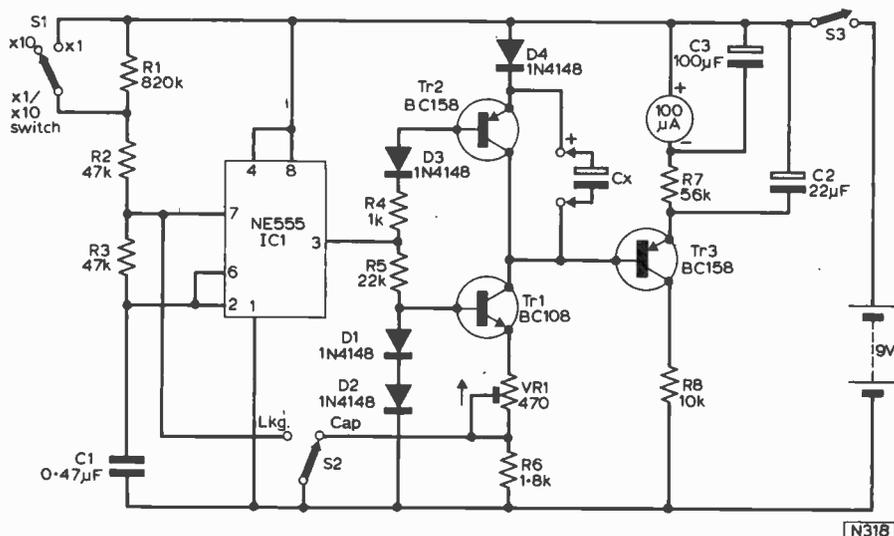
Fig 1: Circuit diagram of the electrolytic capacitor tester.

Transistor $\text{Tr}1$ in Fig. 1 forms a constant current generator, supplying charge current to C_x via $\text{D}4$ and $\text{VR}1$. The diodes $\text{D}1$ and $\text{D}2$ are silicon types and so have a forward voltage drop each of 0.6V , thus fixing the base of $\text{Tr}1$ at 1.2V ($\text{R}5$ can be considered as connected to the positive supply rail via pin 3 at this stage). Now the base/emitter junction of $\text{Tr}1$ forms another silicon diode, again with a volts drop of 0.6V , and so the emitter is at $1.2 - 0.6 = 0.6\text{V}$. From this the emitter current is, by Ohm's law, $I_e = 0.6/\text{VR}1$ ($\text{R}6$ is shorted out by $\text{S}2$ when measuring capacitance). Now the emitter current is also, in the main, the collector current, and so the charge current for C_x is set by the value of $\text{VR}1$. The collector current is fixed at

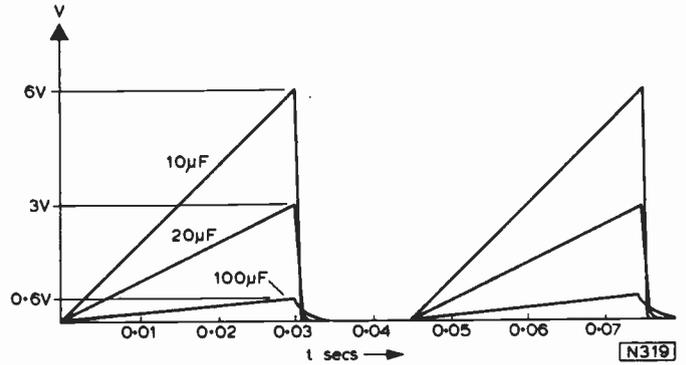
Fig. 2: The maximum voltage reached by C_x is inversely proportional to its capacitance.

The meter movement combined with the series resistor R7 forms a voltmeter with an f.s.d. of 6V. Now were it not for the presence of C2, Tr3 would function as an emitter follower presenting the voltmeter with a faithful reproduction of the waveform across C_x . In practice, however, when C_x discharges, the presence of C2 modifies the situation by

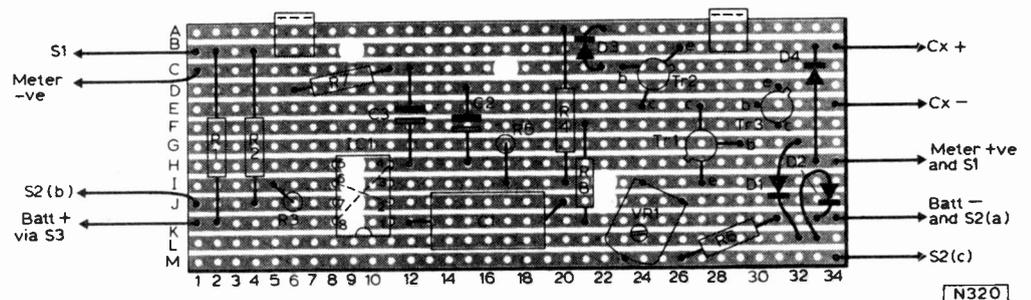
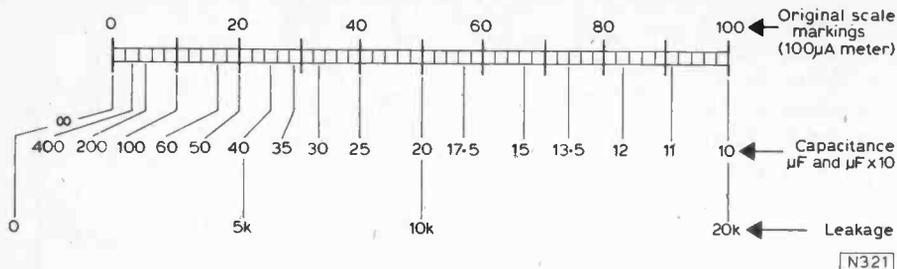
Fig 4: Calibration of the meter scale. For use as a linear scale ohmmeter, the Leakage scale should be fully calibrated.

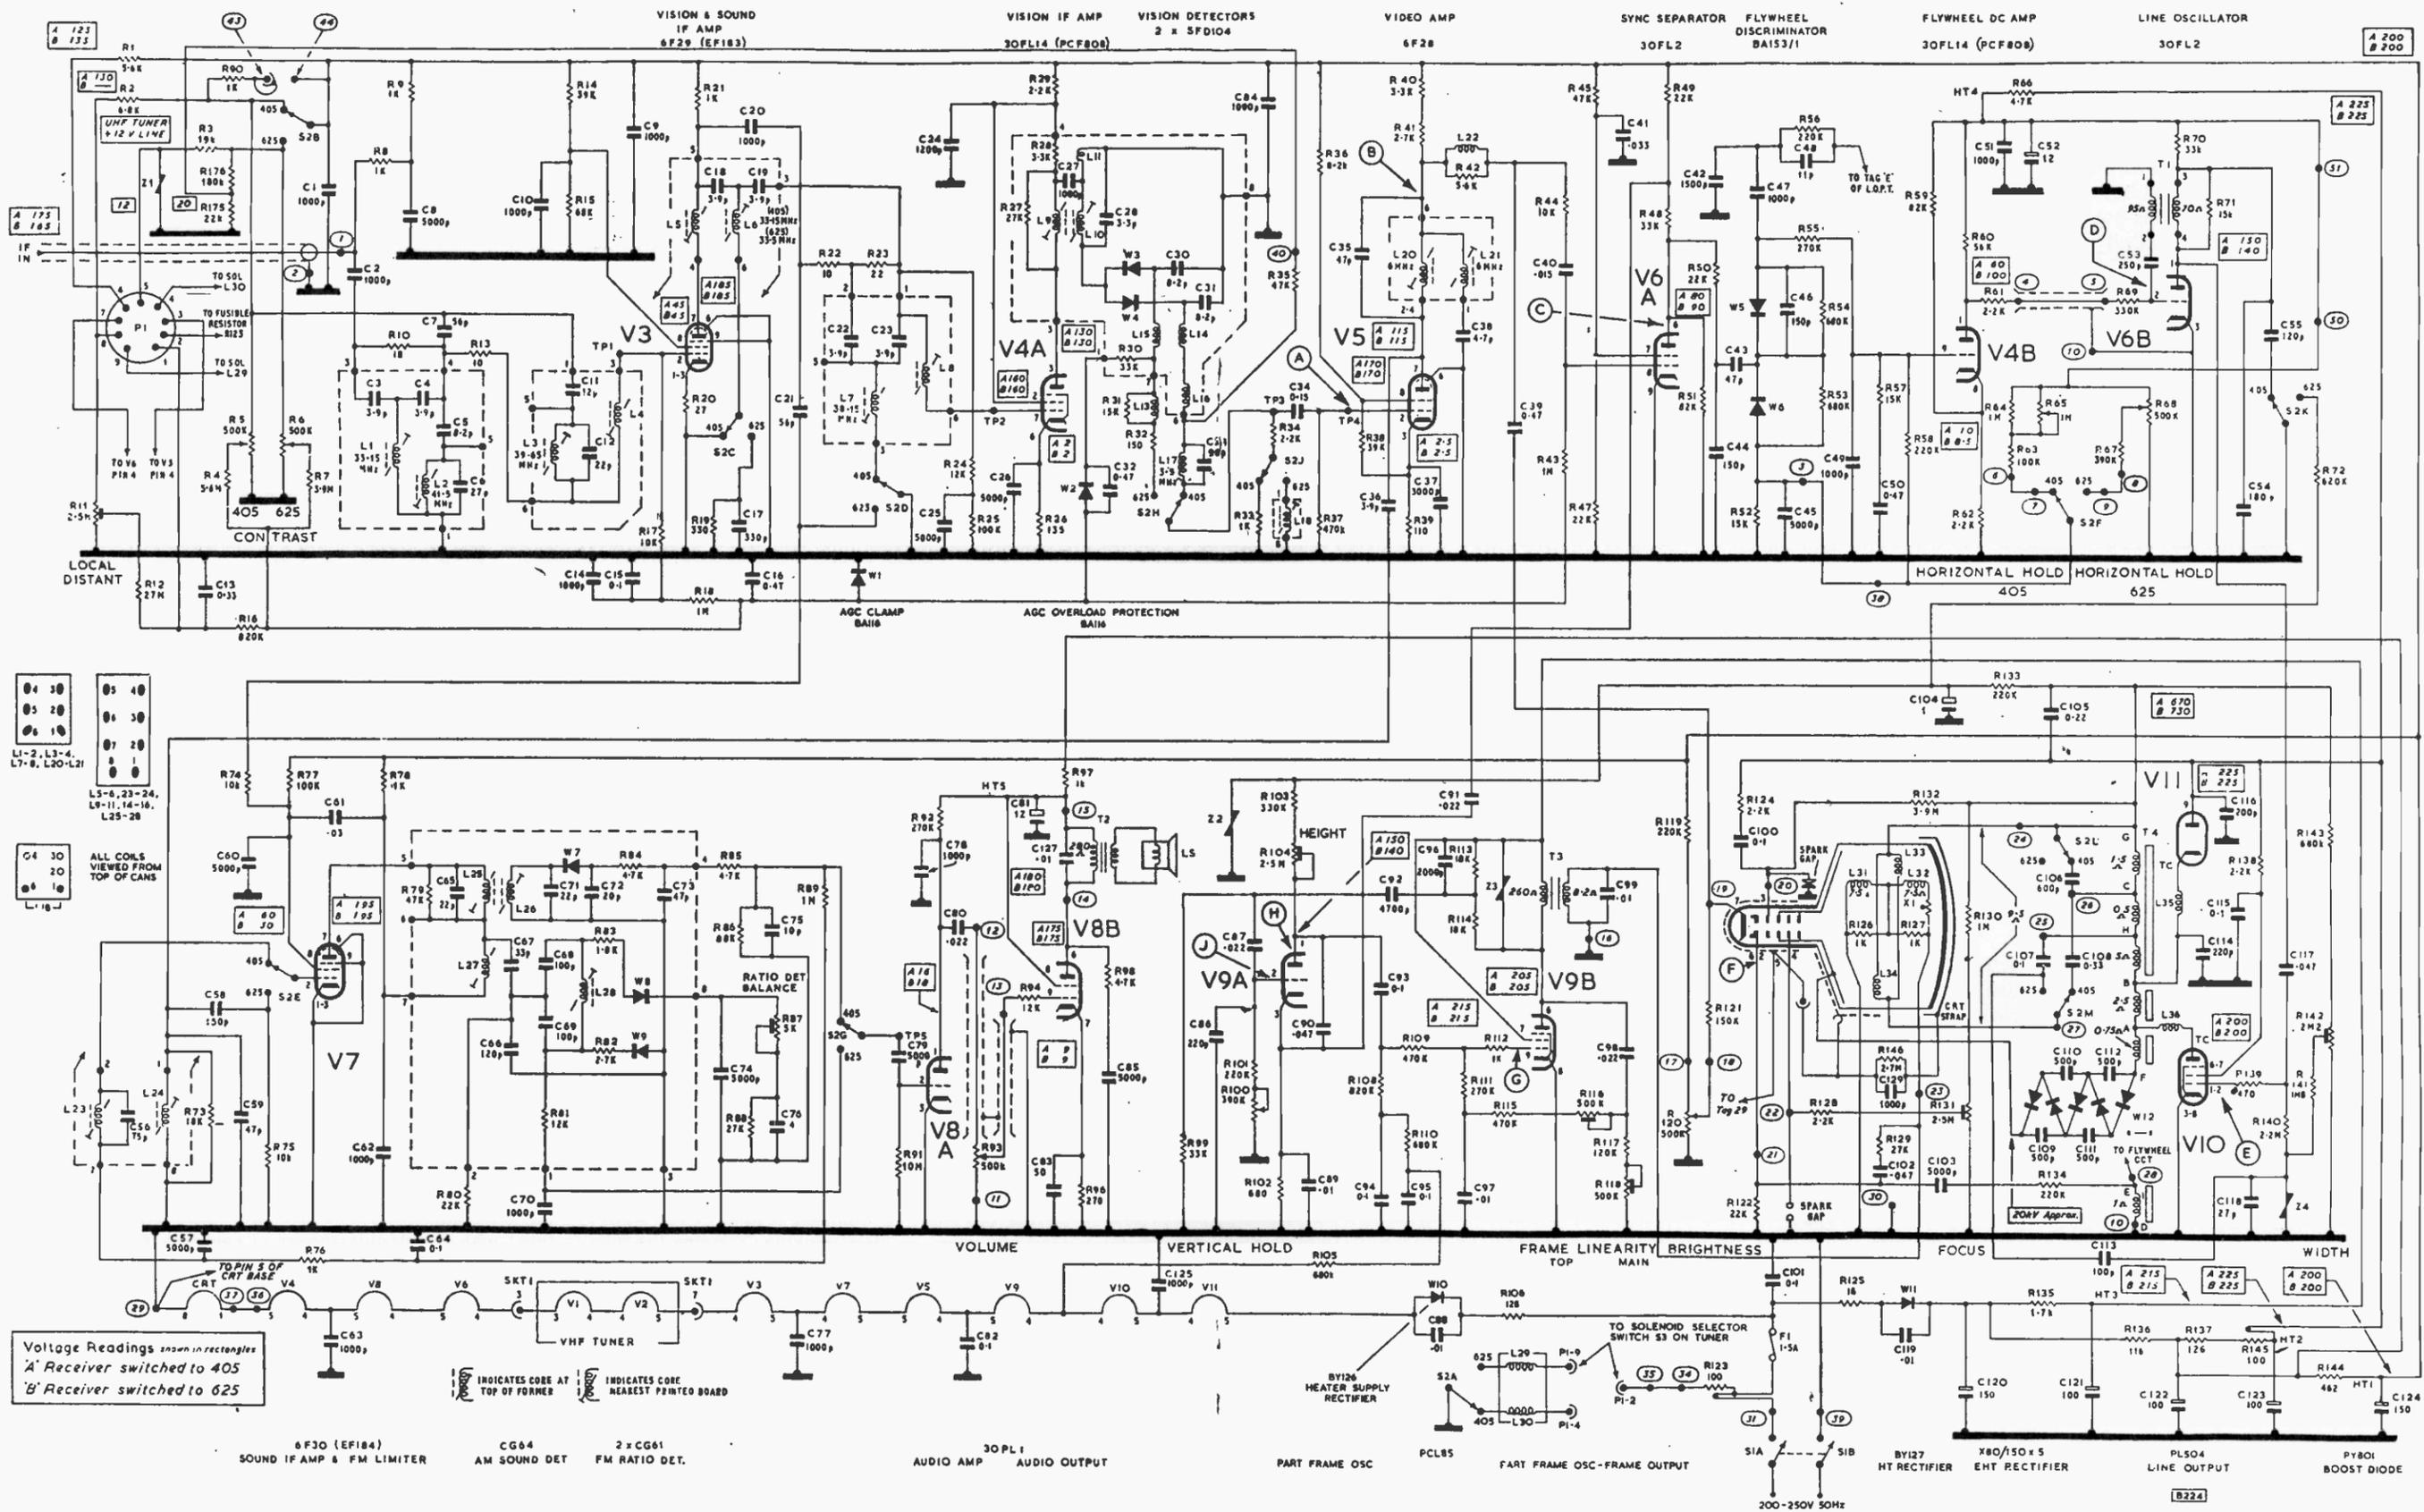
Fig. 1: Circuit diagram of the Thorn 1400 dual-standard chassis - schedule E version incorporating production modifications.

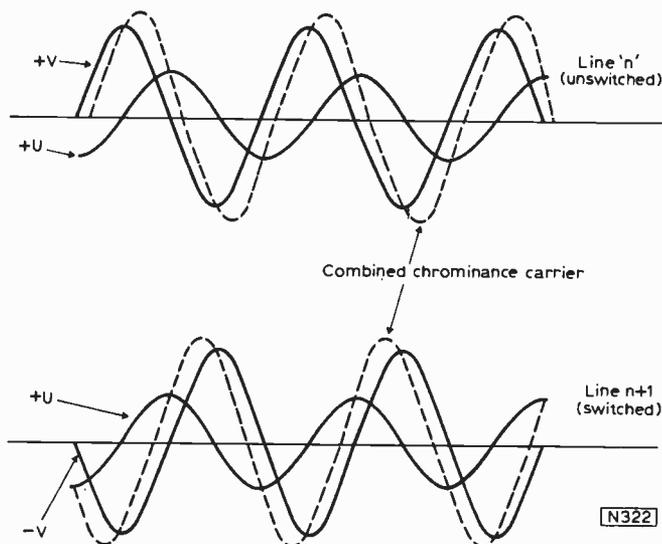
Fig. 1: The chrominance carrier for a purple hue, on successive lines, derived from the U and V signals.

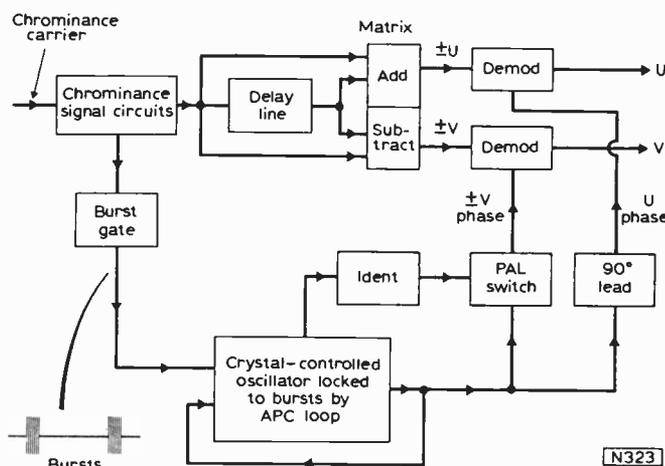
Fig. 2: Block diagram of an ordinary delay line PAL decoder.

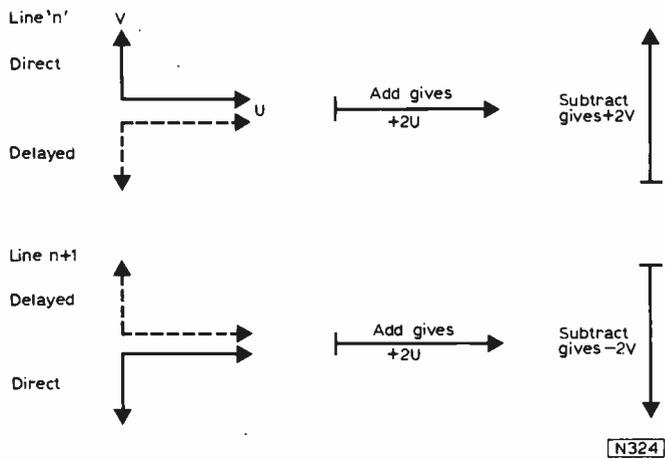
Fig. 3: The delay line/matrix operations on two successive lines.

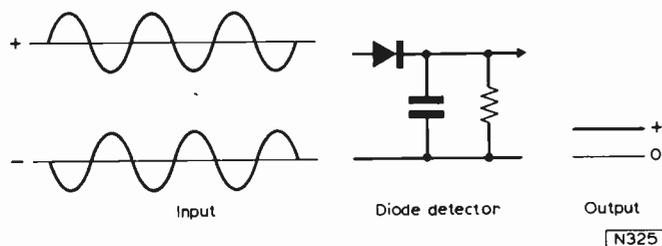
Fig. 4: A simple diode detector will give the same positive voltage output from the two carriers shown on the left.

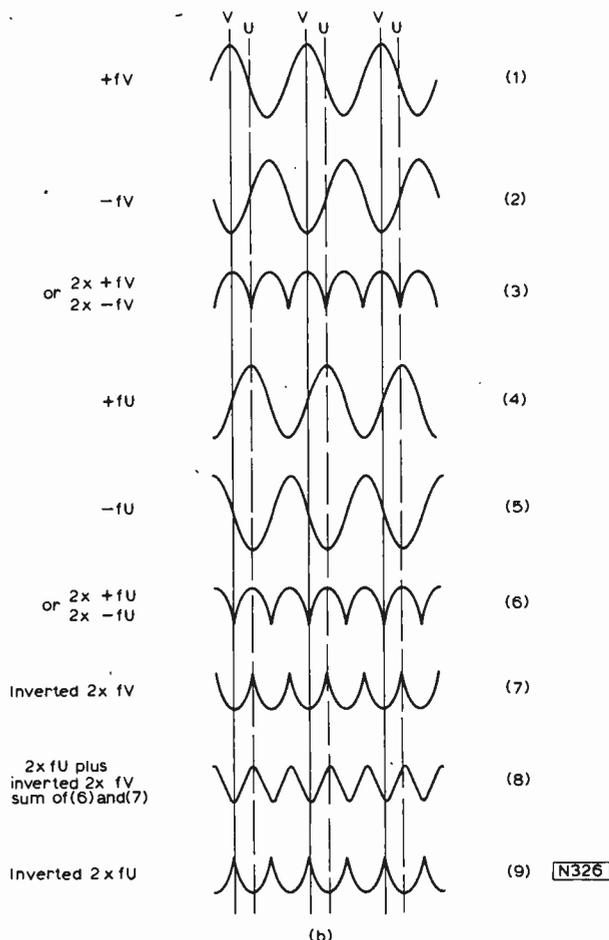
Fig. 5: (a) Frequency doubling by means of a full-wave rectifier circuit. (b) Chroma lock decoding waveforms. Note the phases of the frequency doubled and if necessary inverted U and V signals, enabling them to be used for correct phase locking of the U and V reference oscillators.

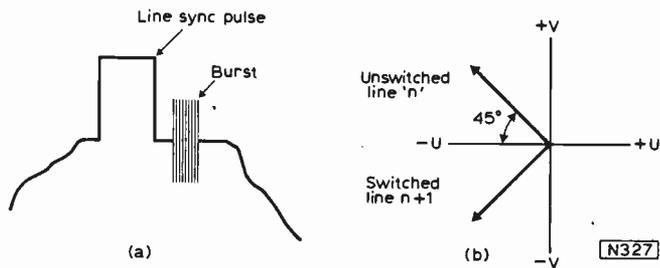
Fig. 6: The burst consists of ten cycles of subcarrier transmitted during the line sync pulse back porch. The phase of the burst alters $\pm 45^\circ$ about the $-U$ phase on alternate lines to indicate whether or not the line contains switched V signal.

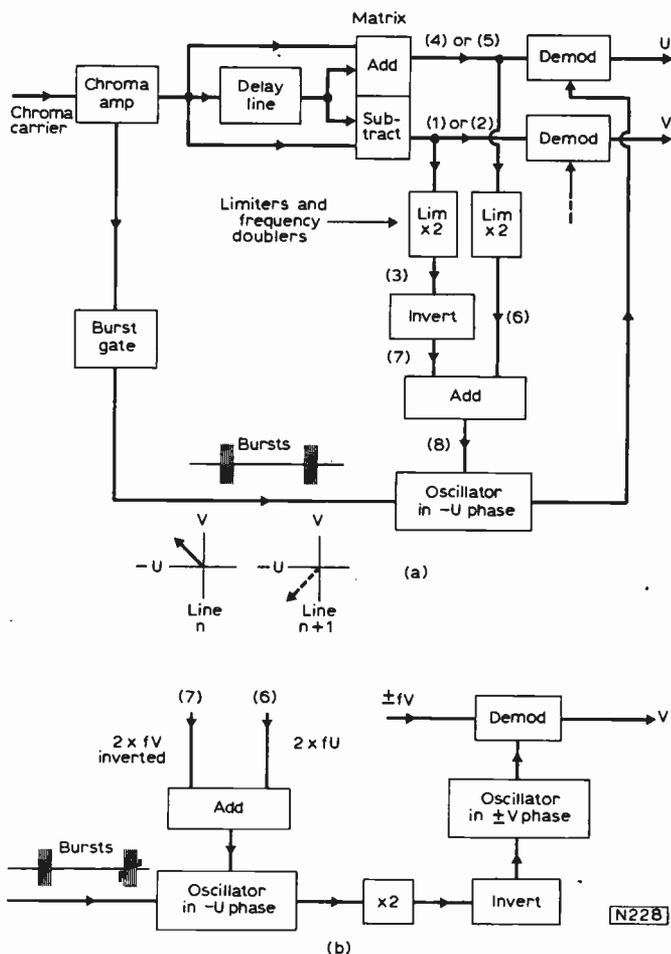
Fig. 7: Simplified block diagram of a basic chroma lock decoder. (a) Generating a reference carrier in U phase. (b) Obtaining a V reference carrier in $\pm V$ phase. For clarity, the a.c.c., blanking, saturation control and colour-killer have been omitted. Numbers (1)-(8) refer to the waveforms shown in Fig. 5.

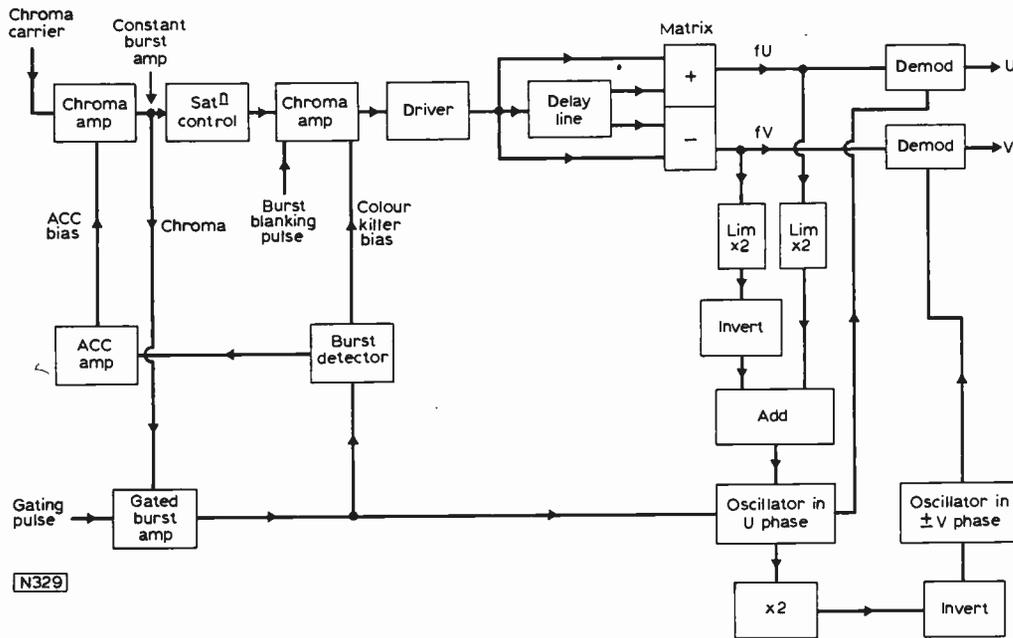
Fig. 8: A complete chroma lock decoder.

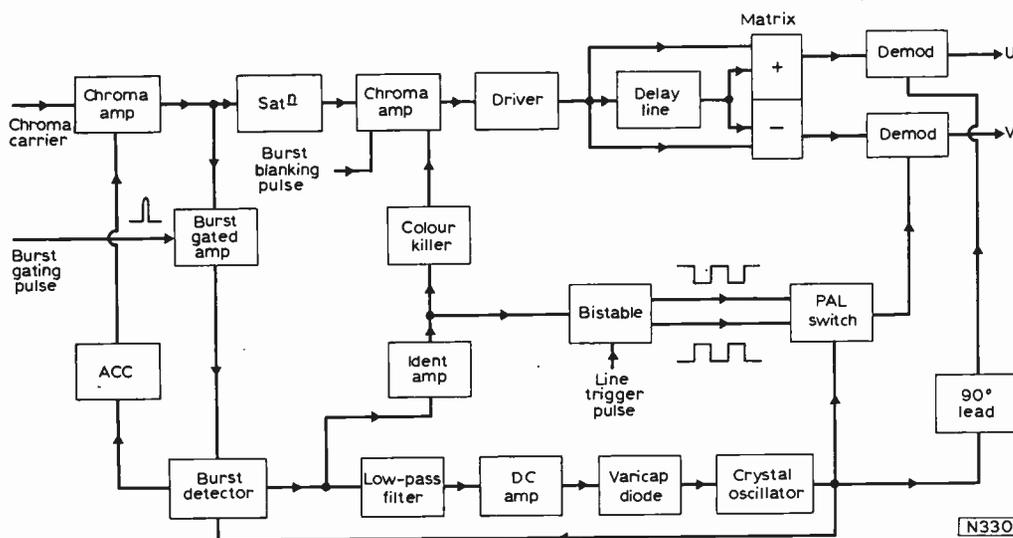
Fig. 9: Normal delay line PAL decoder.

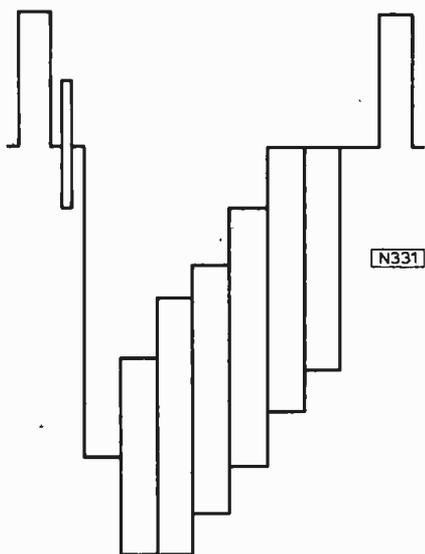
Fig. 10: The composite video signal – for a colour-bar display.

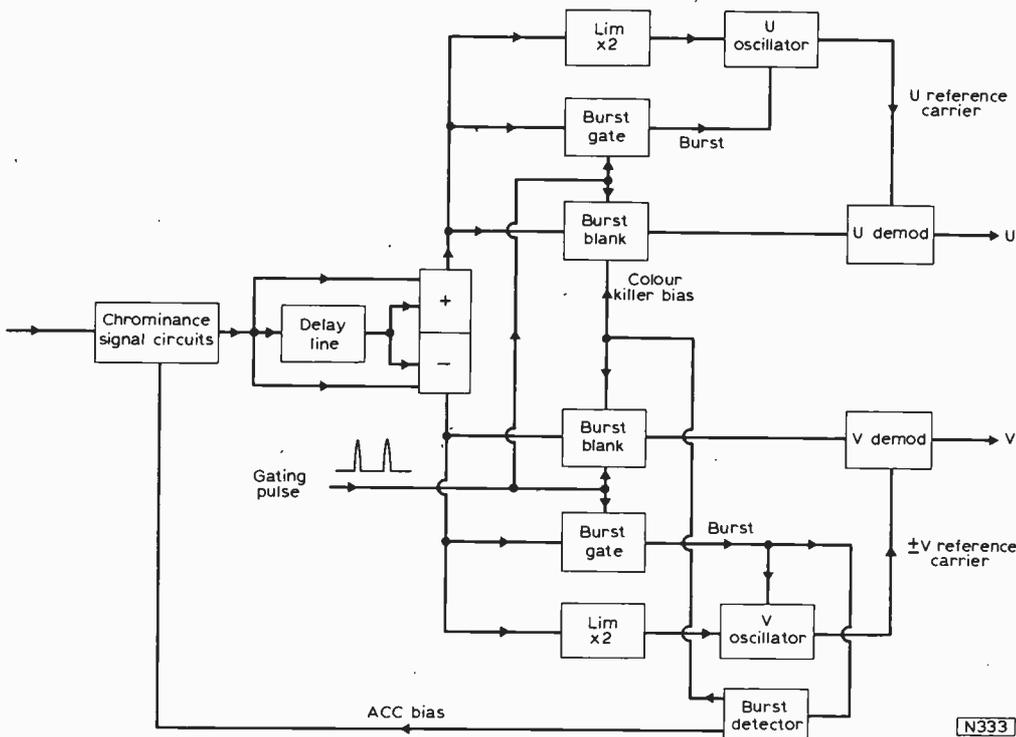
Fig. 12: One of several other possible chroma lock configurations.

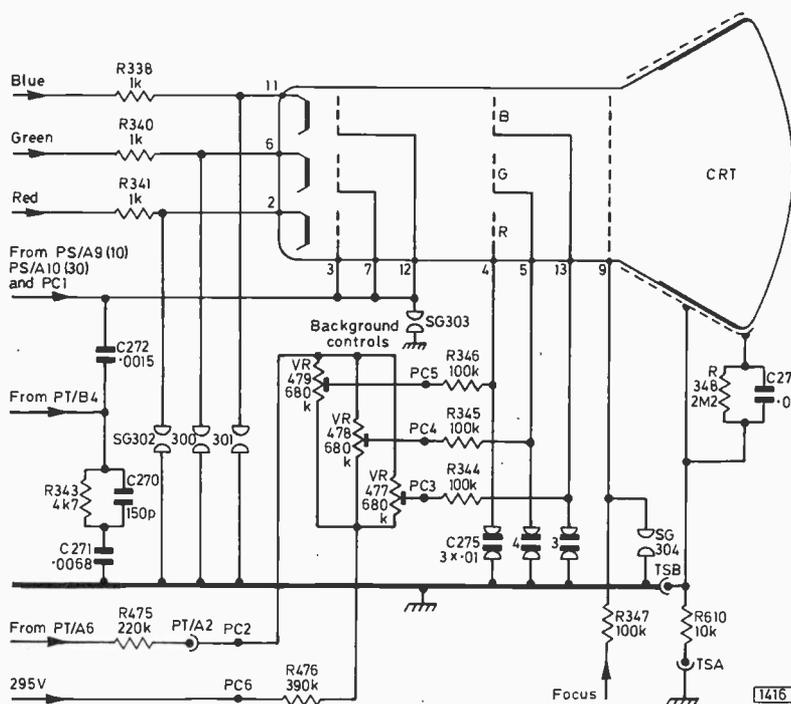
Fig. 1 (left): C.R.T. circuit, 10 series chassis. In the 30 series chassis R610 is omitted, C276 is 0.004μF, VR477-9 are 1MΩ with C409 (0.01μF) shunting R476 and the background controls. C272/R343/C270/C271 are omitted (line flyback blanking is carried out in IC2), the c.r.t. grid bias from R600 and the field flyback blanking pulses from PC1 being fed to pins 3/7/12 via a 10kΩ resistor (R339).

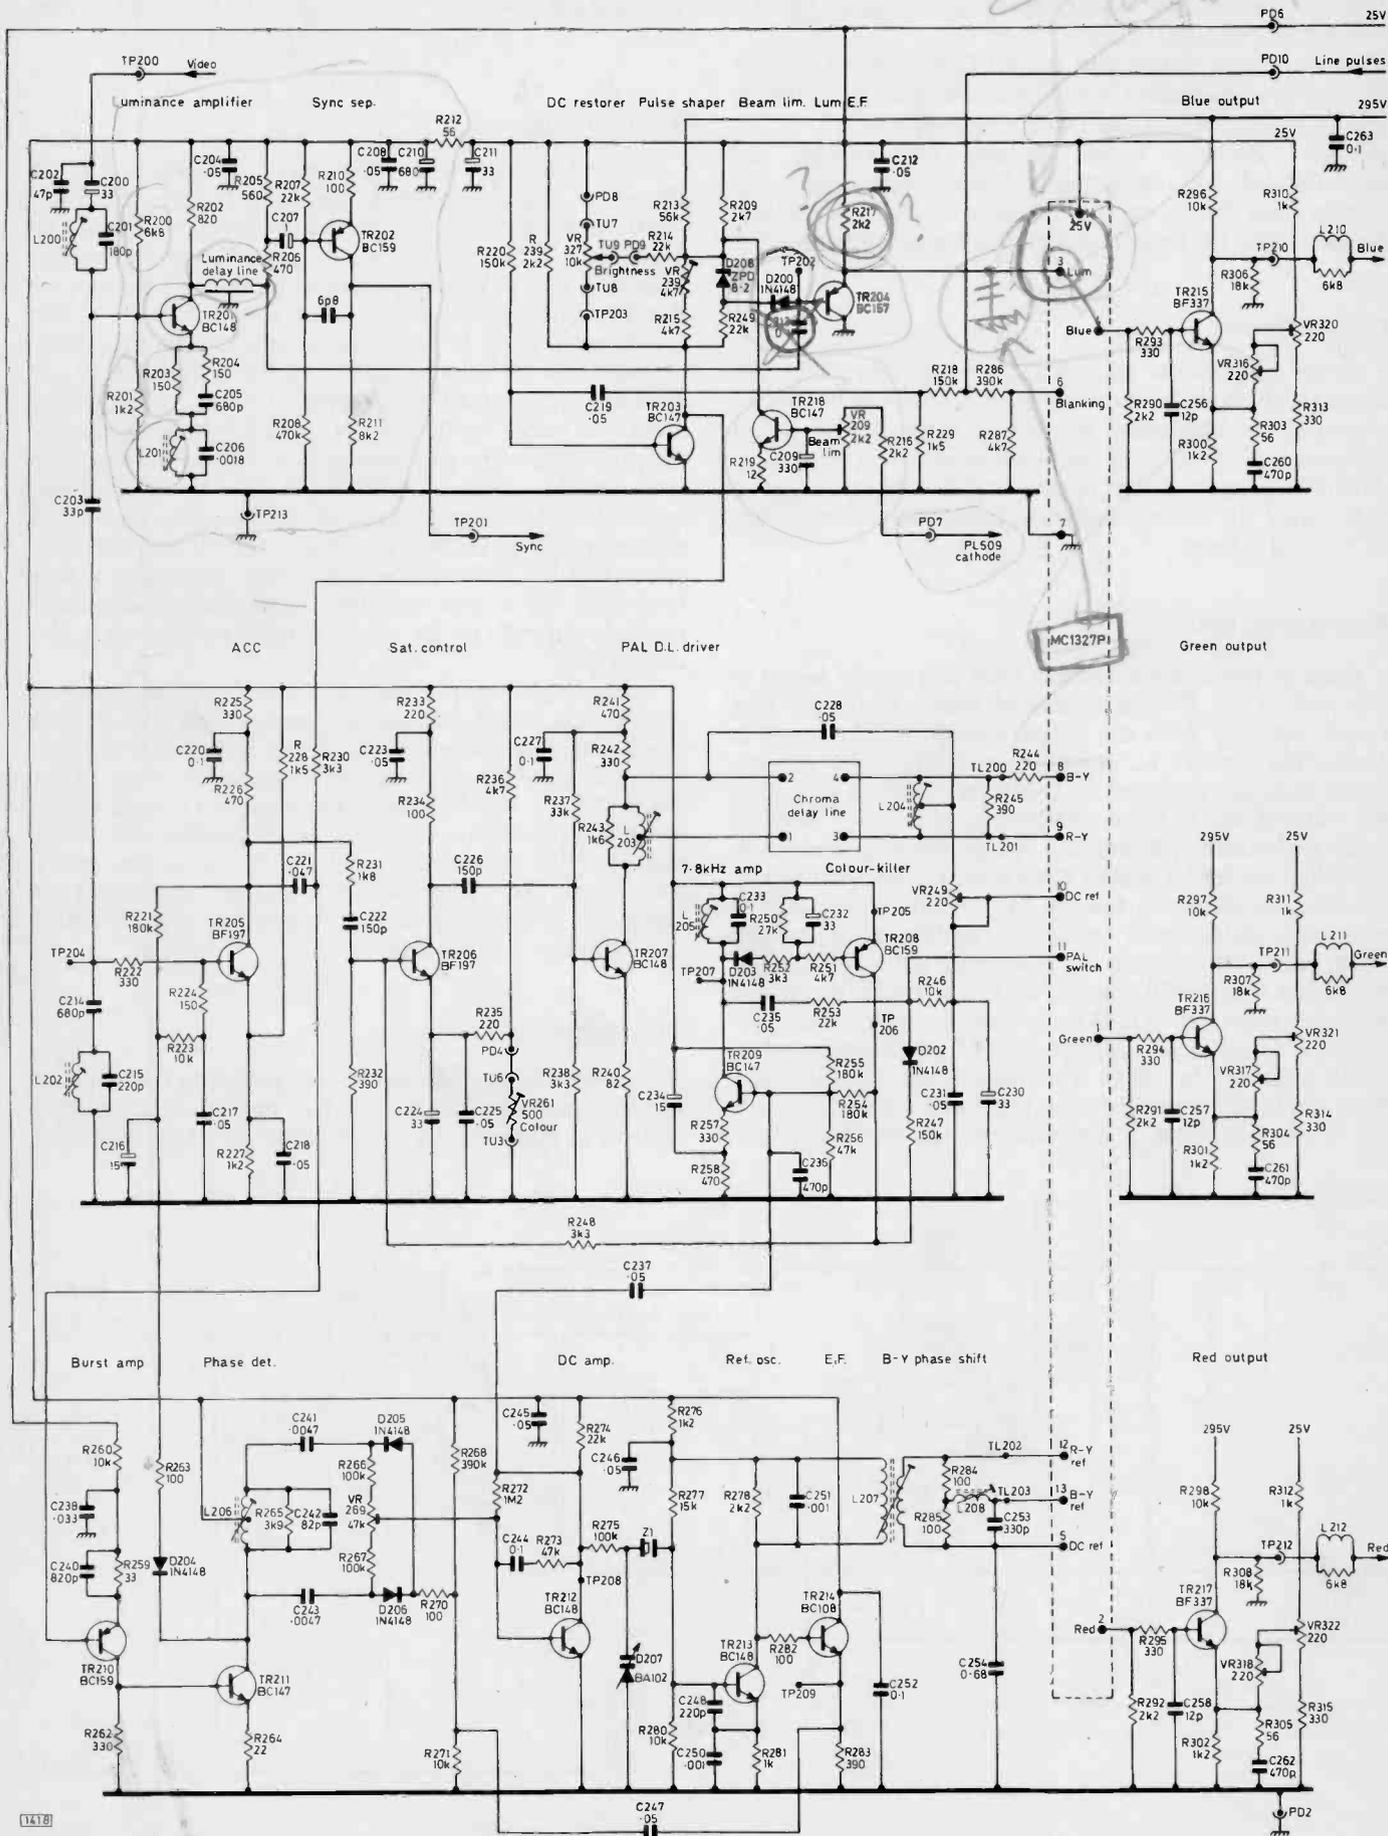
Fig. 3: Circuit of the decoder used in the 30 series chassis.
